Failure paths for levees

February 2022

PREPARED BY
Technical Committee on
Geotechnical Aspects of Dikes and Levees
(TC201)

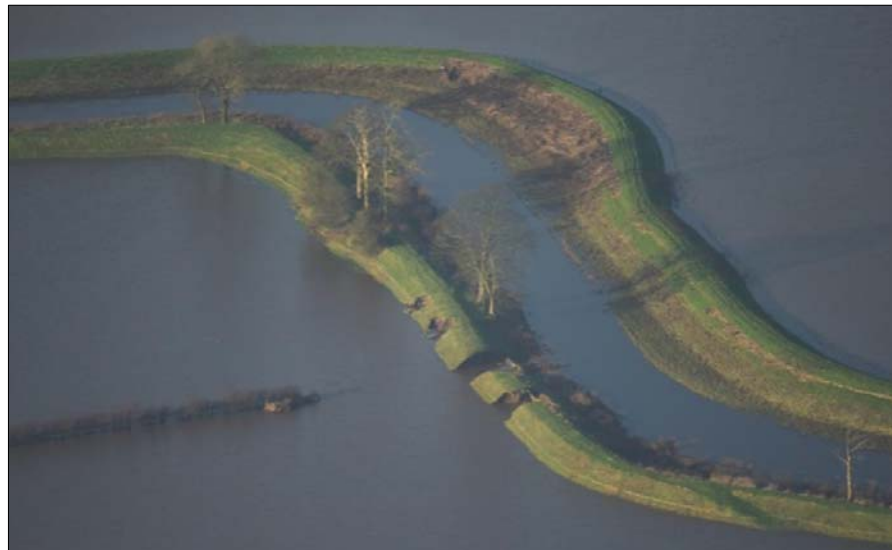
Figure 3.2 Photograph of the situation.

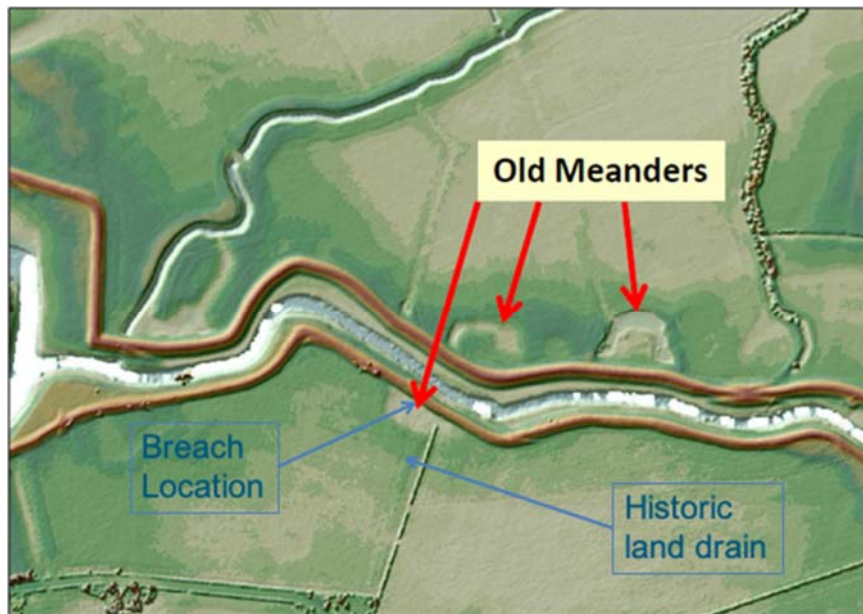
A forensic review of recent LiDAR images showed that the original crest level at the location of the breach was up to 100 mm lower than at surrounding areas. Furthermore, the location of the breach was underlain by both an in-filled historical meander and an old field drain. It is likely that the localized settlement of the crest in the vicinity of the breach was originally caused by consolidation of the in-fill material in the old meander. This meant that the crest level at this location was lower than at surrounding areas; overflow at this location caused rapid external erosion of the levee because of the steepness of the landward slope, about 30 degrees, the quality of the levee fill material (erodibility) and the lack of a landward berm.

Figure 3.4 Overview of the situation.

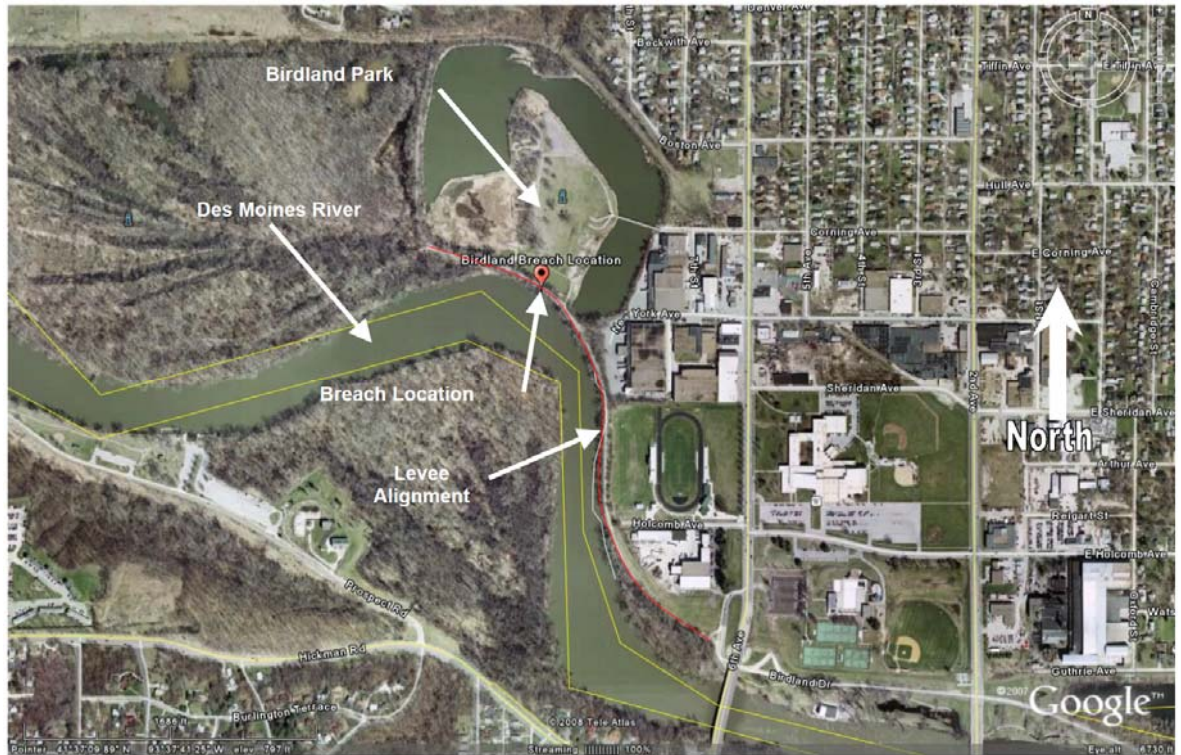
The report predicted that, in the levee's current state of disrepair, there was a 50% chance of failure for a 50-year flood event. By 2008, only a few minor improvements had been funded.

Figure 3.17 Location of the Birdland Levee breach (taken 2007).

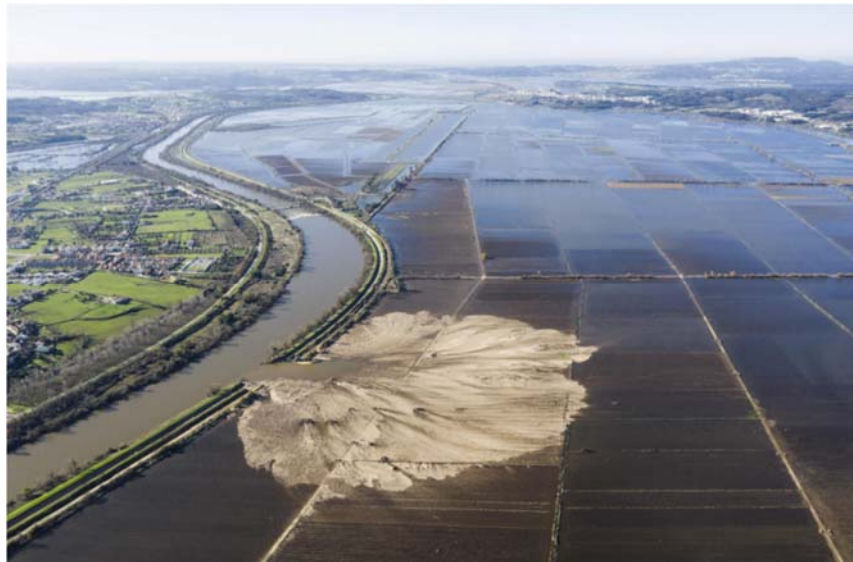
The collapse led to the flooding of the fields in the Central Valley of the Lower Mondego and the cutting of communication routes. Infrastructure was severely damaged, not only the embankment but also the road and the conducting channel at the right bank, for the water supply of agriculture and industries.

Figure 3.20 View of Santo Varão shortly after collapse of the embankment ⁴.

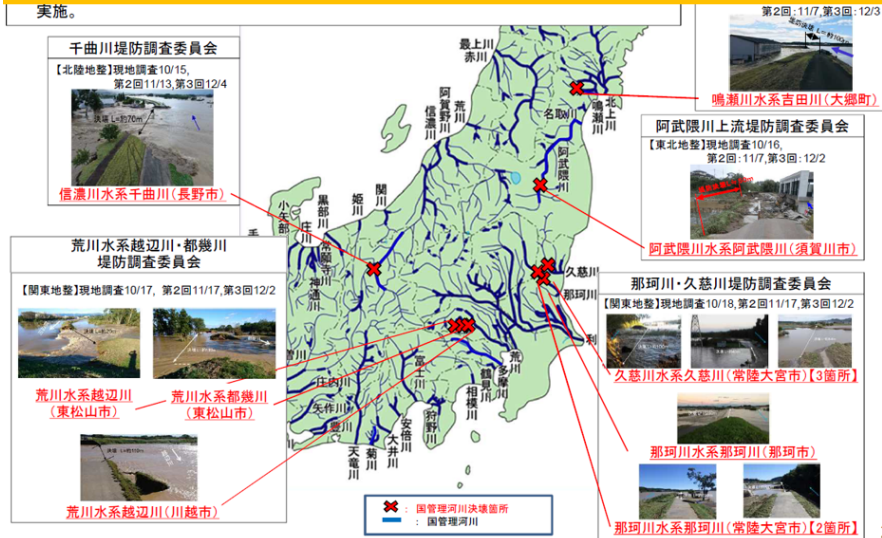
Figure 3.30 Location of overtopping from the presentation 'Picture-Card Show Project' in JGS-JCES', contribution by K. Maeda, M. Ishihara and H. Mori, using materials from the Ministry of Land, Infrastructure, Transport and Tourism in Japan.

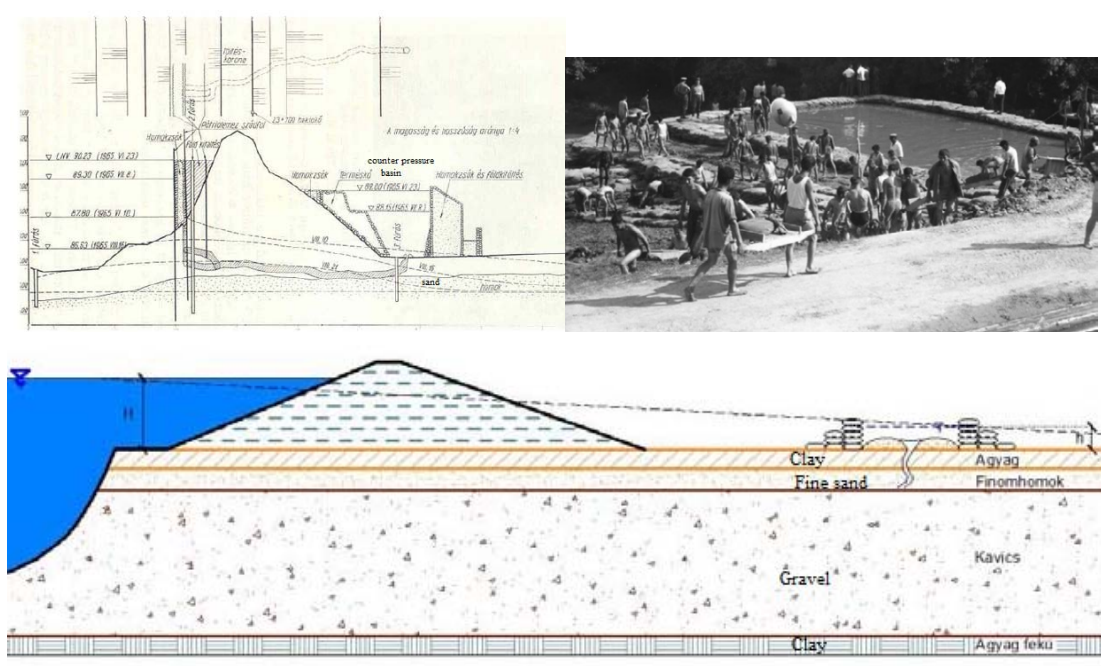
Figure 3.36 Danube, Margitta Island sand boil counter-pressure (top right) and diaphragm walls at the waterside (top left), the cause was the vicinity of an old meander (Garai, 2016). Water level of the counter-pressure basin (bottom).

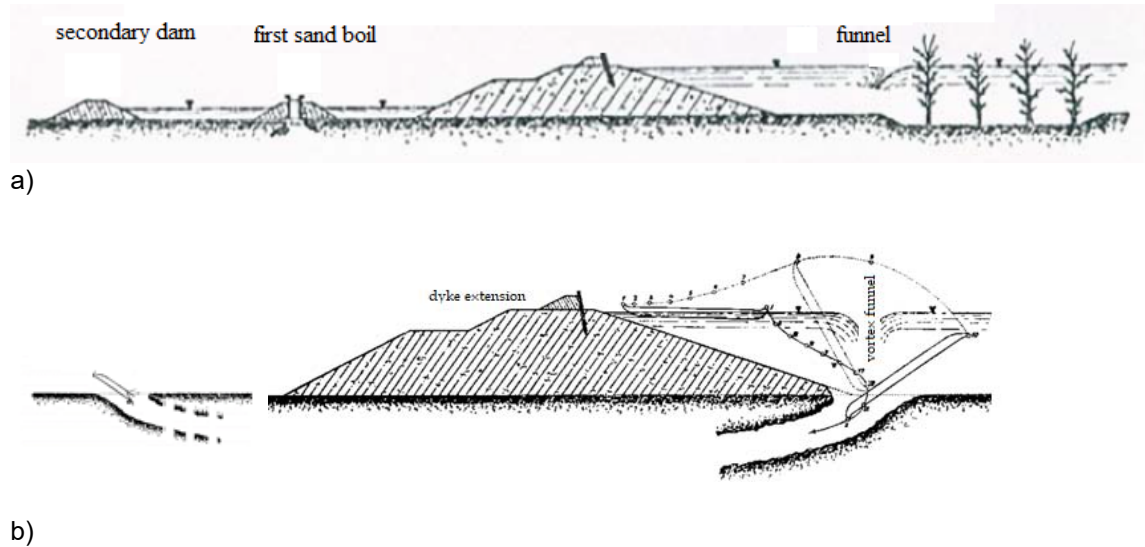
Figure 3.42 Illustration of the boat diving to the pipe, (a) condition some minutes before breach, (b) the path of the boat, which ended on the land side at around the first sand-boil spot.
