## Structural mitigation of a deep-seated slow moving landslide along a major national road in Sri Lanka

**Asiri Karunawardena**

**ABSTRACT:** The government has implemented large-scale landslide mitigation works along the National roads in highland areas to avoid the frequent disturbance of the transport system due to the occurrence of landslides. The stabilization of Kahagolla landslide is one of the largest mitigation works carried out under the “Landslide Disaster Protection Project”. This landslide was first identified in 1957 and creep movements have followed thereafter at different times affecting the road structure. Detailed field and laboratory investigations, instrumentation and monitoring were performed to investigate the characteristics and the possible causes of the landslide. Stability analysis were carried out on the established landslide profile based on the above information and results indicate that some parts of the landslide are in a highly active stage. Also, analysis indicates that the main reason for landslide activation is the increase of ground water level and subsequent loss of slip surface strength. Based on the results of investigations and stability a

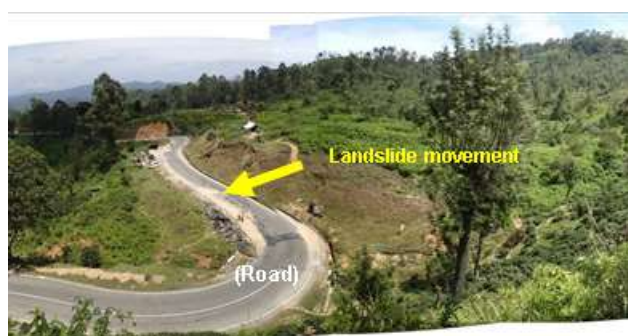
Figure 1. Kahagolla Landslide.

The landslide mass of this site is composed of a colluvium of sand, silt, and boulders. The topographic condition of the site showed features of multiple landslides, gentle but disturbed slopes with a couple of steps formed by smaller scarps, ponds and wet lands scattered in the landslide area. Further, a significant number of open cracks were observed throughout the landslide. According to the topography of the landslide area, the rainfall to the surrounding area flowed into the site in the form of both surface and ground water and was accumulated within the landslide mass and they act as the main triggering factors of landslide. Upsurge of ground water level soon after intense or

prolonged rain period destabilized the slope, along with severe erosion by surface water runoff, thus creating instability in landslide mass and gradual movement of the landslide, damaging the main road located at the toe of the landslide.

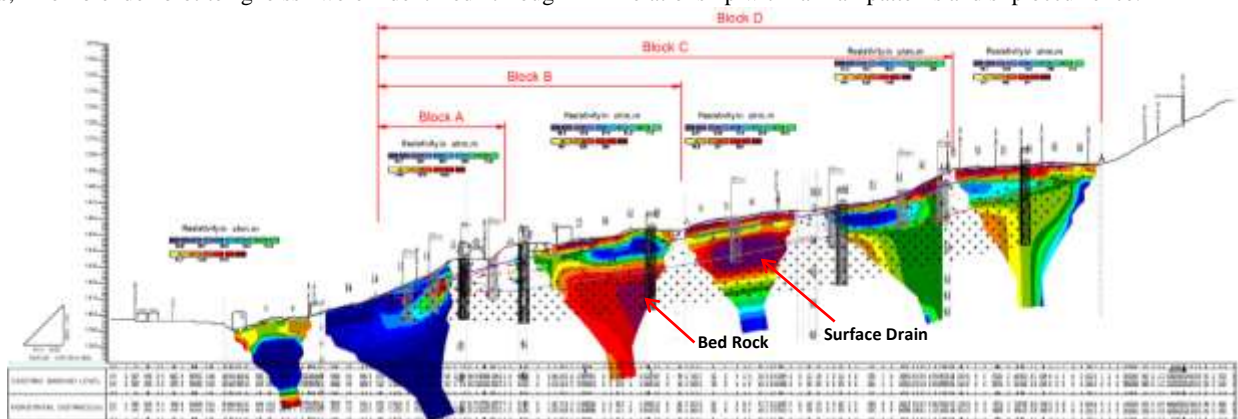
Two types of geophysical explorations, namely seismic and electric explorations (resistivity survey) were carried out at the site. The Two-dimensional electrical resistivity survey was carried out to understand about the weathering state of each layer, depth to the bedrock, aquifers and their continuity, which was very useful in the design of sub-surface drainage. The sub soil profile obtained from the resistivity survey clearly indicated the high water content area inside the landslide. The resistivity profile obtained along the main axis of the landslide is shown in Figure 3.

Figure 3. Resistivity profile along the main axis of the landslide

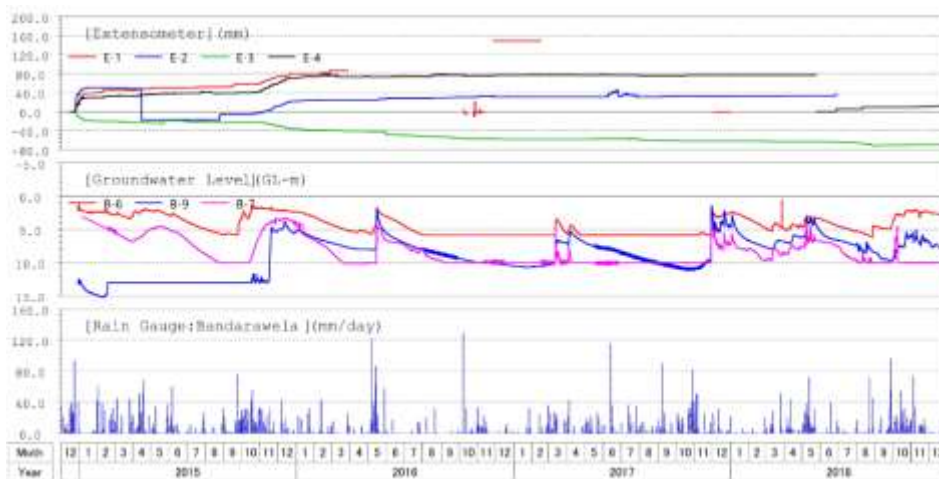
Figure 4. The response of water level meter and extensometer for the rainfall received

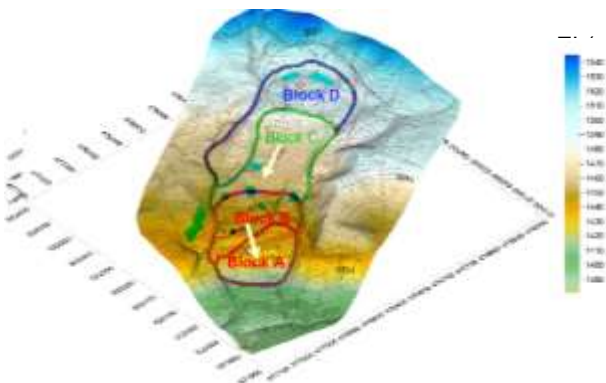
Based on the field reconnaissance and the topographic survey result, the landslide of the site area is divided into four blocks as shown in Figure 5. Block A is located at the toe of the landslide across the road and appeared to be highly active. In block B, height of the scarp was about 3m, however the extension of the scarp towards the side of the landslide was not clear. The main part of the block was gentle but had disturbed the slope. Block C had a 5m high scarp and bare ground was observed around the scarp. Extension of scarp was clearly observed as a form of minor scarp. The main part of the block had a disturbed slope. In the area identified as Block D, the steep slope was located along the estate road and identified as the head scarp. Heavy water seepage and surface water flow were observed in this block during the rainy period. Monitoring results indicated that some parts of the landslide moved actively in rainy seasons. The landslide itself moved repeatedly every year and caused frequent damages to the road. Based on the results of monitoring, it was understood that the landslide area of this site moved intermittently during rainy seasons by various degrees; Block A was the most active but Block B, C and D were still active more or less. This means the countermeasures for the site needed to cope with all blocks. As for the relation of the blocks, it was likely that Block A became activated first then other blocks followed in order of Block B, C and D. It was a rational observation that the blocks moved mutually dependently, and that activity of one block affected the other block consequently.

Figure 5. Identified Landslide blocks and movement direction

The direction of the landslide movement was assumed to head straight to block D and the main traverse line of this landslide was presumed at the center of landslide body delineated by the mountain stream on both sides. The direction of the landslide movement was, however, controlled by the stable ridge located at either side of the landslide body at the middle to lower slope. At the middle of the body, the landslide changed its movement counterclockwise and Block B, and subsequently Block A, moves straight to the main road.

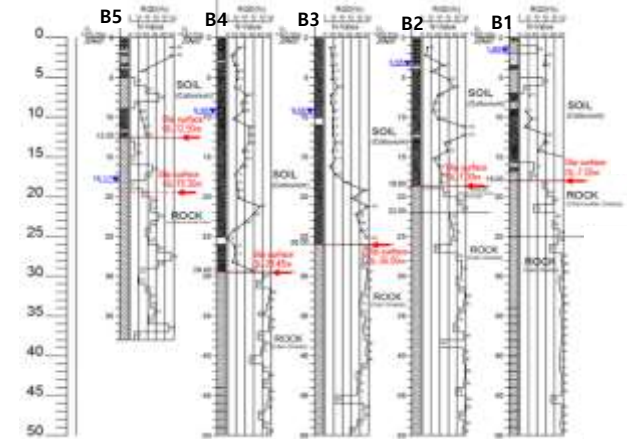
The estimation of the slip surface was mainly done using the core samples collected through the drilling investigation. Typical characteristics of the slip surface such as a thin layer of clay with high water content which is deposit at boundary of stratum were investigated. An effort was made to identify the slip surface on the drilling core sample, based on the above features. In addition, results of the monitoring of inclinometer and pipe strain gauge were considered in the identification of slip surface. However, due to limitations in the quality of core sampling available for the site, the slip surface of the site was assumed mainly based on the boundary between bed rock and overlying colluvium and assumed depth of the slip surface in boreholes is shown in Figure 6. For some sections, the slip surfaces were considered as running through the weathered rock strata. The landslide map and the landslide profile with assumed slip surfaces based on the above data is shown in Figure 7 and Figure 8.

Figure 6. Identified slip surface using output of borehole investigation

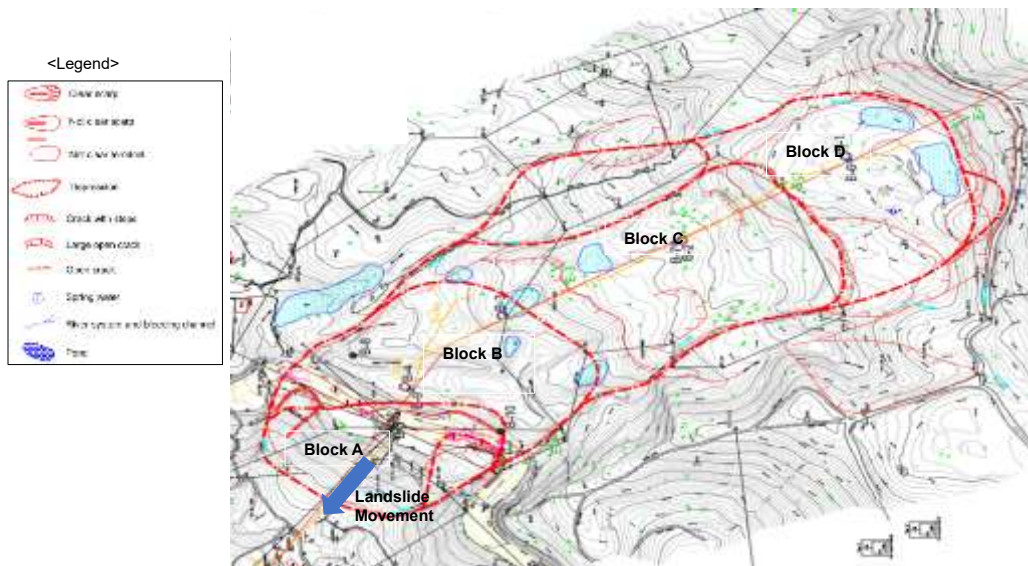
Figure 7. Landslide map showing landslide features

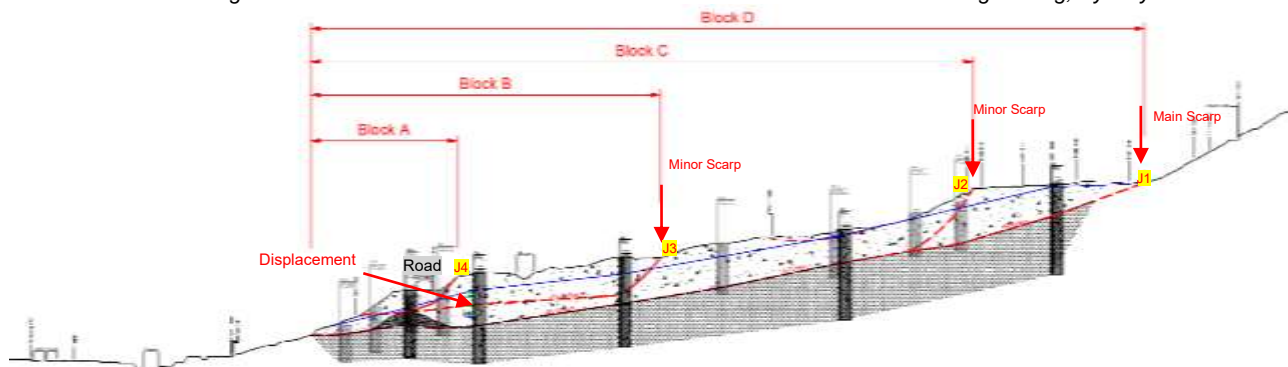
Figure 8. Landslide profile with assumed slip surfaces (J1, J2, J3, J4)

Counterweight embankment plays a huge role in stabilizing the slip surface J1 and J2 while other most critical slip surfaces are stabilizing with groundwater control works. However, in order to achieve desirable safety margin in slip surface J4, ground anchors are also included in the design.

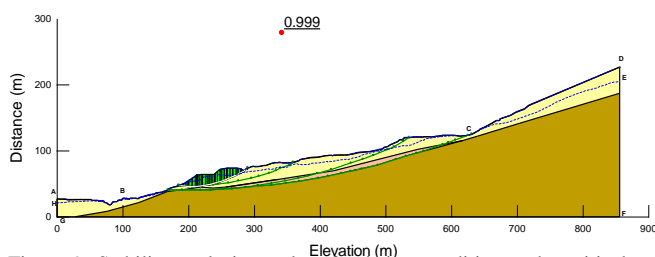
Stability analysis was carried out for the assumed landslide profile and slip surfaces. The analysis was carried out using GeoStudio 2016 from Geo Slope. The Morgenstern Price method was utilized in the analysis as the assumed slip surface geometry of the failure was irregular in shape. The unit weight ( $\gamma$ ), cohesion ( $c'$ ), and the friction angle ( $\phi'$ ) of 18 kN/m<sup>3</sup>, 10 kN/m<sup>2</sup> and 32° respectively was used in the analysis. These parameters were obtained from the laboratory tests conducted from the shear undisturbed samples collected from shear surface of the soil. The ground water level required for the analysis was estimated from the field monitoring results. The performance was verified at critical water level, i.e ground water level when landslide starts to slide. This situation is considered a critical state and the factor of safety at the time of landslide is considered as the critical safety factor and its value was taken as 1.0. However, the factor of safety obtained was considerably higher than 1 and indicated that the shear strength parameters obtained from the laboratory test results were not representative of the properties of the slip surface. This may be due to the heterogeneity of soil characteristics, the disturbance to the soil samples in the process of extraction and testing, sample location not representing the whole area etc. Therefore, selection of appropriate shear strength parameters for the analysis were done by simulating the critical state (FOS=1) of the landslide. Shear strength parameters obtained from the laboratory were used as reference for the trial simulation. Trial analysis were done for different shear strength parameters. Previous studies done for Watawala landslide in Sri Lanka shows that cohesion value of the slip surface was relatively small (Rajaratnam and Bandari 1994). Analysis indicated that when  $c' = 5.25$  kN/m<sup>2</sup> and  $\phi' = 17^\circ$ , stability model reasonably simulates the observed field deformation condition. Stability analysis results of existing condition of Block A under critical water level is presented in Figure 9.

Figure 9. Stability analysis results of existing condition under critical water level \_Block A

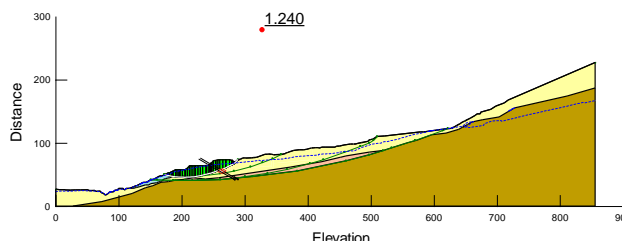
Figure 10. Stability analysis results with mitigation option of using ground anchors for Block A

Stability analysis had been conducted to determine the scale and quantity of landslide countermeasure works required to maintain the stability of the landslide and so ensure the target safety factor. The design safety factor of 1.2 was targeted by considering infrastructure such as main transport road, some houses, tea cultivation and stream that could be affected in the event of a landslide occurrence. In the selection of design safety factor, both technical and financial aspects were considered. The effectiveness of application of countermeasures were analyzed by GeoStudio 2016 using the Morgenstern Price which is widely used for simple landslide stability analysis. In the selection of countermeasures both control type and preventive type works were examined. Control works were designed to mitigate the landslide by changing natural conditions such as topographic and ground water conditions. Preventive works were designed to stop part or all landslide activity using restrain forces by artificial structures such as retaining wall, soil anchors, piles etc. Stability analysis results with mitigation option of using ground anchors for Block A is presented in Figure 10.

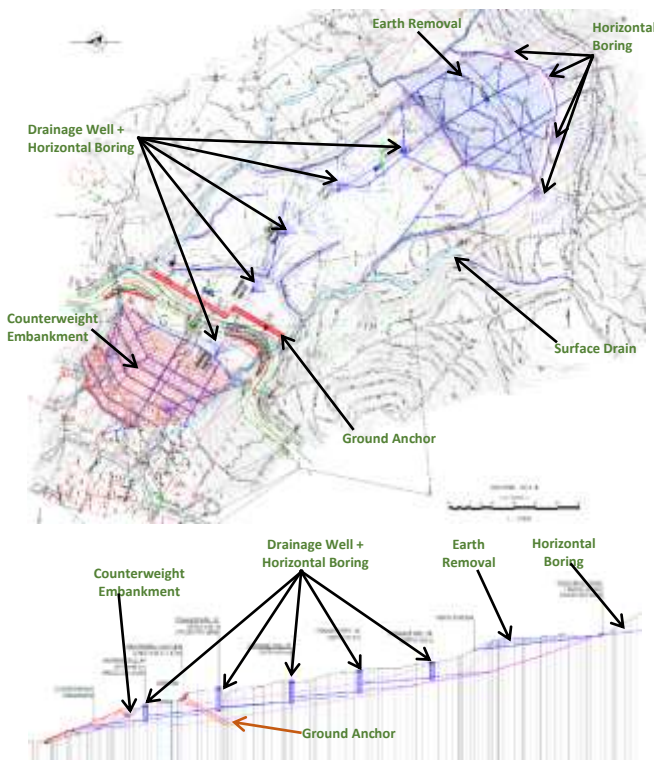
Figure 12. Plan view and cross section of proposed countermeasures

Based on the results of investigation and stability analysis, several suitable combinations of countermeasures were considered, and examined to decide a couple or more appropriate combinations of countermeasures in terms of both economic efficiency and design requirements. From the more appropriate combinations of countermeasures, an optimum combination of countermeasures was selected by careful examinations and comparison among them. The improvement of safety factor with application of each counter measures are given in Figure 11. The plan and cross section of proposed countermeasures for the landslide mitigation are given in Figure 12.

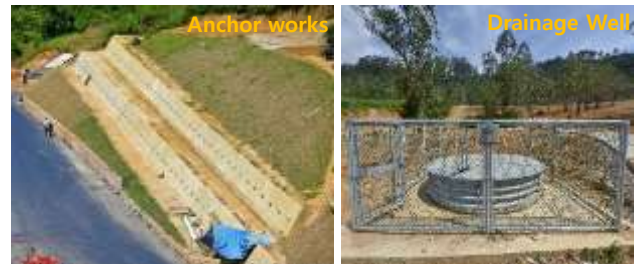
Figure 13. Photographs of implemented countermeasures

The designed countermeasures were constructed at the site using the Japanese technology and in accordance with Japanese Standards in order to stabilize the landslide. Work was carried out under the full supervision of a Japanese expert and transfer of the technology to the local construction industry was expected. Stabilization involved the construction of surface and subsurface drains and drainage wells to lower the ground water levels. Surface drains were constructed to intercept and divert the surface runoff reducing infiltration and divert the surface water away from the landslide. The drainage wells with horizontal drains were constructed at identified locations to control the ground water level below the design level. Earth removal at the head of the landslide and counter embankment construction at the toe area of the landslide was done with the aim of balancing the force and improving the overall stability of the landslide. Ground anchors were installed just above the road which was

located at the toe region of the landslide to prevent the shallow landslide which caused the frequent damages to the road.
