Economizing the Soil Nailing Design by Drainage Improvement – Case History at Ginigathhena

S.O.A.D. Mihira Lakruwan^(1,2), S.A.S. Kulathilaka⁽³⁾

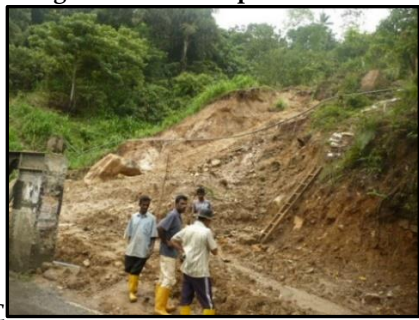
Fig. 3 Failure after toe excavation

rapidly with economic and population growth in the area. Based on that, the bridge was proposed to be widen. Some excavation was done at the toe of upper slope of the bridge on the purpose of widening the bridge. Ancient landslide above the bridge got activated with this excavation and the failure was propagated to upper slope. It was reported that there was no rain at the time of the initial failure. With the occurrence of rainfall in the area later, failure was further activated. Fig. 2 and Fig. 3 shows the location map of the area and failure just after the rainfall event respectively.

With the high ground water table of the area, slope was already at a critical stable condition and with the removal of the toe support by the excavation at the toe, slope became unstable leading to reactivation of the landslide. With the rainfall that occurred in the area

latter, landslide propagated further. After the failure, the unstable soil mass was supported by the bridge structure and slope was at critical stable condition. However, there was a possibility of further activation of this landslide as a deep-seated failure with heavy rainfall and such activation would have been led to a catastrophic failure damaging the bridge and the road. Also, there was a requirement for road widening. Therefore, it was decided to mitigate this landslide while accommodating the widening requirements.

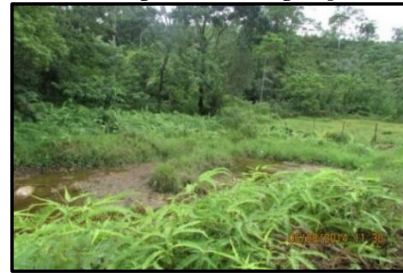
Fig. 4 Marshy area at the top

Landslide area is covered with thick colluvium deposit with boulders, which had been transported from the ancient landslide. This is underlaid by highly crystalline metamorphic bed rock. Main landslide area is a sloping ground with an undulating topography and just above the crest of the landslide there is a water logged marshy area which is the main reason for the prevailing high water table in the area. Water collected in the upper slope is flowing through the water stream at a side of the landslide. Fig. 4 and Fig. 5 shows the waterlogged marshy area at the top and the stream flowing at a side of the landslide respectively.
