### **The Geo-Engineers without Borders Committee**

## The Mulitaka landslide, Papua New Guinea, May 2024

## Heavy rains in Rio Grande do Sul, Brazil, May-June 2024

### The 2025 Myanmar earthquake

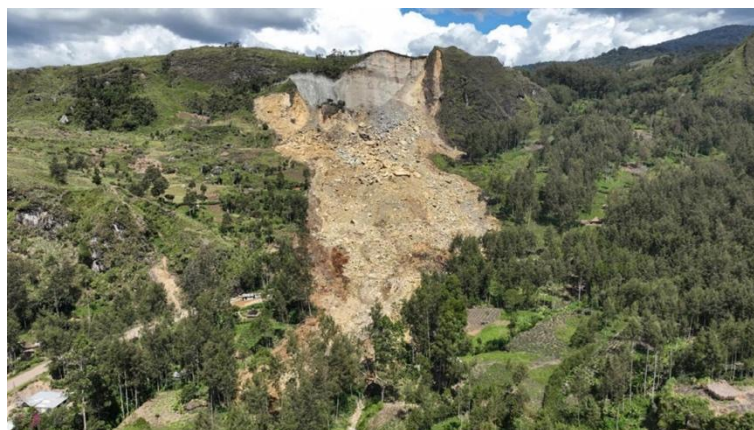
In the Enga Province of Papua New Guinea's Highlands, part of Melanesia, an approximately 650 m long and 150 to 200 m wide landslide occurred on 24 May 2024 at 03:00 local time.

*Figure 1. The Mutilaka landslide in Papua New Guinea (24/5/2024). The landslide is 650 m long. (Photo Dr. Jan Kupec).*

The landslide inundated multiple dwellings, resulting in several hundred fatalities. It is believed to be a rock topple mechanism where toe buckling occurred on very steep bedding, affecting dwellings located near the Highland Highway. Authorities estimate that hundreds of people were living directly below and in the run-out area. The landslide also appears to have triggered multiple rotational and translational landslides, some of which were several hundred metres away from the initial debris run-out area.

The team proposed a realignment of the roading corridor to avoid an area considered highly susceptible to further landslides, including rainfall triggered slope instability.

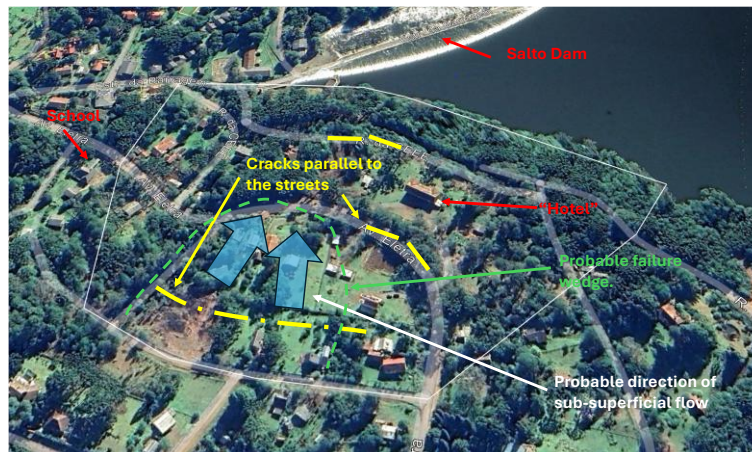
Figure 3 shows a downslope movement towards the Salto dam reservoir close to Santa Francisco de Paula, with the cracks parallel to the streets observed, the probable wedge failure derived from our observations and the probable direction of sub-superficial flow. A critical issue was to know whether or not it was possible to reopen the school whose classes had been suspended. Together with the Geological Survey of Brazil, we concluded that it was located outside the risky zone and could be reopened.

*Figure 3. Downslope movement toward the Salto Dam Reservoir and nearby school outside the risk area.*

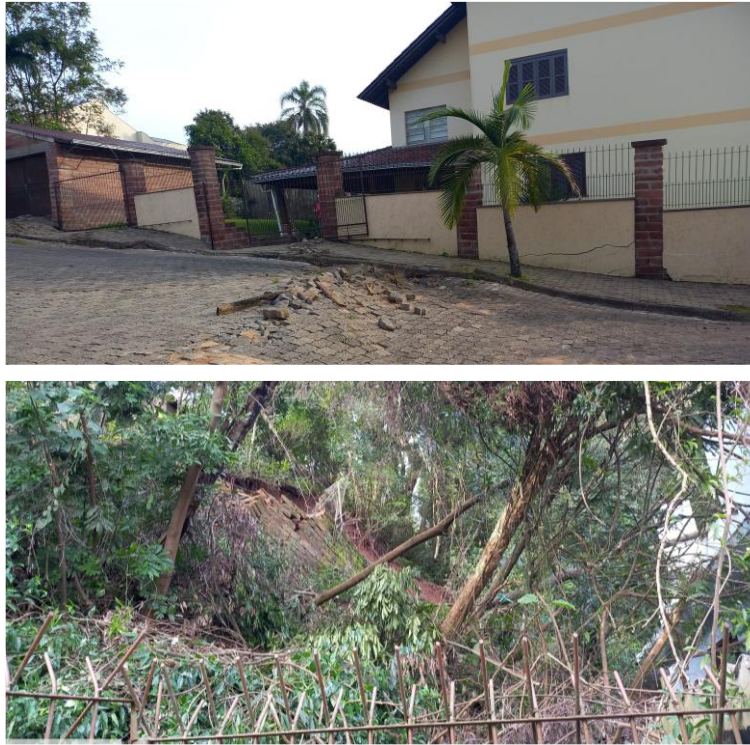
In Santa Cruz do Sul, observations showed that the main cause of the problems lied in pre-existing instabilities that were worsened by rainfall. The entire region has been subject to ground movements for years, and this intense event not only intensified the problem (see Figure 4) but also, in a way, exposed the underlying causes.

*Figure 4. Cracks in streets and instability suggesting large scale ground failure.*

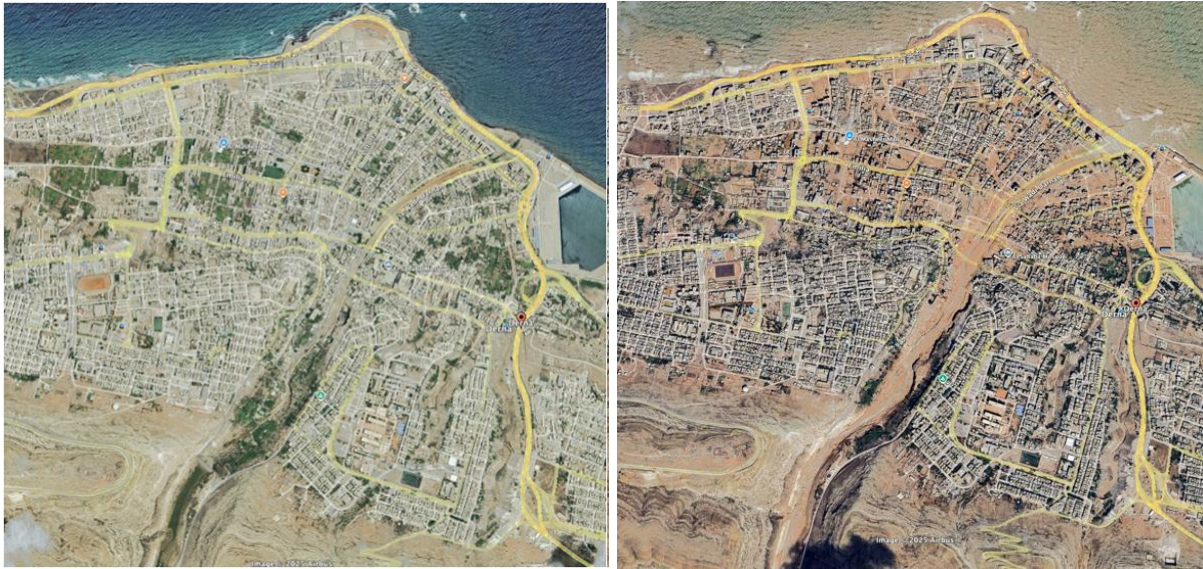
Figure 5. Views before and after the devastation due to the floods in Derna, Libya, on September 18, 2023 (Google earth).

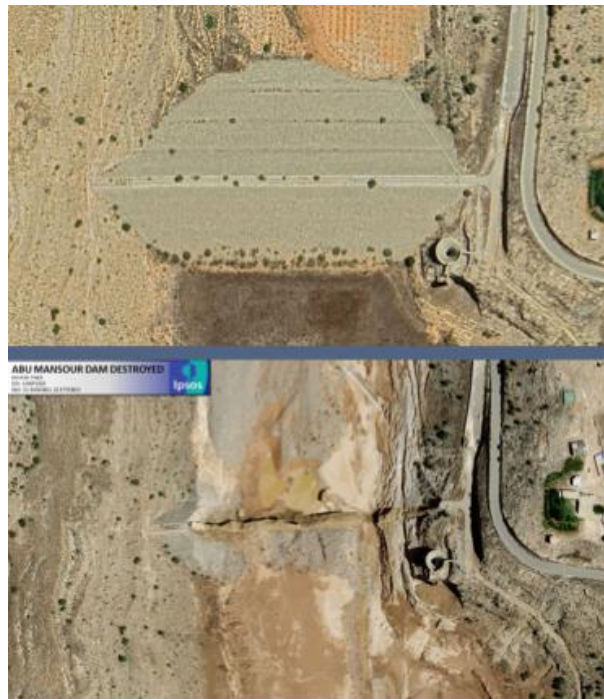
As seen in Figure 6 (showing Abu Mansur dam before and after failure), both dams were embankment dams with (too) thin clay core founded on karstic limestone, built in the 70's. They were 73 and 40 m high above foundation for Abu Mansur and Derna, respectively. They had known structural weaknesses, including excessive settlement significant seepage, sometimes conveying dirty water, reported since the 1980s. It appeared that both dams were in such a weak condition that the flood of September 2023 was almost a trigger that led to their failure. Unfortunately, this flood was so massive that the dam failures resulted in a tragedy.

Figure 6. The Abu Mansur embankment dam, before (Google Earth) and after collapse (IPSOS image).

Challenges in estimating rainfall, such as spatial variability and limited reliable data, added uncertainty to determining the event's return period, which ranged from 500 to 5,000 years. Due to poor bedrock conditions, it was recommended that the foundation conditions should be carefully assessed before building new dams upstream of this heavily urbanized area. The

design flood should be reassessed in a conservative approach taking into account the effect of climate change. It is noted that efficient flood protection does not necessarily mean rebuilding storage dams. Any long-term solution should rely on an urban development plan taking into account the right-of-way of the flood control arrangements to be built.

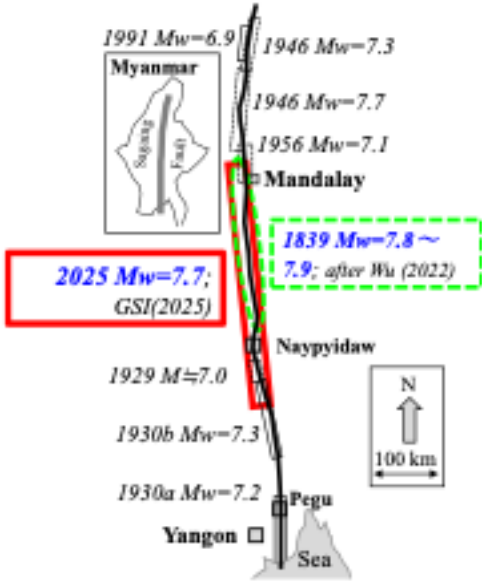
On March 28, 2025, at 12:50 MMT, a Mw 7.7 earthquake struck near Mandalay, Myanmar, along the Sagaing Fault (one of Southeast Asia’s most seismically active fault systems) at a shallow depth of 10 km (see Figure 7, that also shows strong earthquakes occurred since 1929). This earthquake was one of the largest to hit the region in decades and caused widespread destruction across central Myanmar. Its impacts extended beyond Myanmar’s borders, with shaking felt in neighbouring countries as well, including in Bangkok, 1000 km away. The scale of damage to infrastructures, buildings, and cultural heritage sites underscored the seismic vulnerability of the country.

Figure 7. Historical earthquakes caused by Sagaing fault (Modified from Soe and Watkinson, 2011 and Wang et al., 2014).

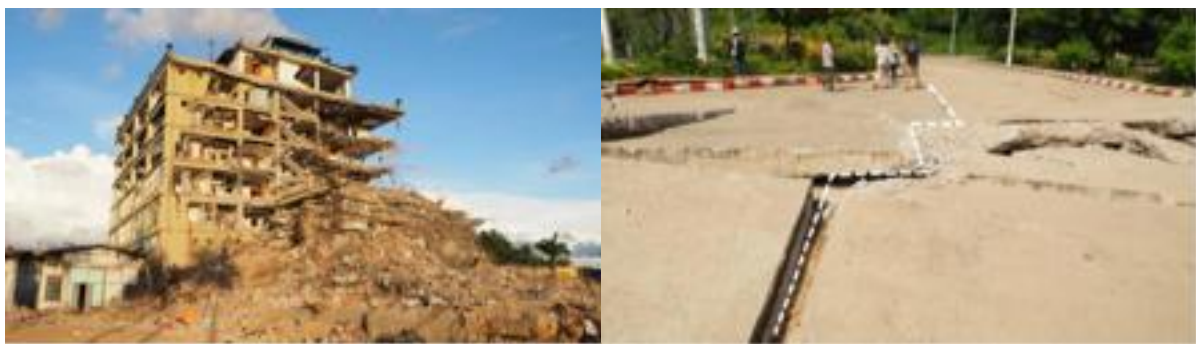
In various buildings in which ground floors consisted of columns with very few shear walls (Figure 9a), it was observed that lower stories completely crushed, whereas upper floors resisted better. This highlighted a fundamental design deficiency that must be urgently addressed in future seismic design codes and retrofitting programs, particularly for reinforced concrete buildings in high-risk areas.

In some places, the fault could directly be observed at surface, like in Naypyidaw where the observed ground motion intensity was high. Figure 9b shows a significant right-lateral displacement accompanied by shear deformation of the ground surface in the Children’s Specialized Hospital. Buildings situated directly atop the fault rupture that sustained severe damage, whereas a room located about ten meters away from the rupture suffered much less damage. This confirmed that, in this area, the primary cause of fault-induced damage was surface deformation rather than ground shaking.

Figure 9. a) Sky Villa condominium in Mandalay (207 fatalities); b) Children’s Specialized Hospital in Naypyidaw.

- Retrofitting vulnerable soft-storey structures,
- Expanding seismic monitoring networks,
- Developing regional hazard assessments that incorporate long-period seismic impacts.
