**EFFECTIVENESS OF SUBSURFACE DRAINAGE AND
VEGETATION IN ENHANCING THE SLOPE STABILITY:
A COMPREHENSIVE CASE STUDY ON
BADLUSIRIGAMA LANDSLIDE**

Thesis submitted in partial fulfilment of the requirements for the degree Master of
Engineering in Foundation Engineering and Earth Retaining Systems

Department of Civil Engineering

University of Moratuwa

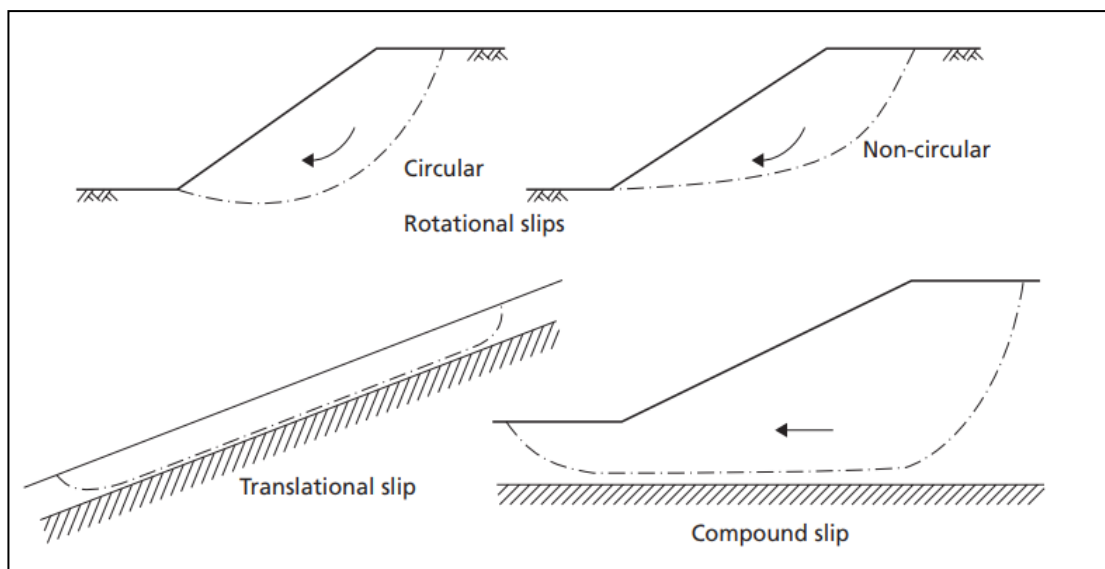
Figure 2.1: Types of slip surfaces (Knappett and Craig, 2012)

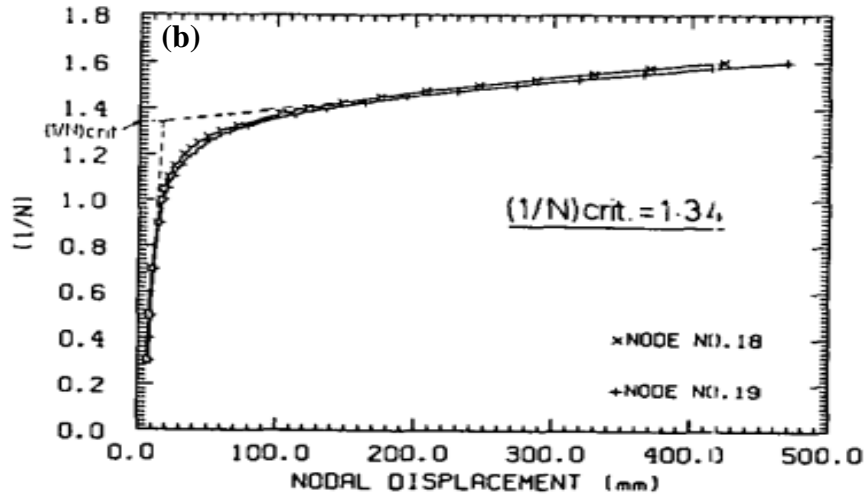
The displacement vector plots could be used to locate the critical slip surface. Figure 2.7 (a) shows a homogeneous slope with an intrusion of a weak layer. The nodal displacement plot obtained for the slope at nodes 18 and 19 (Figure 2.17 (a)) are shown in Figure 2.7 (b). According to this the critical factor of safety of the slope is 1.34. Figure 2.8 (a) illustrates that total displacement vectors can indicate the shape of the failure surface. Figure 2.8(b) which presents the incremental displacement vectors in the last excavation increment can provide even a better illustration. The displacement vectors have clearly identified the non-circular failure surface.

Figure 2.7 (a): A homogeneous simple slope composed of two soil layers
 (b): Nodal displacement curves obtained for the slope at Nodes 18 and 19
 (Donald and Giam 1988)

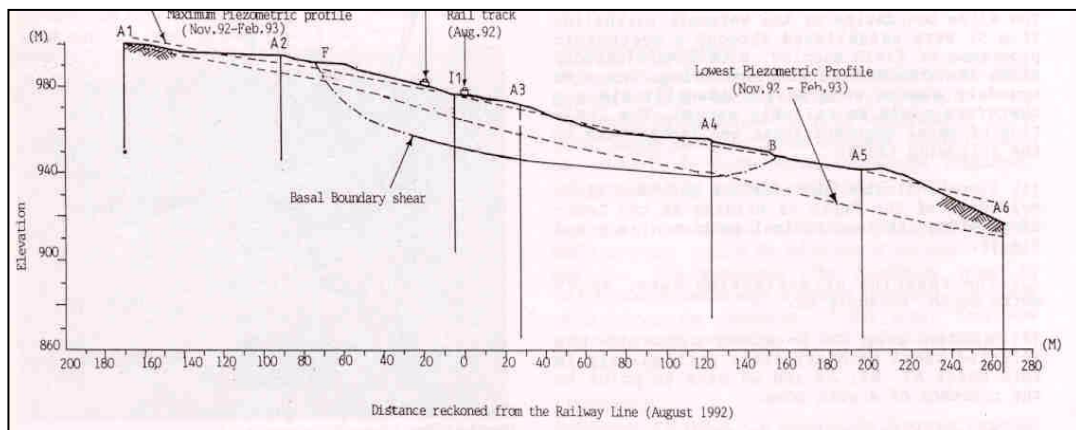
With the large movements taken place along this failure surface over a long period, shear strength has reduced to residual values. The major issues to be addressed in rectifying the slide is the deep slip surface and substantially larger areal extent. It was difficult to reach the deep failure surface along the full length of the slide with uni – directional drains. Therefore, it had been decided to permanently lower the water table using directional drilling technique, beneath the slide. In addition to drainage measures, deep wells and eductor system too has been installed for rapid draw down and dewatering. Also this is the first application of directional drilling technique to landslide mitigation. The system of directional drains which was just under the identified potential failure surface would be able to relieve the pore water pressure building up there quickly.

Figure 2.17: Cross section along the shear plane (Rajaratnam and Bhandari, 1994)

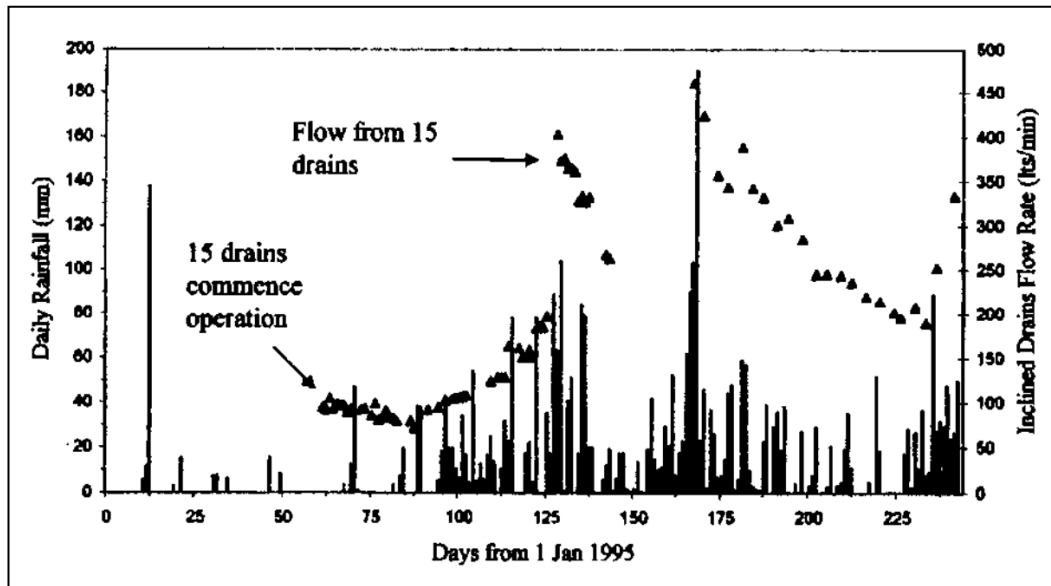
Figure 2.20 Rainfall and discharges from the sub surface drains (Chandler and Broise, 2000)

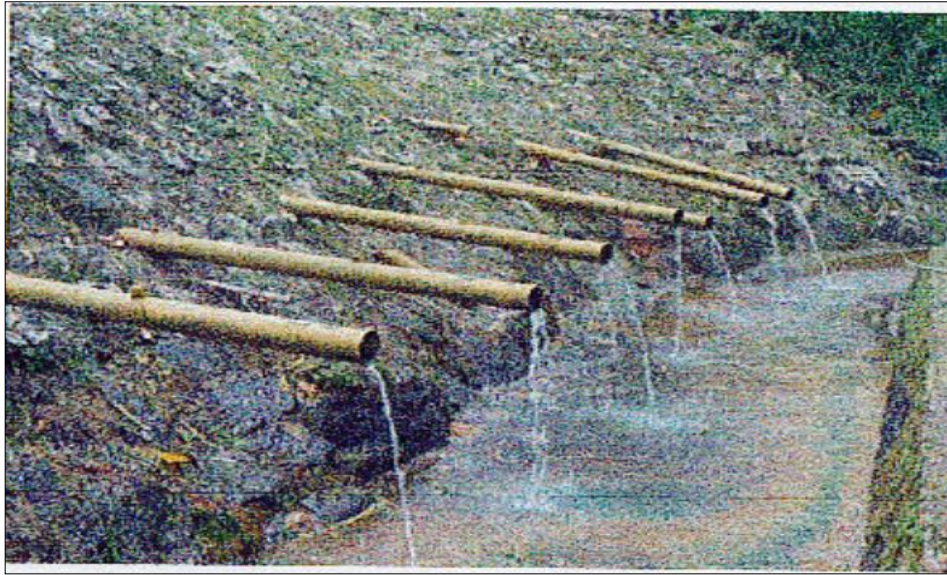
The case study has shown the effective use of long subsurface drains as a drainage blanket beneath the slide to stabilize the slide. Adoption of directional drilling technique has enabled the installation of long drains in compatible with subsurface conditions so as to attain the maximum efficiency. Apart from that, rectification of Watawala landslide is a good example which illustrates the effective use of sub surface geological, hydrological and geomorphological conditions along with the structural measures of slope stabilization. The system of drains function even today although there are some reports of blockages (Figure 2.21).

Figure 2.21: Photograph taken at Watawala in June 2018

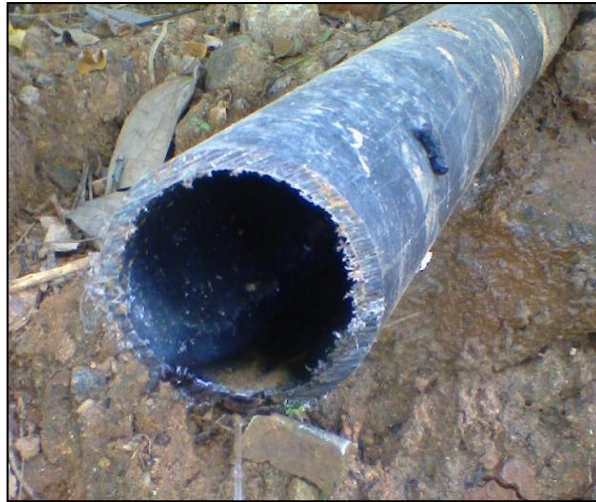
Observations from the piezometers installed in the boreholes were also considered when designing the subsurface drains. Figure 2.23 shows outlet of a subsurface drain installed at the site

Figure 2.23 Outlet of a subsurface drain installed at the site

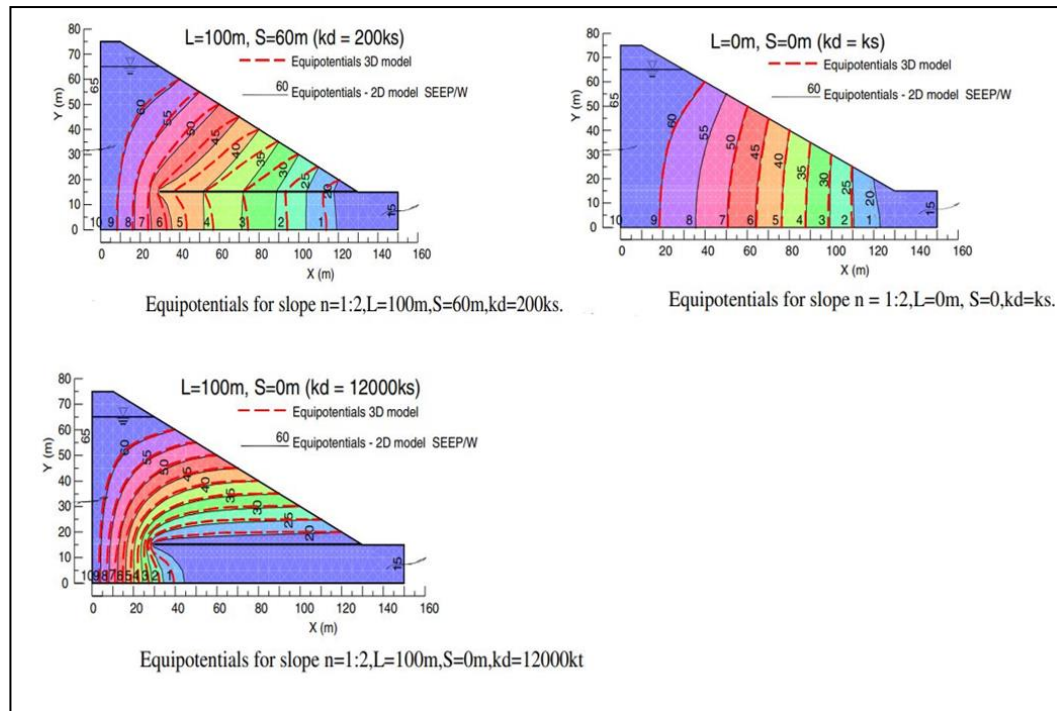
The Equation 2.5 can be used to estimate the equivalent hydraulic conductivity of the drain material to be used in the 2D seepage analysis. Using this relationship an equivalent hydraulic conductivity for drain material, for a specific drain length, spacing and soil hydraulic conductivity can be obtained. The results of the analysis conducted varying the parameters have shown that they are in a good agreement with the results obtained from the 3D analysis Nonveiller (1981) (Figure 2.26).

Figure 2.26 Equipotential lines obtained from 2D and 3D seepage analysis for different drain lengths and spacing (Gjetvaj et al., 2009)

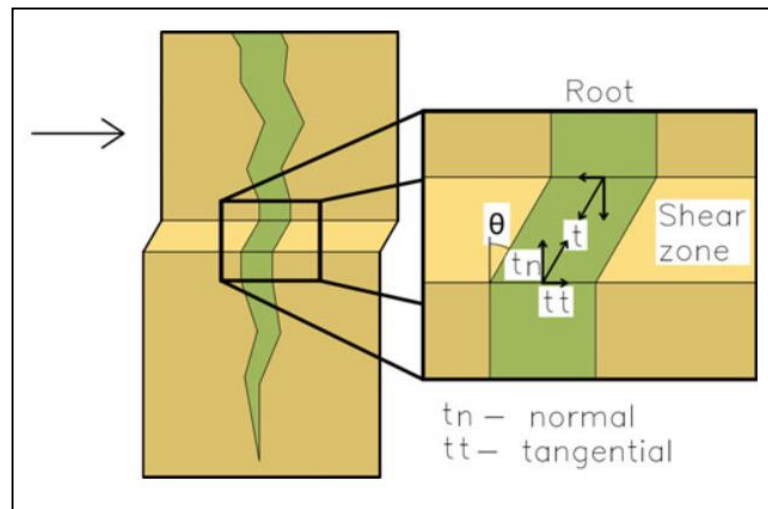
Figure 2.29 : Schematic diagram of the stresses in the root during shear (Dias et al., 2017)

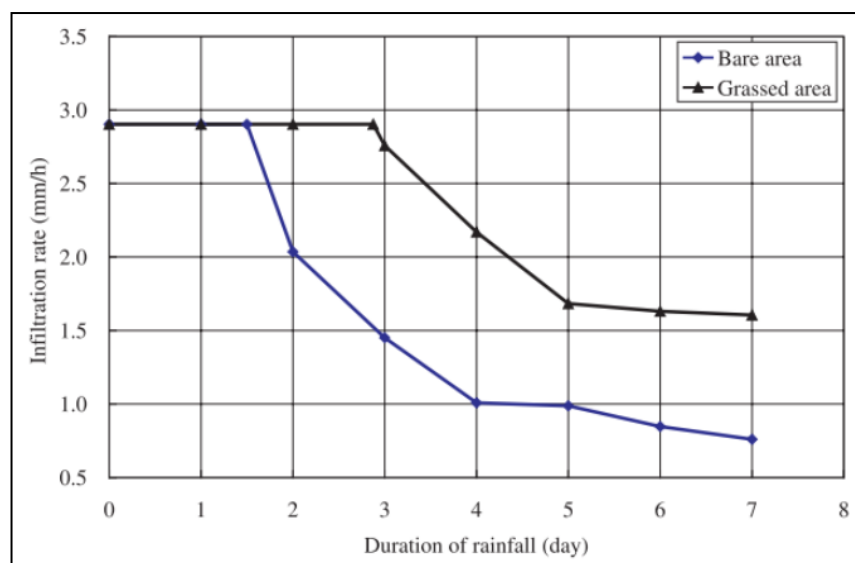
Figure 2.42 Rate of infiltration into a bare area and a vegetated area of slope (Zhan et al., 2007)

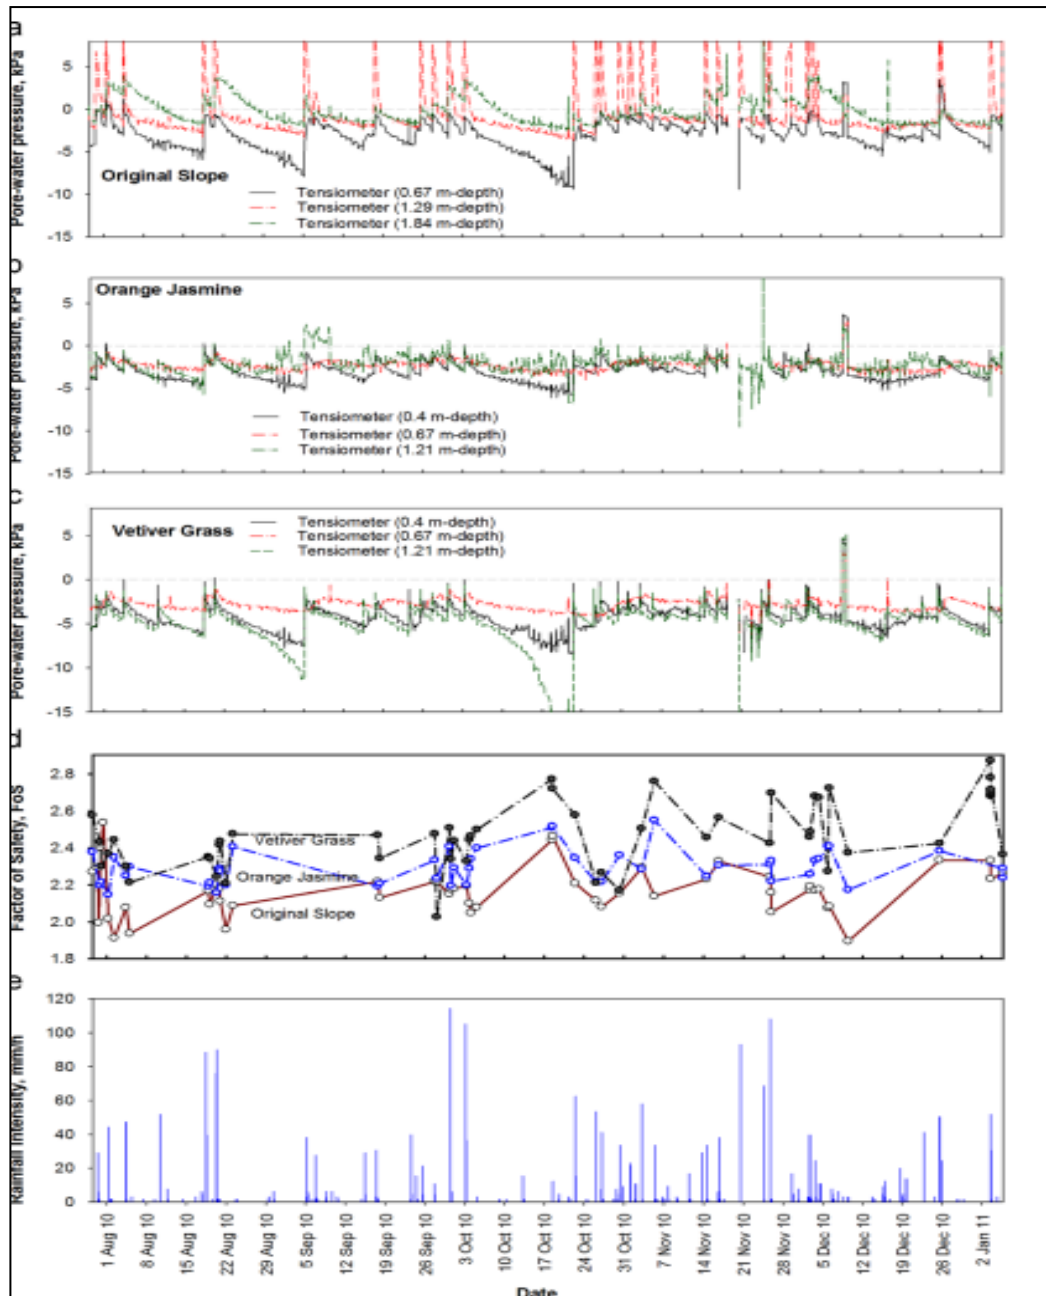
Figure 2.43 Pore water pressure variations with rainfall at different depths for (a) bare slope, (b) Slope with Orange and Jasmine, (c) Slope with Vetiver grass, (d) FoS variation and (e) Rainfall intensity (Rahardjo et al., 2014)

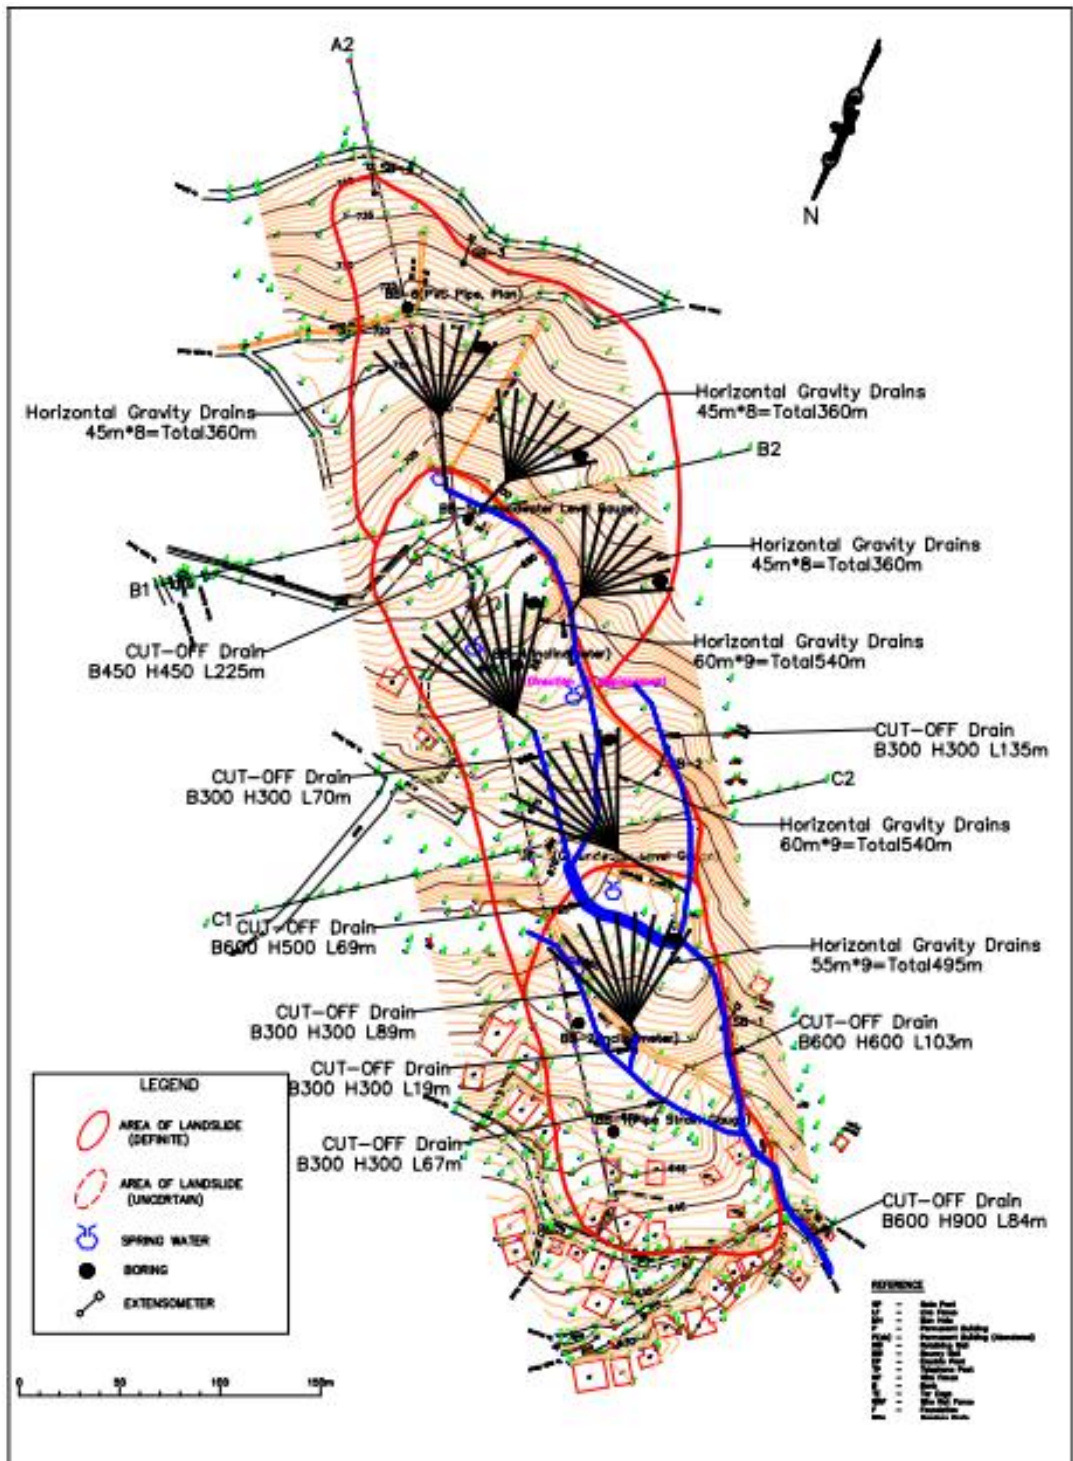
Figure 3.9 Plan View of the subsurface drainage improvement (JICA Report, September 2015)

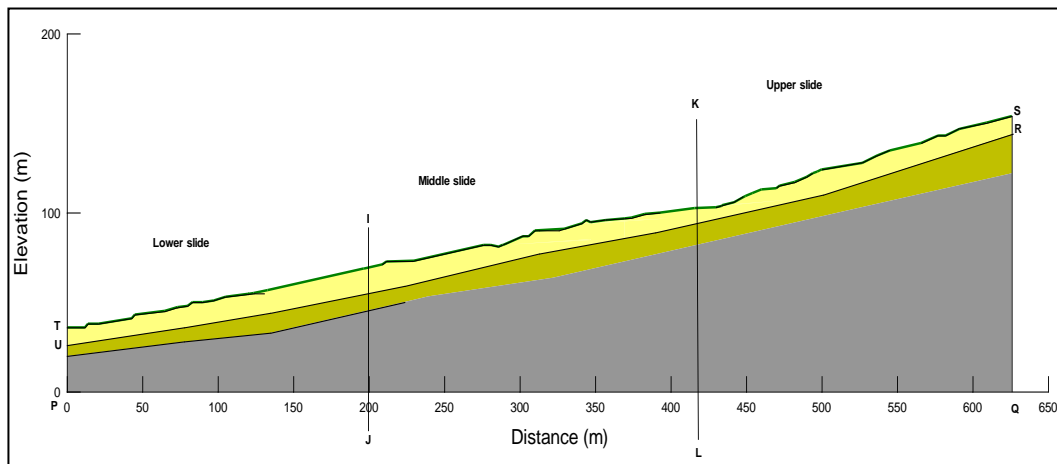
Figure 5.3 Cross section idealized in SEEP/W

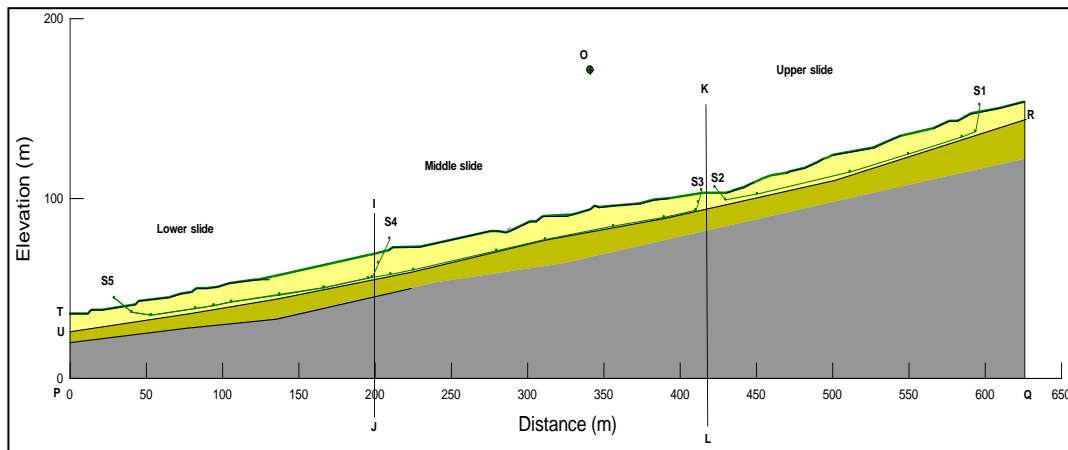
Figure 5.6 The slip surfaces of each slide are fully defined in SLOPE/W module

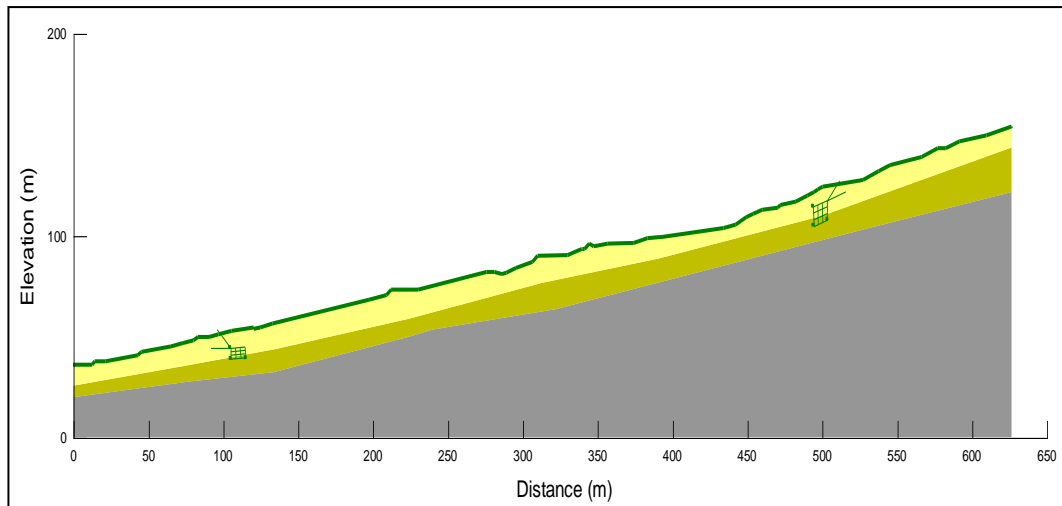
Figure 5.20 Definition of the composite slip surface using block specified method

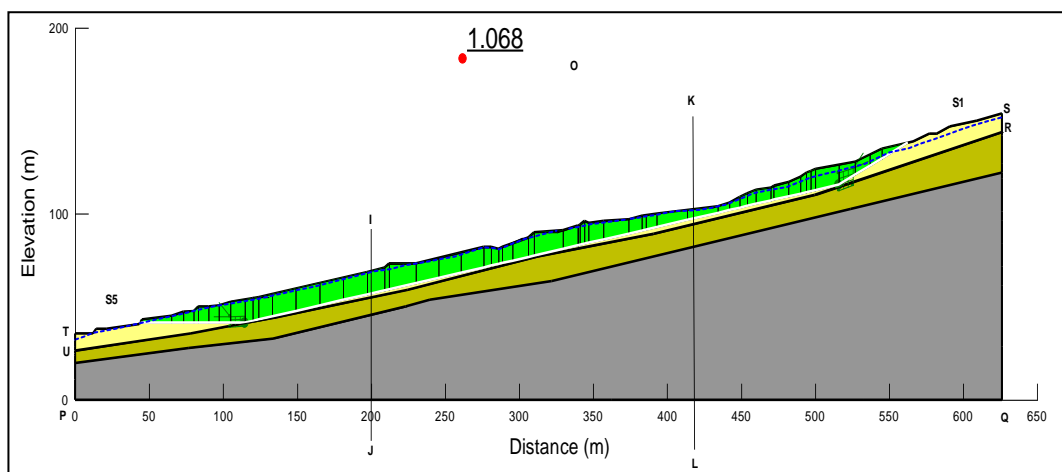
Figure 5.21 Factor of safety of the composite slip surface under existing conditions

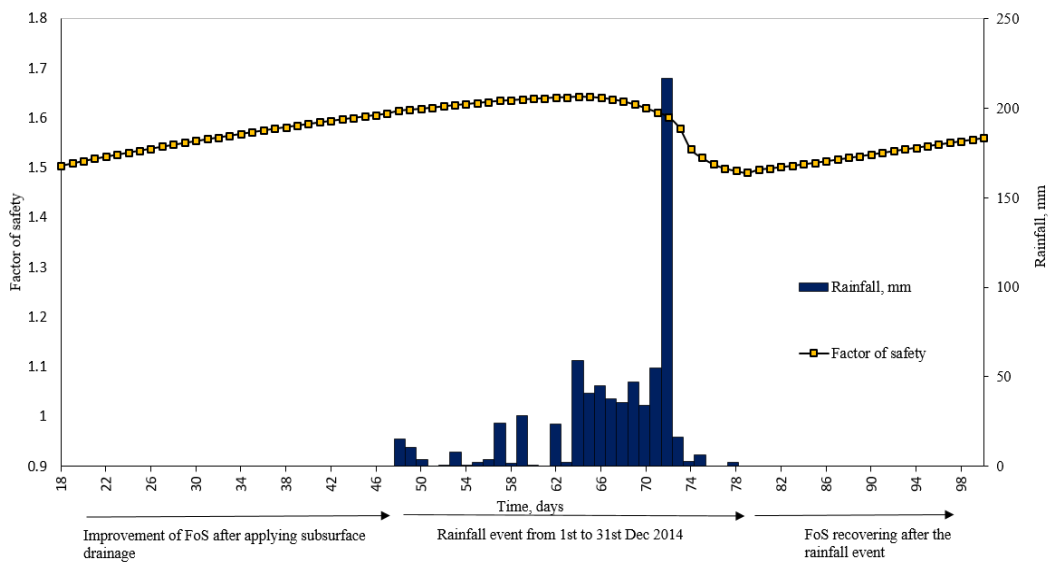
Figure 5.24 Variation of factor of safety of the composite slip corresponding to rainfall event from 1st to 31st December 2014

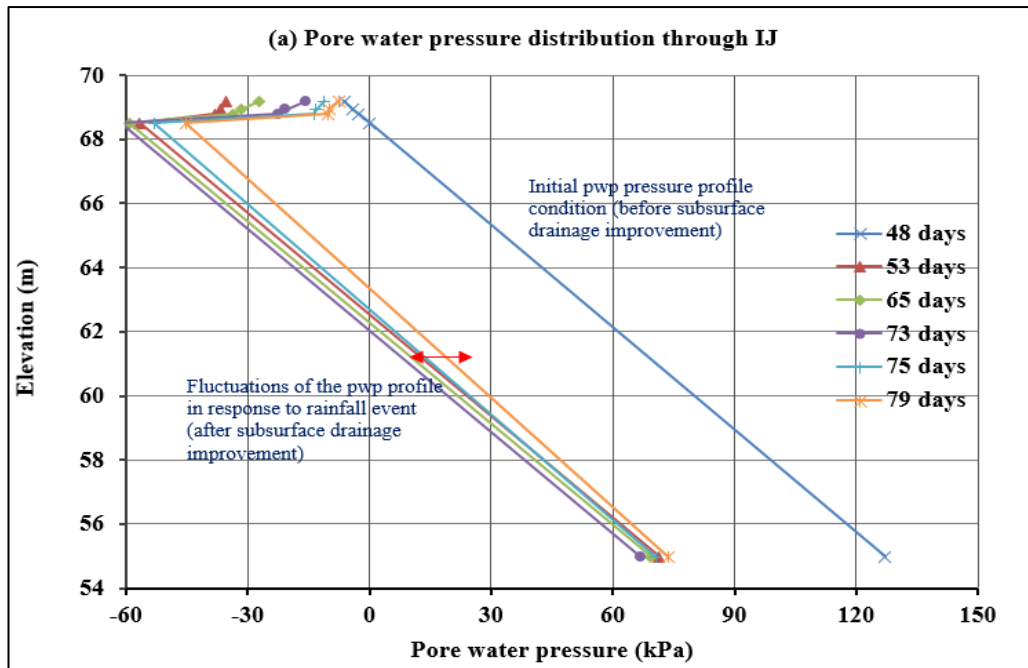
Figure 5.26 Pore water pressure variation during the actual rainfall event: (a) Section IJ, (b) Section KL

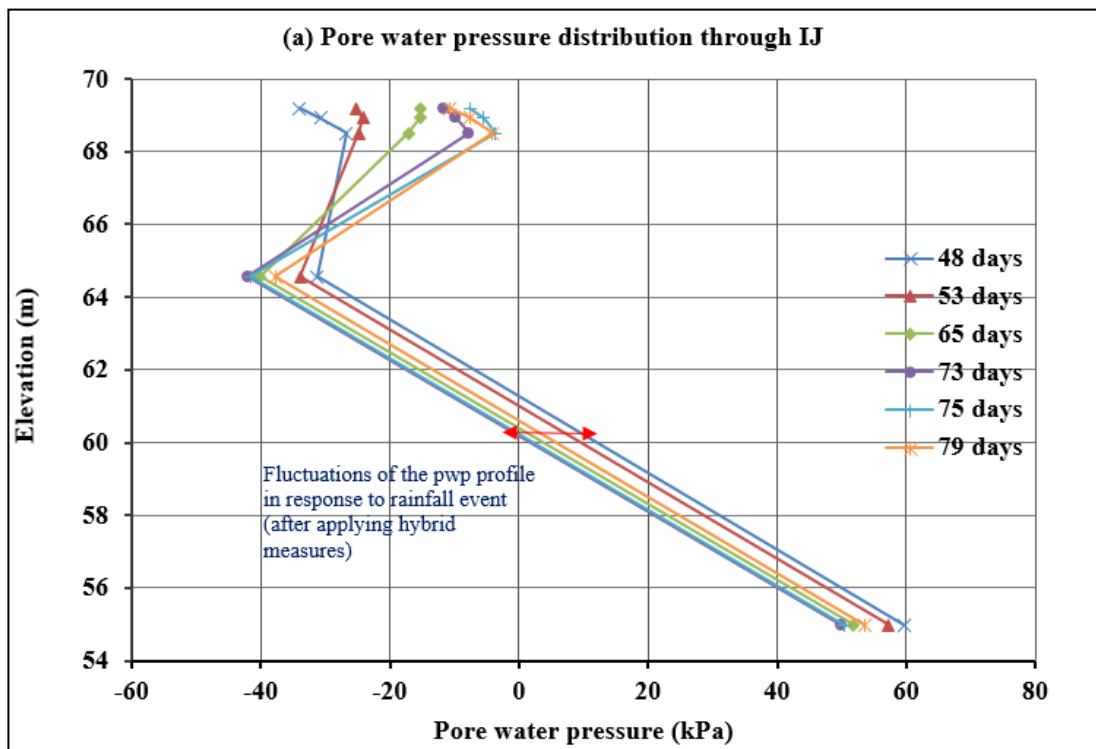
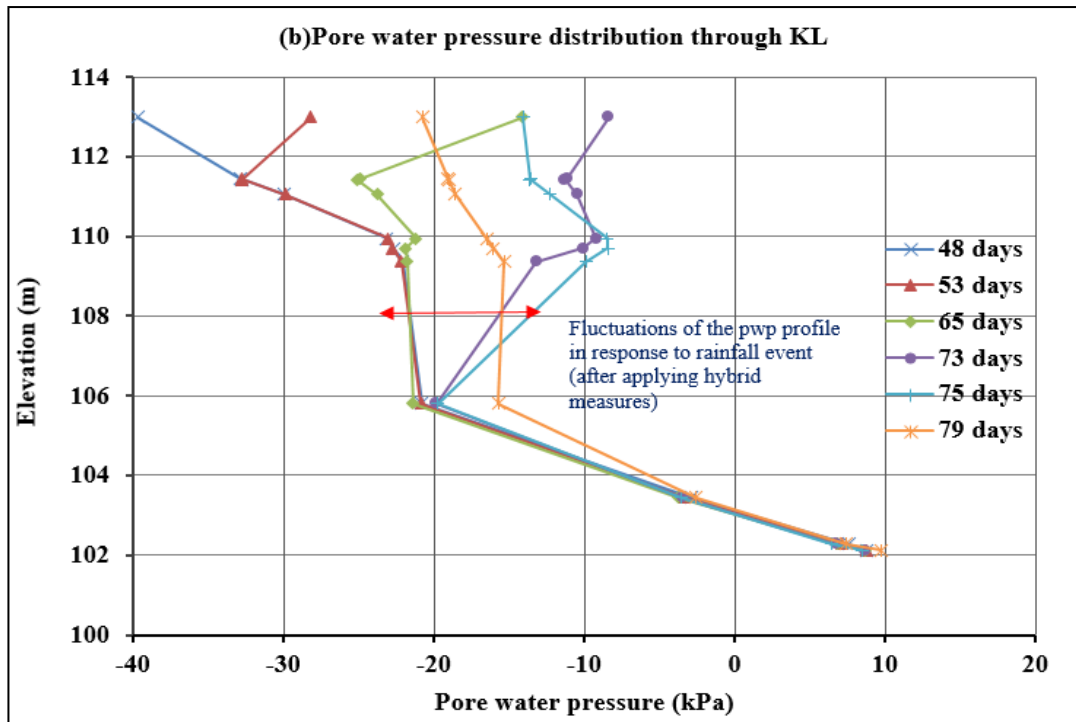
Figure 5.31 Variation of the pore pressure profile of the slope after implementing hybrid measures under the actual rainfall event: (a) Section IJ, (b) Section KL

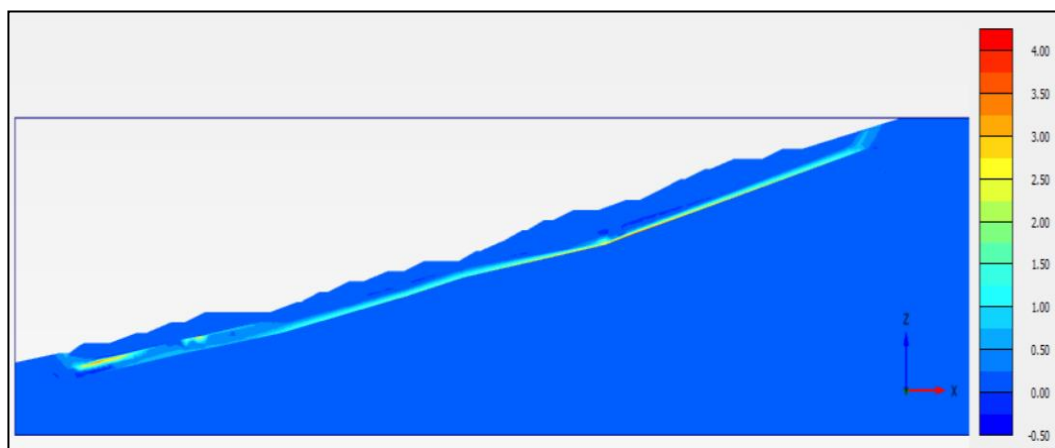
Figure 6.8: Deviatoric shear strains along the failure plane

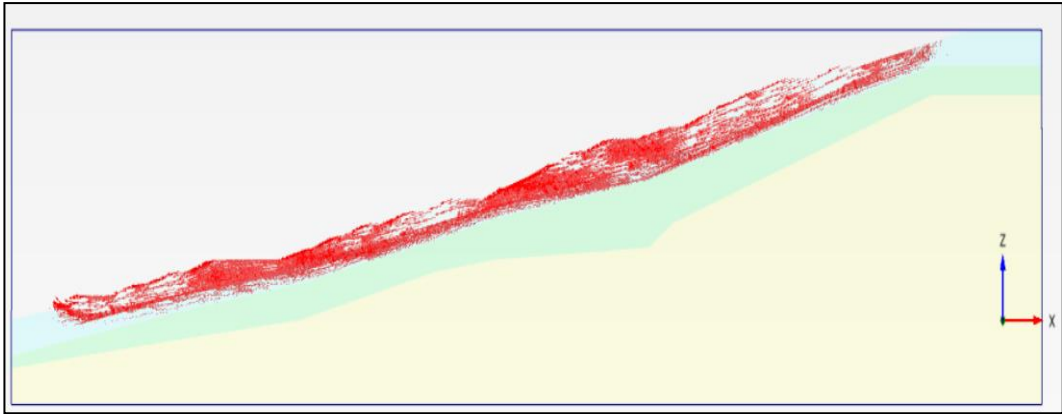
Figure 6.9: Vectors showing incremental displacements in the moving mass

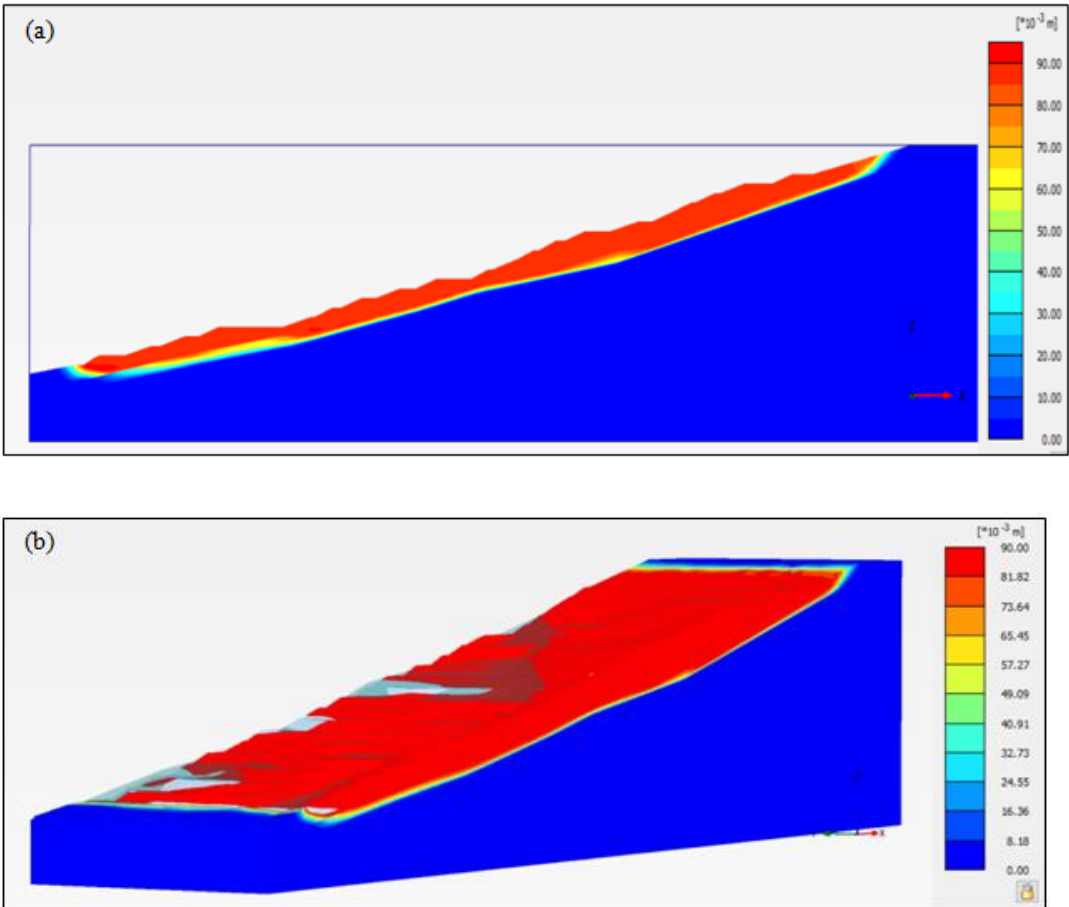
Figure 6.10: Shadings indicating the incremental displacements in the moving mass (a) along the section PQ, (b) 3D view

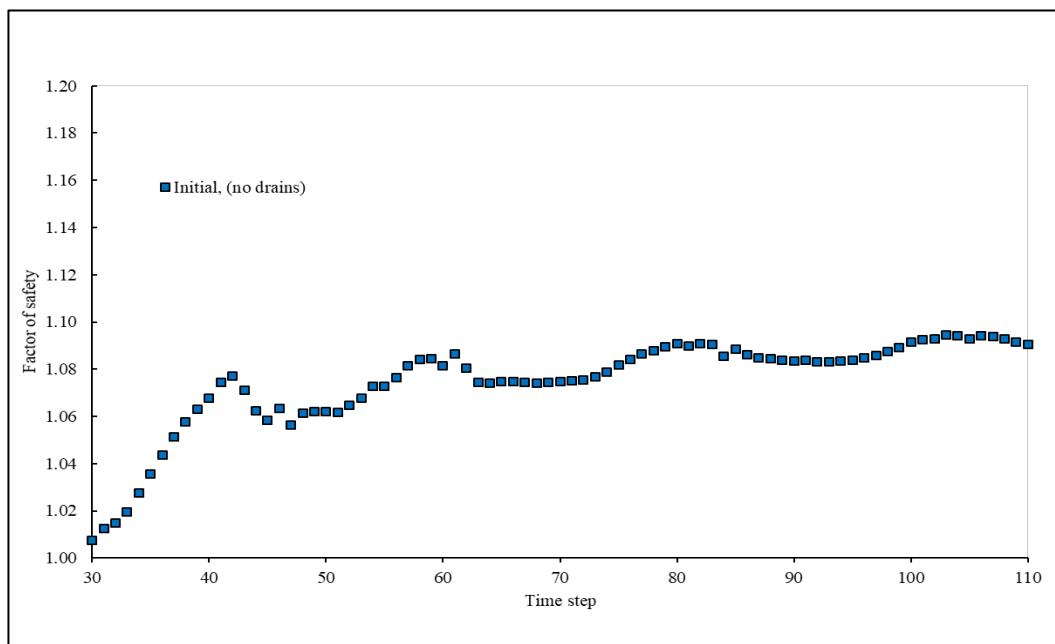
Figure 6.11: Plot showing the initial factor of safety of the slope

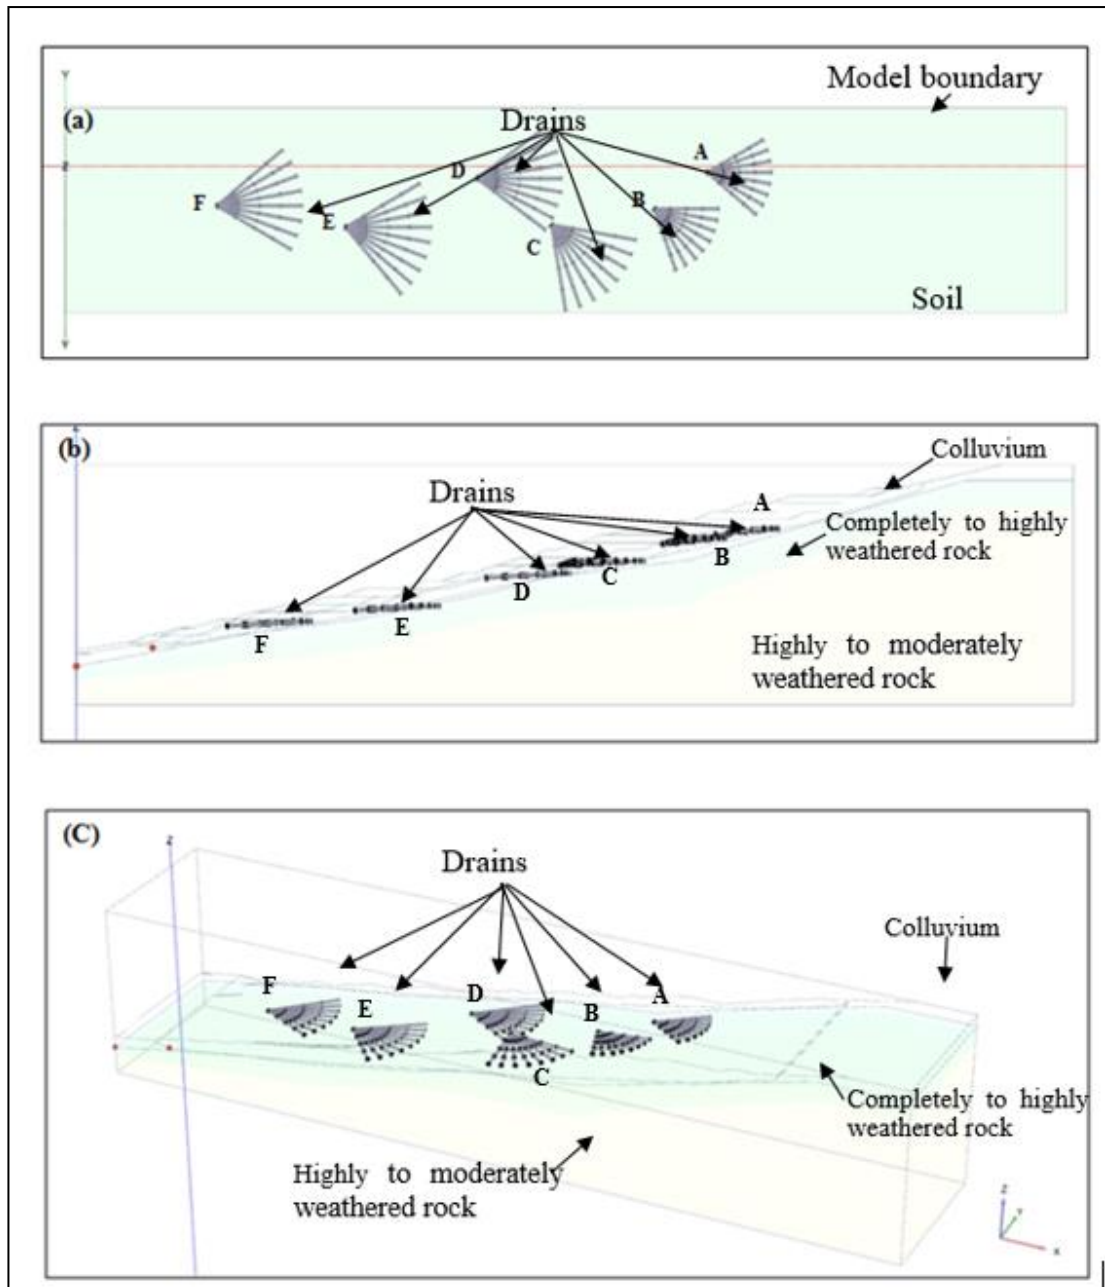
Figure 6.12 Spatial arrangement of the subsurface drainage system (a) top view, (b) front elevation, (c) perspective view

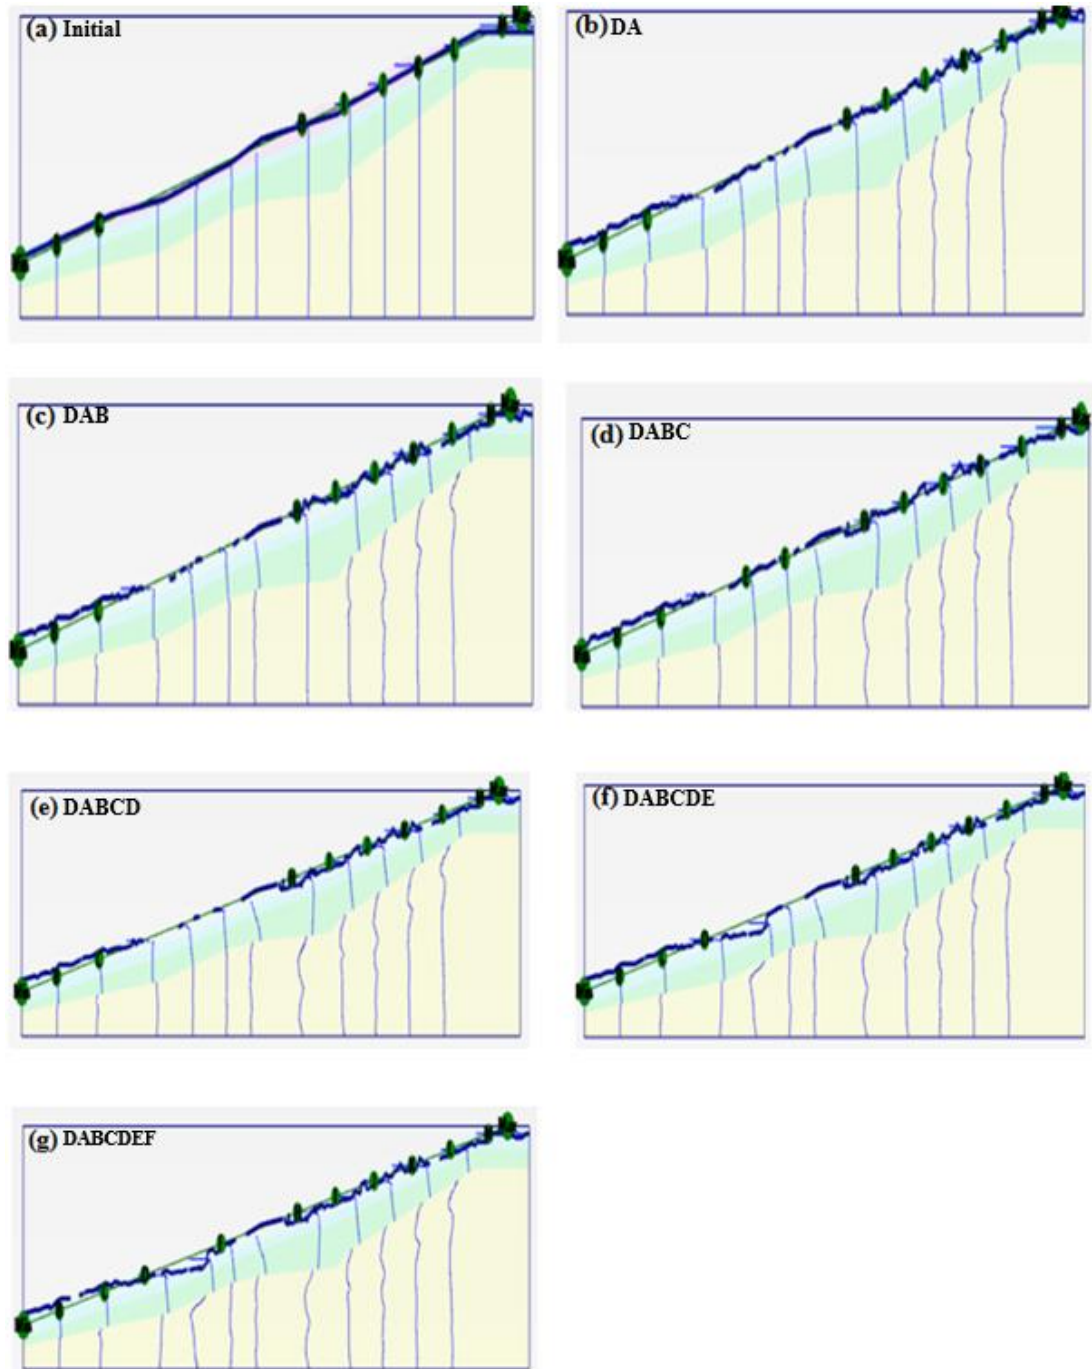
Figure 6.13: Variation of the ground water table with drainage improvement: Case 2- top down (a) Initial, (b) DA, (c) DAB, (d) DABC, (e) DABCD, (f) DABCDE, (f) DABCDEF

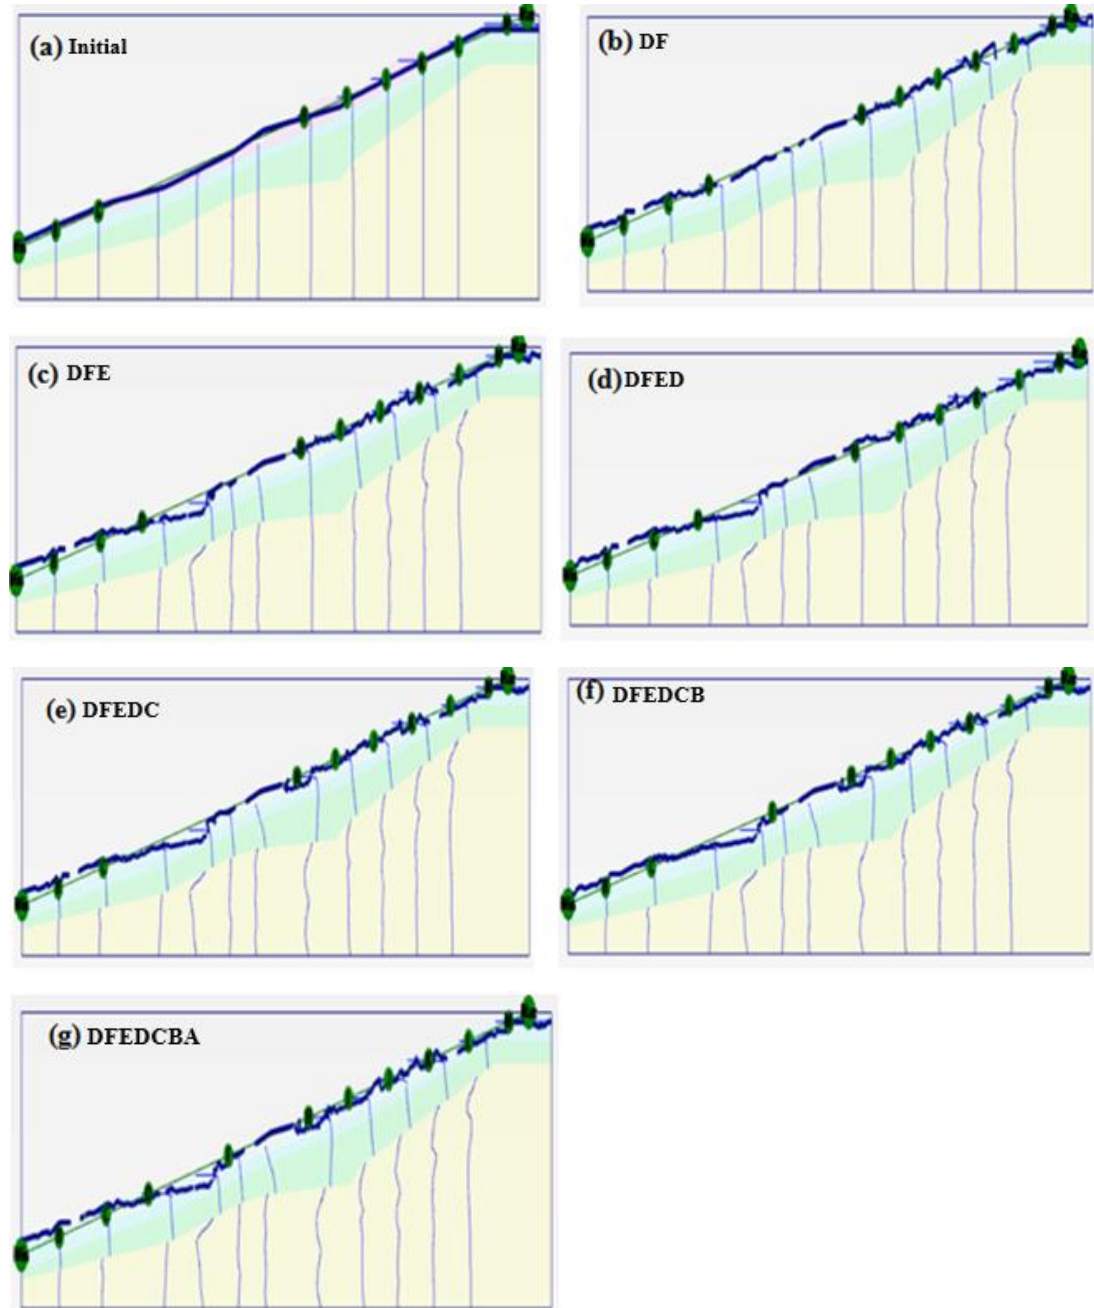
Figure 6.14: Variation of the ground water table with drainage improvement: Case 2 -Bottom up (a) Initial, (b) DF, (c) DFE, (d) DFED, (e) DFEDC, (f) DFEDCB, (f) DFEDCBA

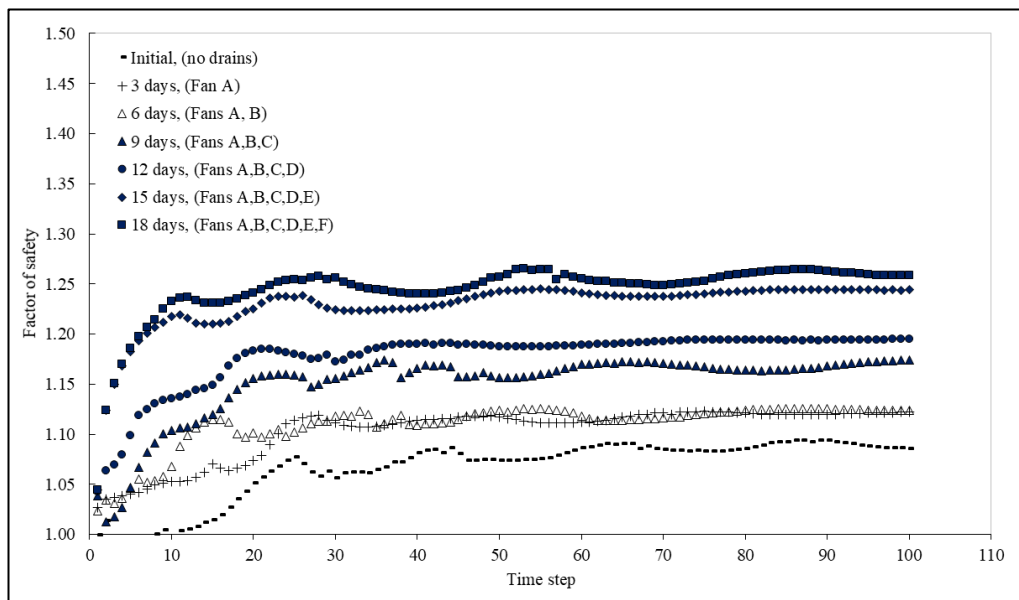
Figure 6.15: Variation of factor of safety pertaining to Case 2

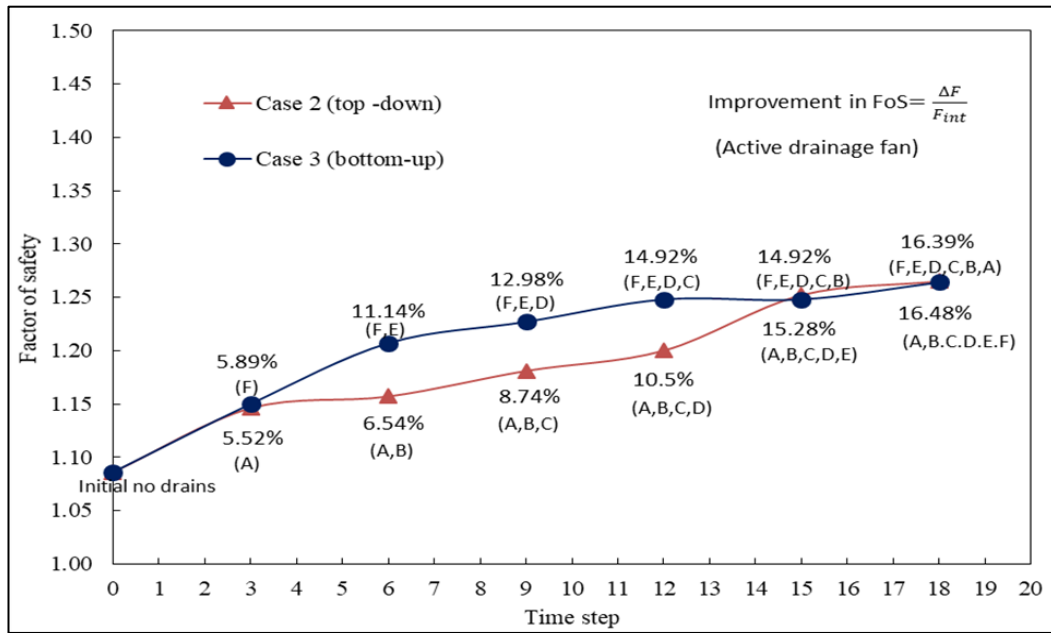
Figure 6.17 Plot showing the variation of factor of safety with time under two cases
