**EFFECTIVENESS OF SUBSURFACE DRAINAGE AND
VEGETATION IN ENHANCING THE SLOPE STABILITY:
A COMPREHENSIVE CASE STUDY ON
BADLUSIRIGAMA LANDSLIDE**

Thesis submitted in partial fulfilment of the requirements for the degree Master of
Engineering in Foundation Engineering and Earth Retaining Systems

Department of Civil Engineering

University of Moratuwa

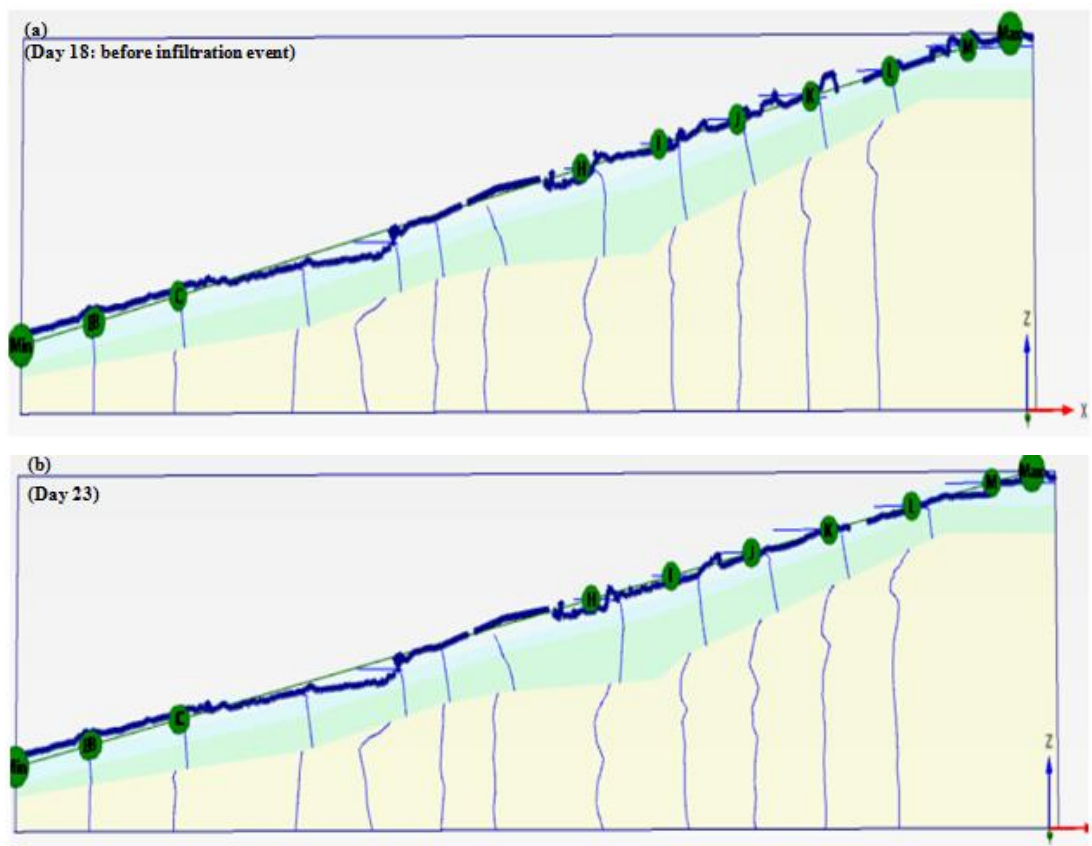
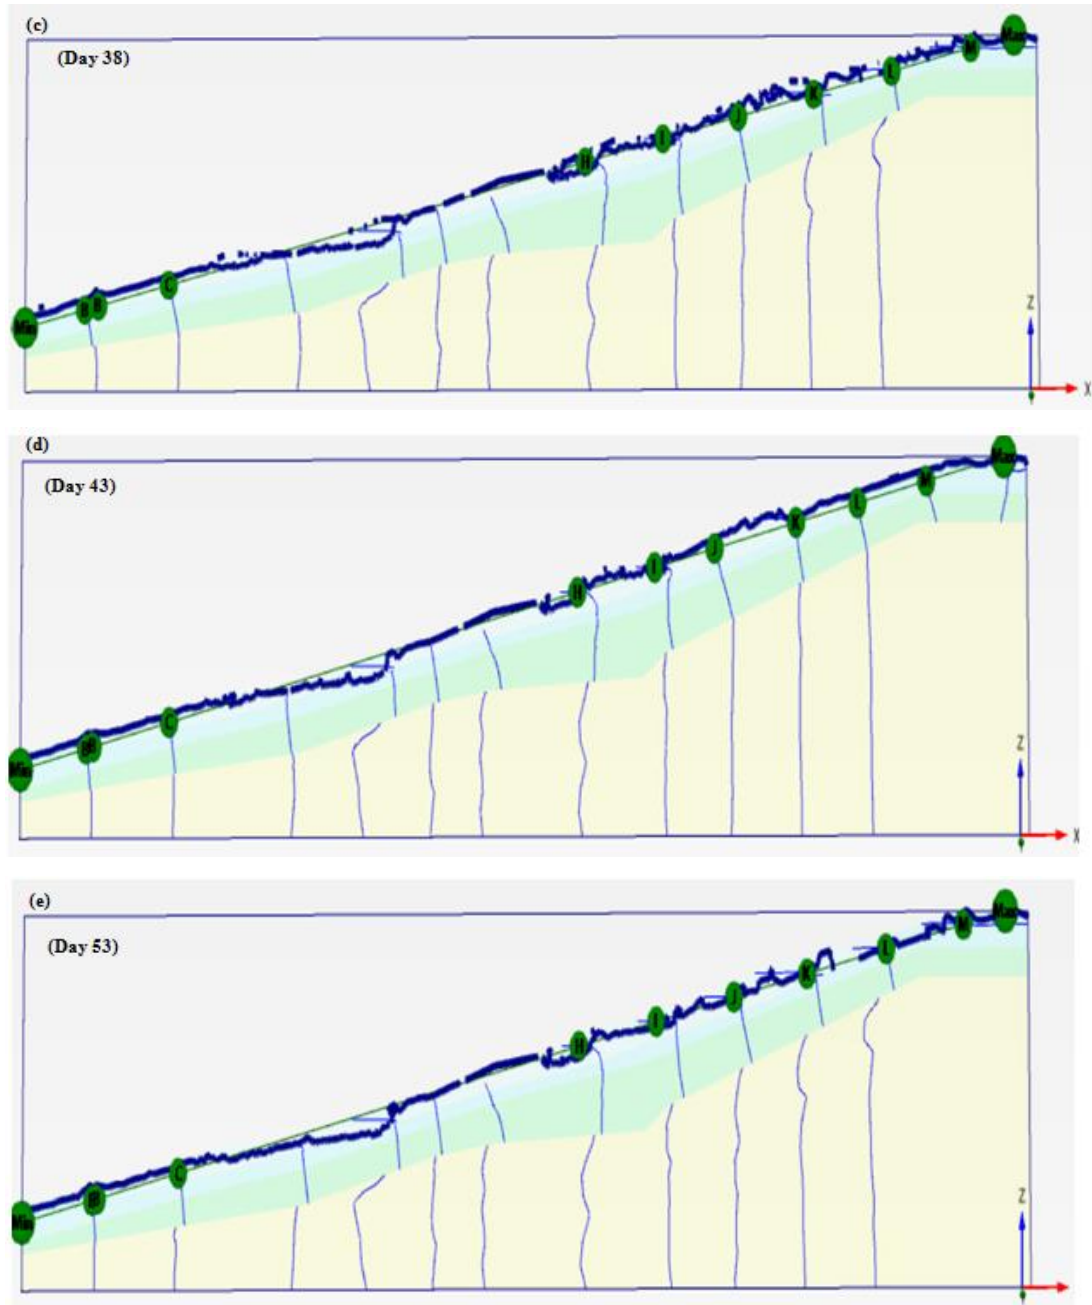
Figure 6.19: Variation of ground water table due to critical rainfall event: (a) Day 18, (b) Day 23, (c) 38, (d) Day 43, (e) Day 53
