**ENHANCEMENT OF THE STABILITY AT THE SITE
OF AN ANCIENT LANDSLIDE IN A ROAD CUTTING
WITH DRAINAGE AND REINFORCEMENT – CASE
HISTORY AT GINIGATHHENA**

M.Eng. in Foundation Engineering and Earth Retaining Systems

Department of Civil Engineering

University of Moratuwa

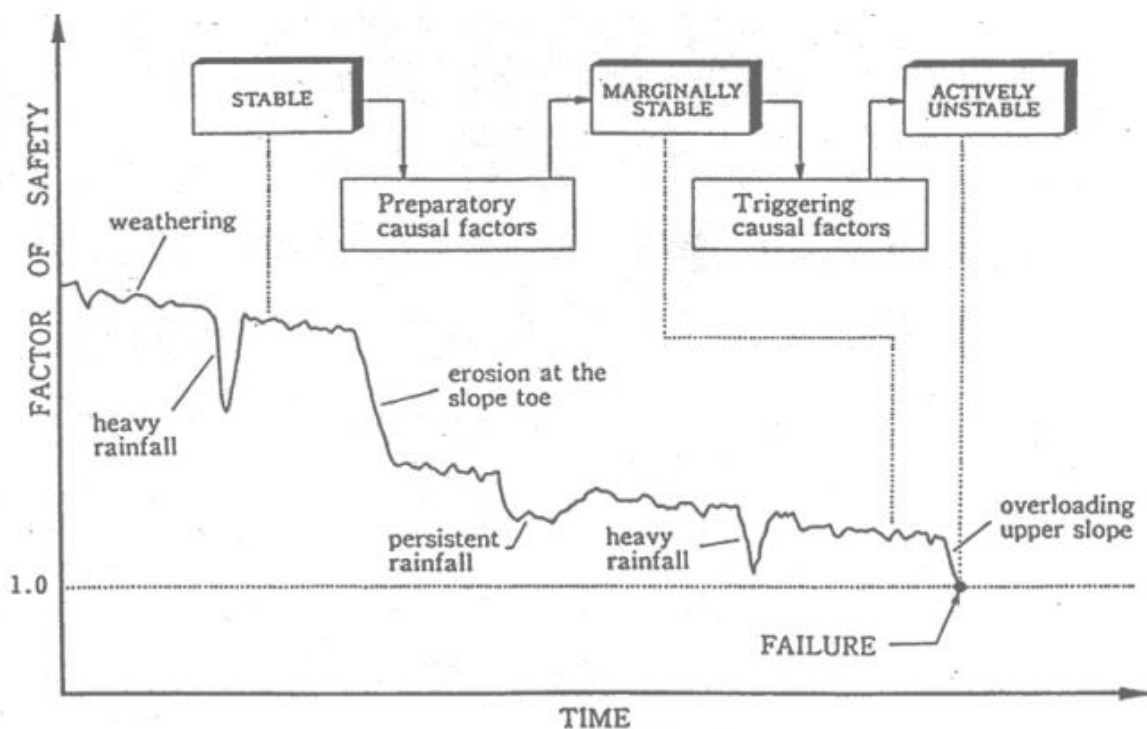
Figure 2.1 : Example of FoS variation with time (Popescu, 2002)

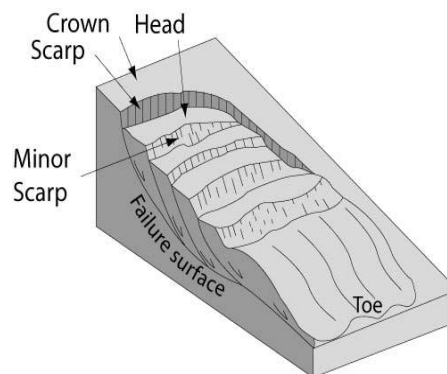
- Rotational Slide (Figure 2.2) – The slip surface is curved upward concavely (spoon-shaped) and the slide moves roughly rotational about an axis that is parallel to the ground surface and transversely across the slide. The rotation surface may be circular or non-circular depending on the ground condition. This type of failures commonly occur in the soil slopes where the bed rock is quite deep.

Figure 2.2 : Rotational Slides (British Geological Survey, 2019)

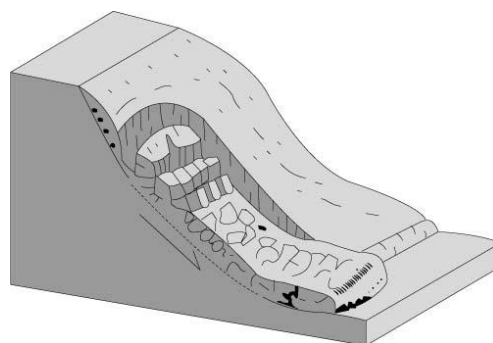
- Translational Slide (Figure 2.3) – The landslide mass moves along a roughly planar surface with little rotation or backward tilting. This type of slides commonly occurs along a geological discontinuity such as faults, joints, bedding planes or interface between soil and rock. Rain induced landslides in slopes of long extent could also follow this mode of failure.

Figure 2.3 : Translational Slides (British Geological Survey, 2019)

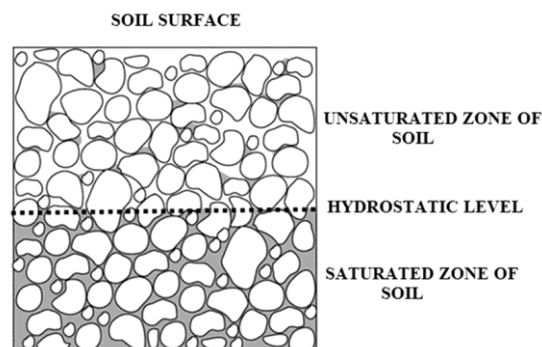
Soils are formed by solid particles with voids in between. Voids may be filled with either air or water. When all the voids in soil are filled with water, it is known as saturated soil. When only a part of voids in soil is filled with water and remaining voids are filled with air, it is known as unsaturated soil. Generally, soil below the ground water level is completely saturated and soil above the ground water level is unsaturated (Figure 2.7). In fine grained soil, saturated zone may extend to some height above the ground water level by capillary rise.

Figure 2.7 : Saturated and Unsaturated Zones of Soil (Belciu, et al., 2017)

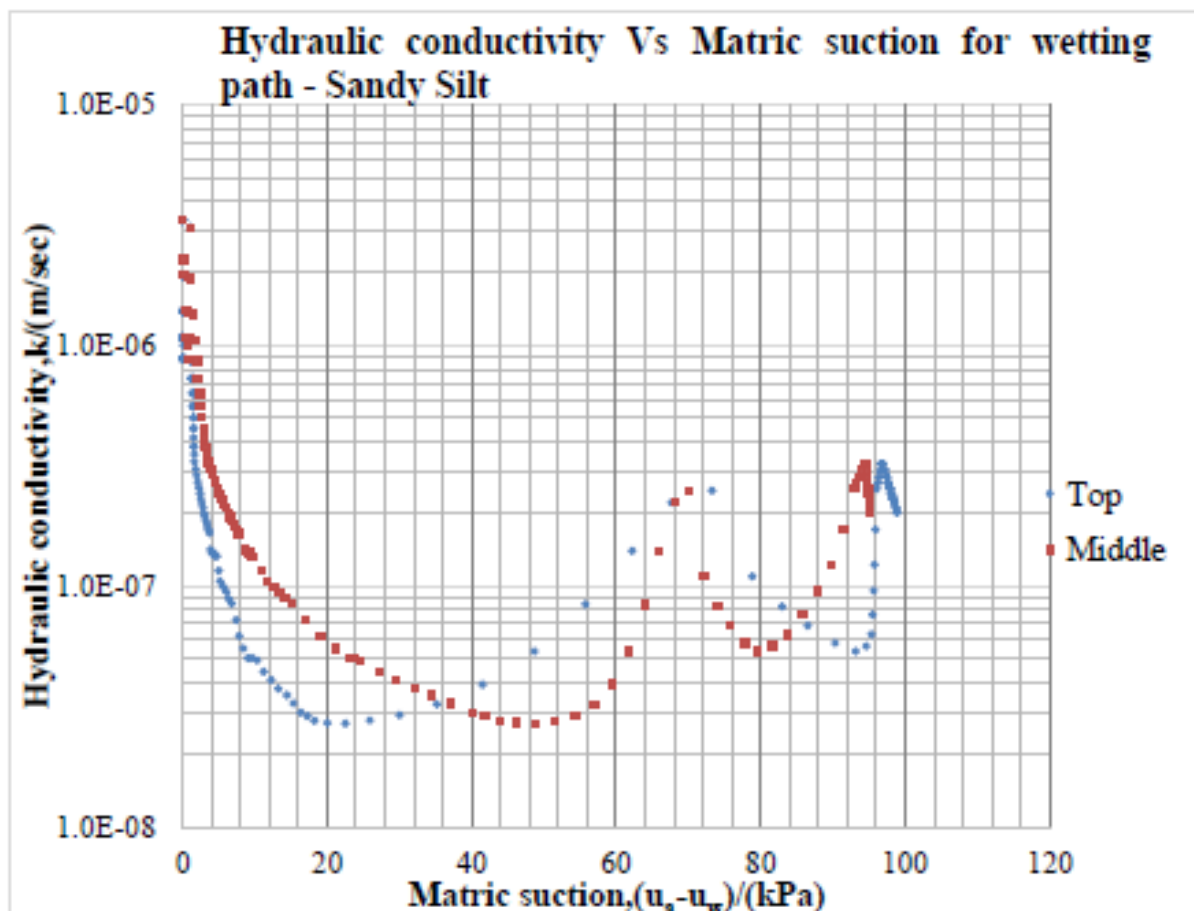
The results of the permeability function obtained are shown in Figure 2.9.

Figure 2.9 : Graph of Hydraulic Conductivity vs Matric Suction for wetting path – Sandy Silt (Vasanthan, 2016)

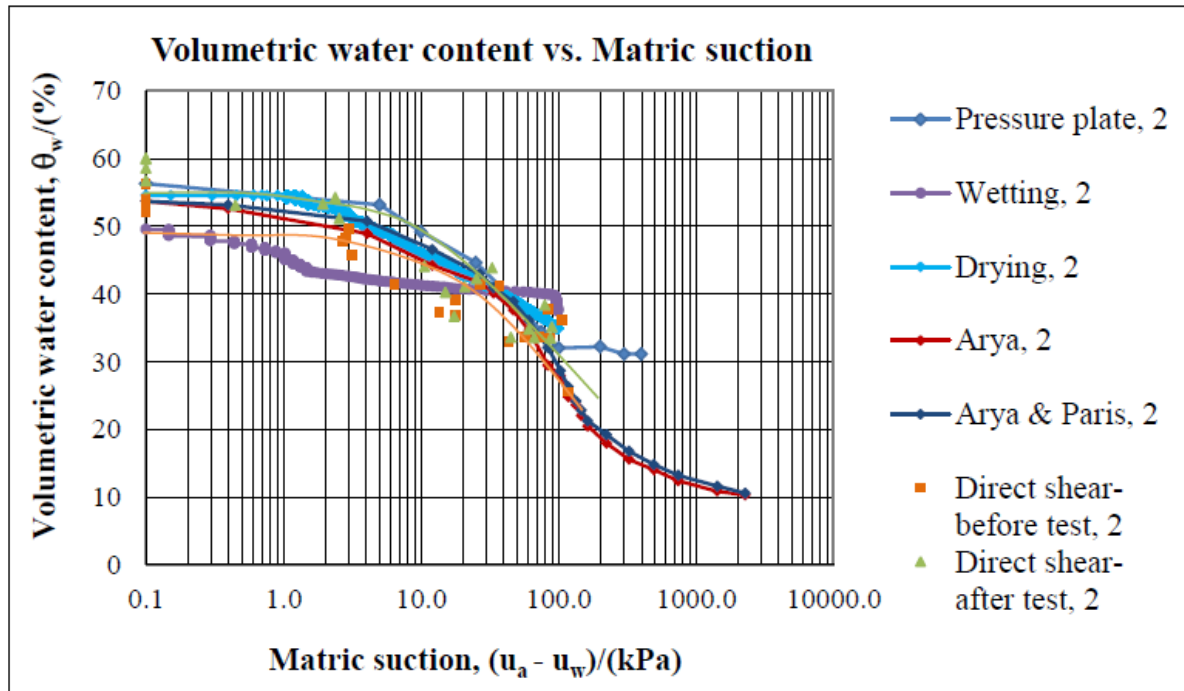
The SWCC obtained for the soil samples using different methods such as wetting path, drying path and pressure plate and, comparison with the results of other researches are presented in Figure 2.10.

Figure 2.10 : SWCC for Silty Sand from various methods (Vasanthan, 2016)

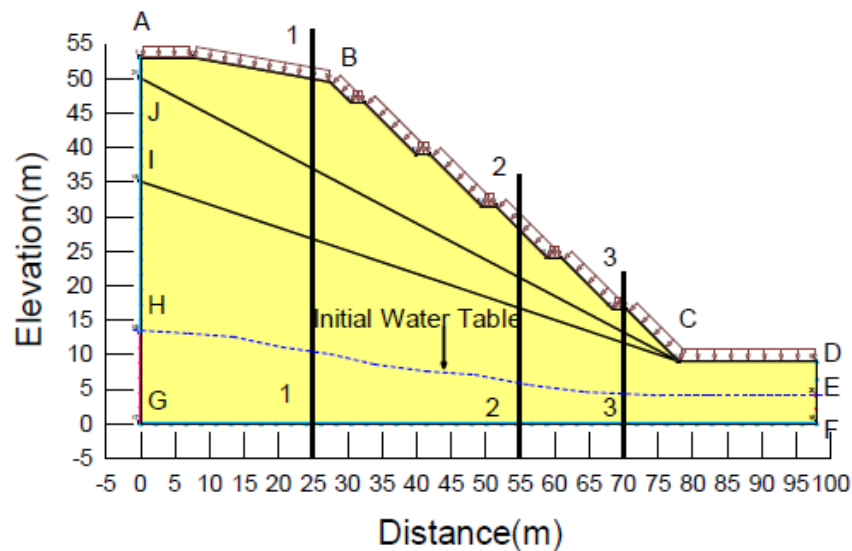
Case 2, a less weathered layer (Weathered Rock-WR) underlies a thick residual soil layer (boundary of residual soil and weathered rock is the line IC in Figure 2.11). In Case 3, the less weathered layer underlies a thin residual soil layer (boundary of residual soil and weathered rock is the line JC in Figure 2.11). The second layer (WR) is with greater shear strength and lower permeability.

Figure 2.11 : Geometry of the selected slope with boundary condition (SEEP/W model) (Sujeevan & Kulathilaka, 2011)

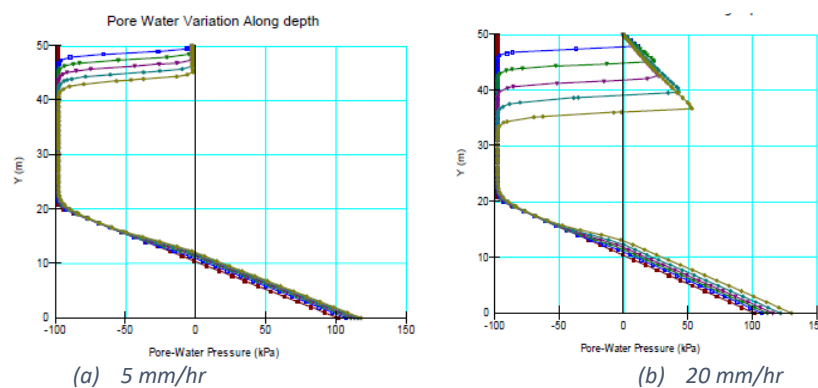
The changes in the pore water pressure regime with the rainfall was plotted for section 1 & section 2 (Figure 2.12). For homogenous condition (Case 1), at 5 mm/hr rainfall, as the rain progressed, matric suction depleted and eventually become zero close to the surface of the slope. At 20 mm/hr rainfall, not only the matric suctions were lost but also positive pore water pressures were developed at the top level – a perched water table condition. The development of the positive pore water pressure and the rise of the ground water table were more significant at lower levels.

Figure 2.12 : Results of Case 1 _ Section 1-1 with matric suction upper limit (Sujeewan & Kulathilaka, 2011)

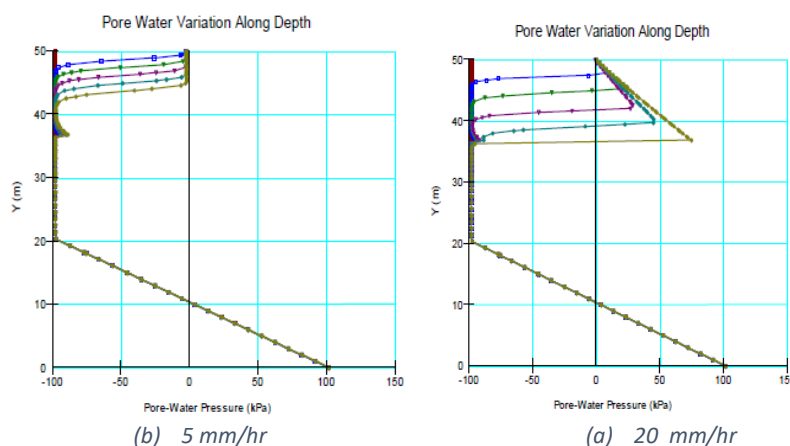
When a highly weathered rock layer is underlying the residual soil, the downward movement of water is hampered and water gets accumulated at the boundary. It makes high positive pore water pressure with hydrostatic gradient above that boundary. In the meantime, there is no rise in ground water table due to this barrier effect. Variation of the pore water pressures with time for Case 3 with upper limit for matric suction, for 5 mm/hr and 20 mm/hr rainfalls are shown in Figure 2.13.

Figure 2.13:- Results of Case 3 _ Section 1-1 with matric suction upper limit (Sujeewan & Kulathilaka, 2011)

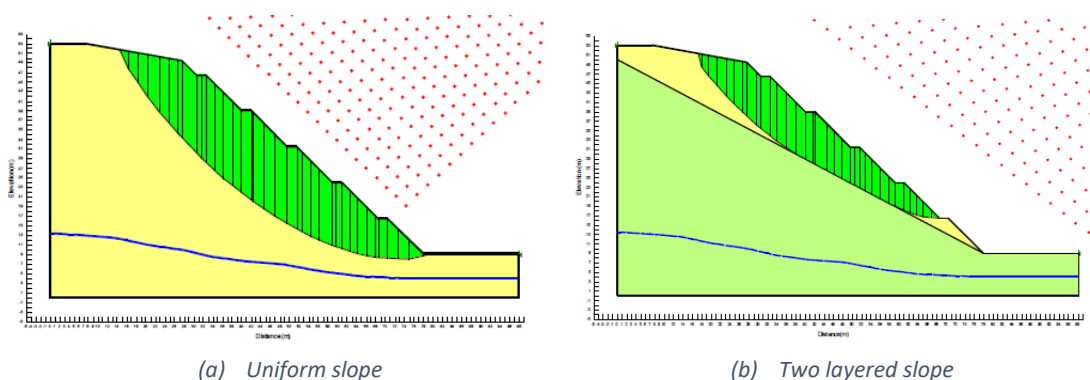
The shape of the critical failure surface was corresponding to the duration of the rainfall. At the initial stages of the rainfall or during the dry season, the prevailing high matric suctions near the surface induces greater shear strength. As such, critical failure surfaces are quite deep as shown in Figure 2.14 for the uniform slope and two layered slope. In two layered slope, critical slip surface follows the boundary of the two layers. With the rainfall infiltration the loss of matric suction and development of perched water table has developed near the surface. This loss of matric suction would reduce the apparent cohesion closer to the ground surface. As such, the critical failure surfaces corresponding to the latter stages are much shallower as illustrated by Figure 2.15.

Figure 2.14 : Critical failure surface at dry condition (Kulathilaka & Sujeevan, 2011)

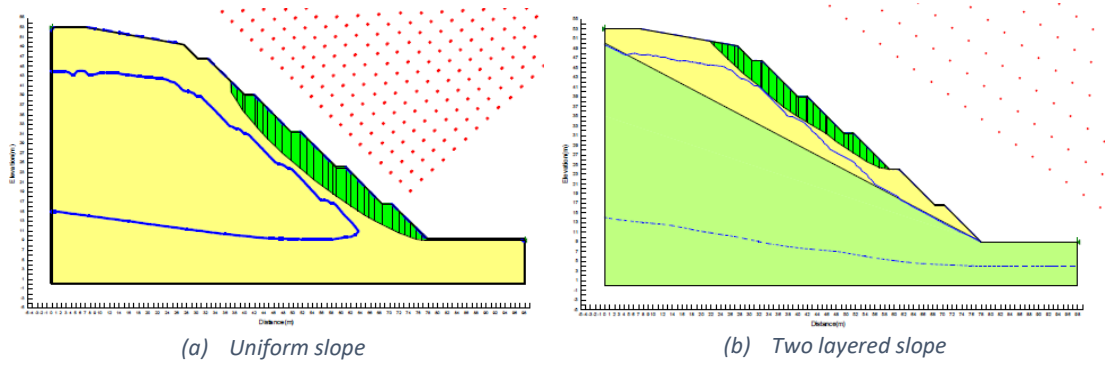
Figure 2.15 : Critical failure surface at wet condition (Kulathilaka & Sujeevan, 2011)

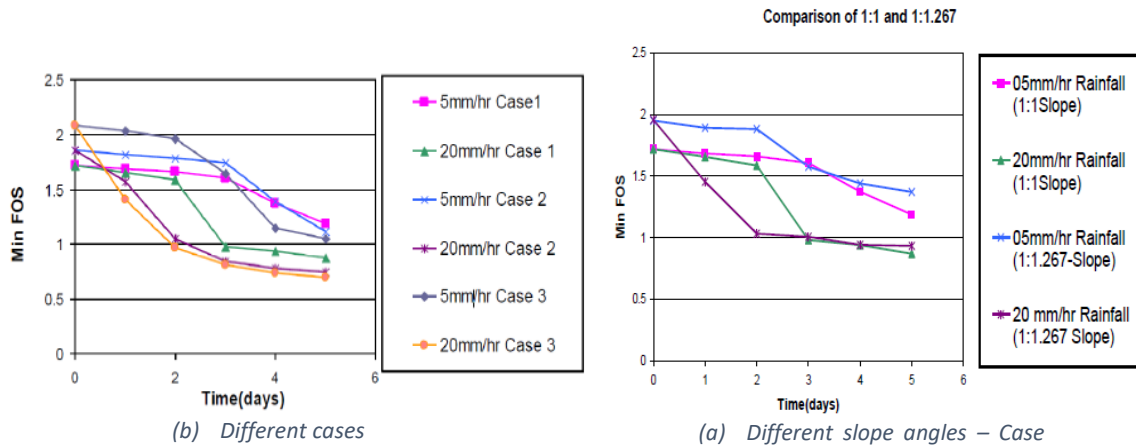
Kulathilaka & Sujeevan (2011) presented the reduction of the safety margins of the slope with the rainfall, for the three idealized geological conditions as, uniform residual soil (case 1), thick layer of residual soil underlain by weathered rock (Case 2) and a thin layer of residual soil underlain by weathered rock (Case 3), (Figure 2.16 (a)).

Figure 2.16 : Variation of minimum FoS with duration of rainfall (Kulathilaka & Sujeevan, 2011)

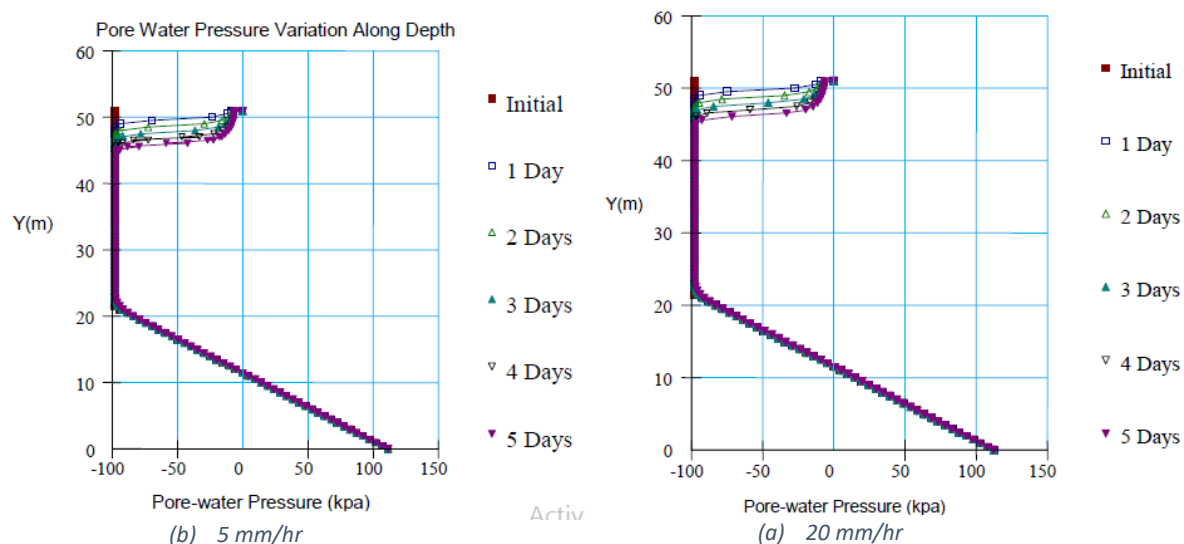
Figure 2.17 shows the pore water pressure distribution of the Case 1 slope with surface drainage improvement for different rainfall intensities. Analysis results shows that, with the presence of surface drains complete depletion of the matric suction and development of positive pore pressures (perched water table) is prevented and rise of ground water table is minimized. Similar effects were observed for the Case 2 & Case 3 also.

Figure 2.17 : Results of Case 1 _ Section I-1 with surface drains (Kulathilaka & Kumara, 2013)

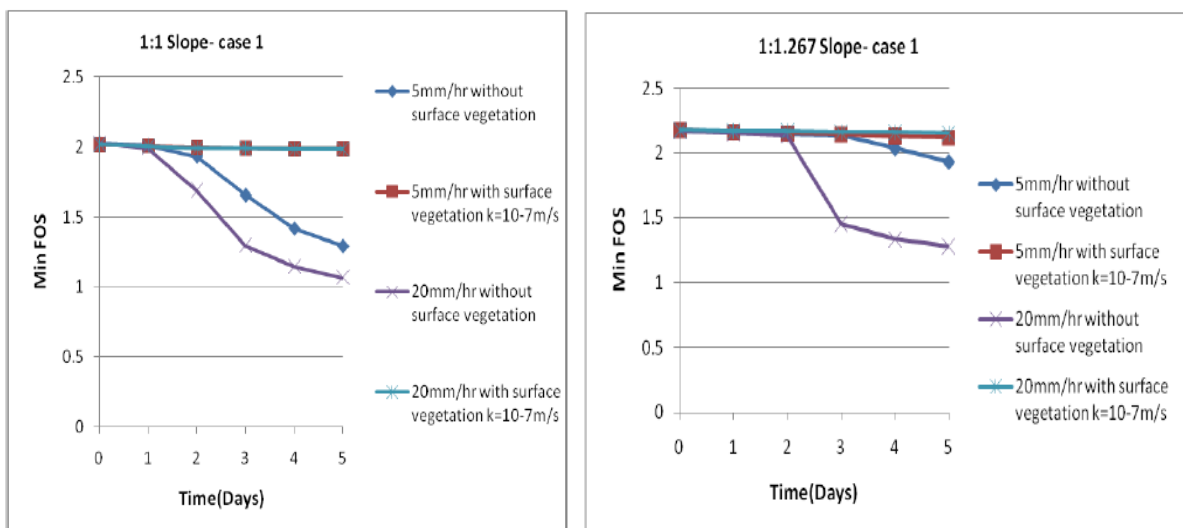
Comparison with variation of the FoS of a mild slope with gradient 1:1.267 illustrated that reduction of the slope angle alone will not ensure a sufficient safety margin under prolonged rainfall condition. The provision of adequate surface drainage measures ensure that safety margins will not reduce significantly with the prolonged rainfalls.

Figure 2.18 : Variation of minimum FoS with duration of rainfall (Kulathilaka & Kumara, 2013)

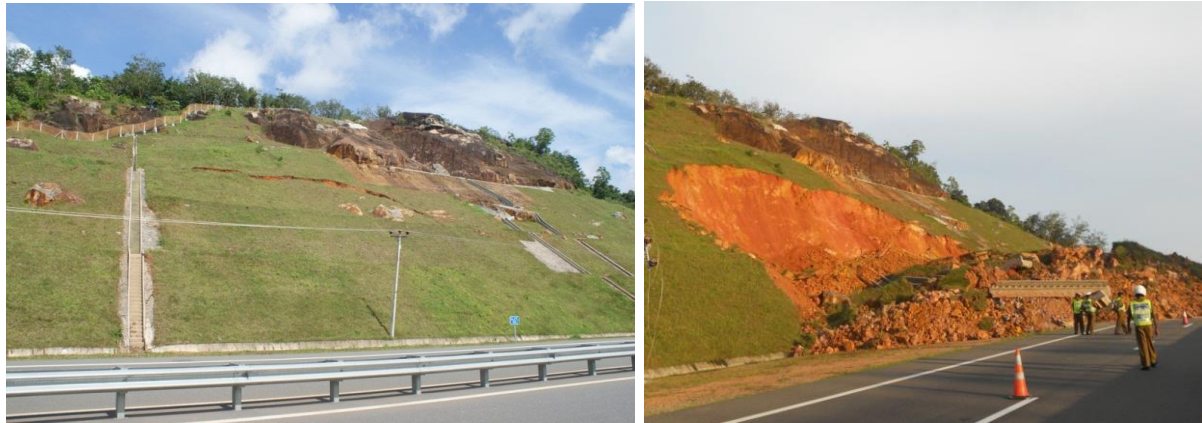
A failure occurred in the evening is illustrated in Figure 2.19 (b). The tension crack that showed up in the morning indicating the imminent failure can be seen in Figure 2.19 (a). The failure was back analyzed in the form of a parametric study considering possible scenarios of defective system of surface drains and the presence of relict joints. Identification of faults in the system of drains prompted this approach.

(b) Slope just before failure (tension crack open)

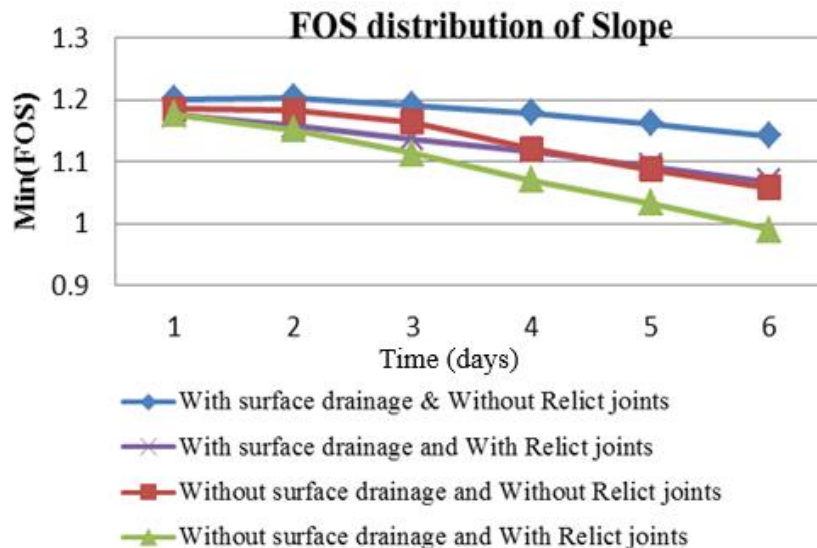
Stability of the slope before failure was analyzed against the actual rainfall encountered at the time of failure, which is a prolong rainfall about 6 days with maximum of 7 mm/hr. Surface drainage system had been constructed for this slope at the road construction stage. However, surface drains had not functioned well at the time of failure. The analysis was done for four cases such as; with & without surface drains and with & without relict joints systems. Results of analysis are presented in Figure 2.20. It clearly shows that the FoS value is less than unity at the time of failure when there are relict joints and when the surface drainage system is not present or else not functioning well. That implies that if the drainage measurers were well maintained and functioning well, this failure could have been prevented.

Figure 2.20 : FoS variation with time (Idirimanna, 2016)

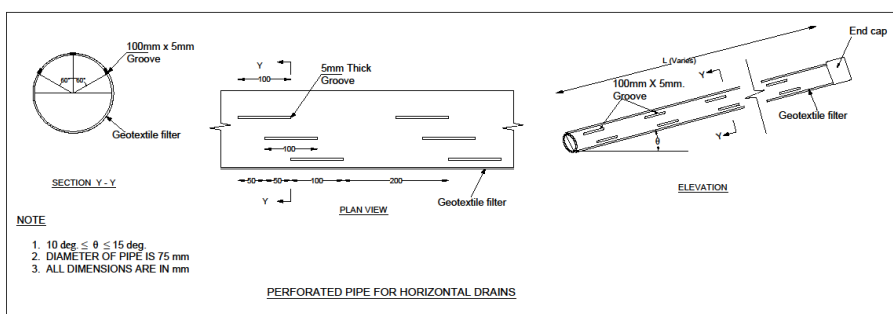
Sub horizontal gravity drains are perforated or slotted pipes installed in to the slope in an appropriate orientation (Figure 2.21). The simplest form is a straight pipe of appropriate length placed at a desired horizontal spacing at different level in the slope (Figure 2.22).

Figure 2.21 : Perforated pipe for sub horizontal gravity drains (National Building Research Organisation, 2016)

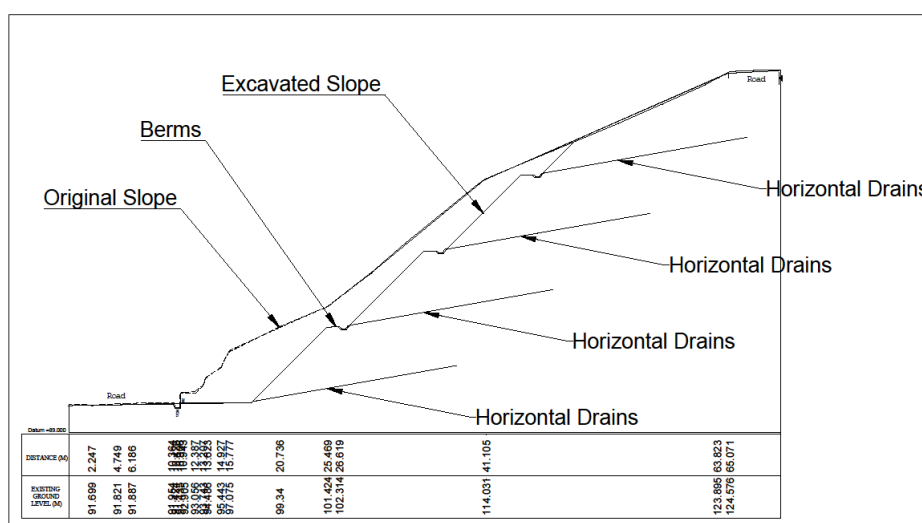
Figure 2.22 : Typical arrangement of sub horizontal gravity drains (National Building Research Organisation, 2016)

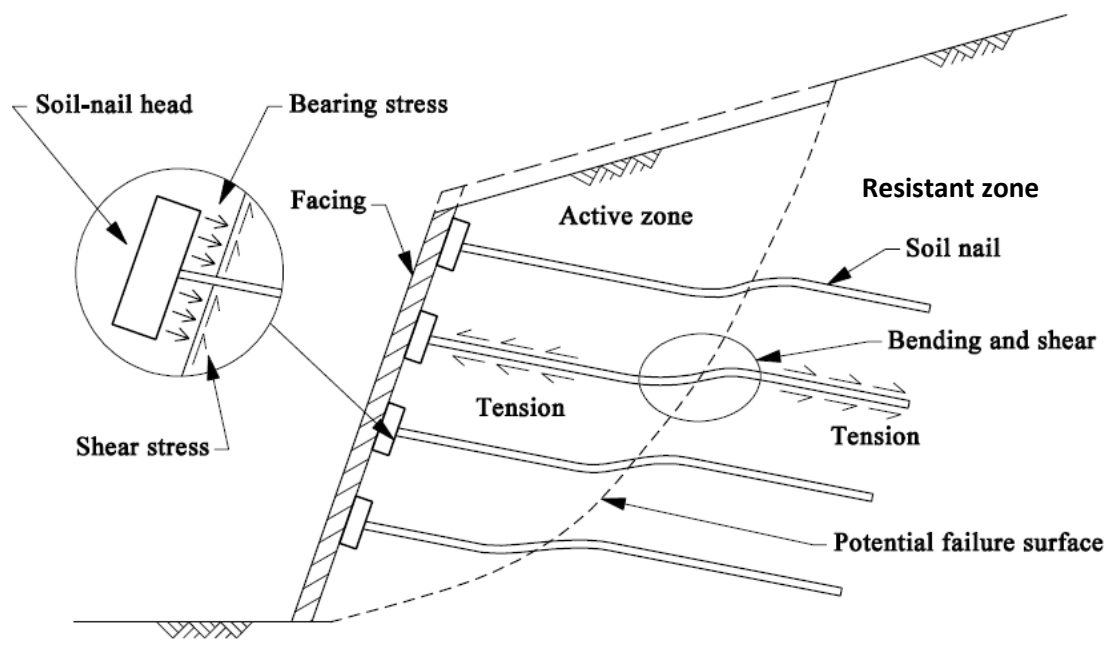
The mechanism of stabilization in soil nailing is illustrated in Figure 2.23.

Figure 2.23 : Soil nailing system (GEO, Hong Kong, 2008)

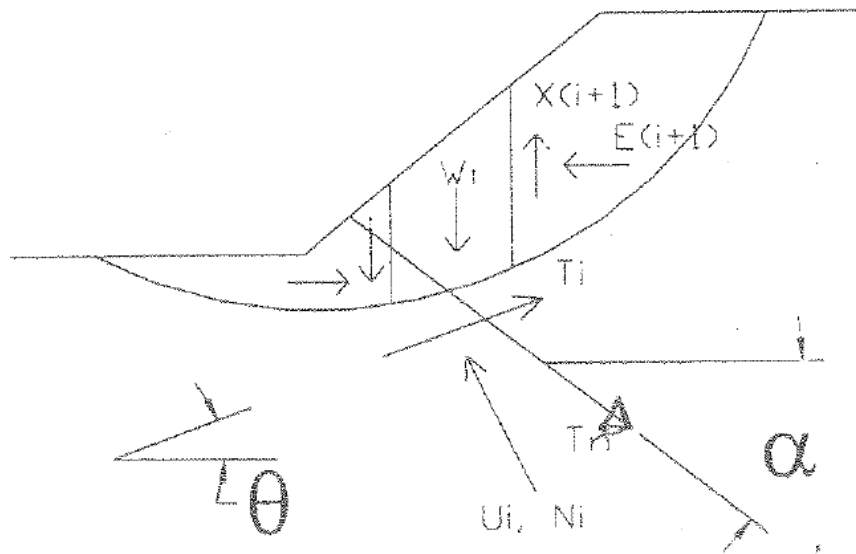
Two analytical models were developed by Kulathilaka & Mettananda (2002) for analysis of stability of soil nailed system. Analytical model based on the Bishop's Simplified Method (Bishop, 1955) can be used for circular failure surfaces and it is described below.

Figure 2.24 : Forces on potential failure mass (Kulathilaka & Mettananda, 2002)

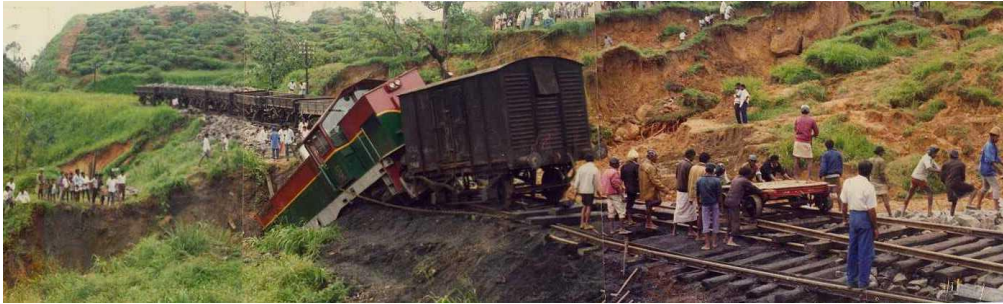
Watawala landslide mitigation is the first large scale landslide mitigation work carried out in Sri Lanka. It was a landslide that initiated in 1950's and had been moving periodically in the periods of heavy rain. A major failure occurred in June 1992 damaging nearly 100 m length of the Colombo - Badulla railway track between Galboda and Watawala (Figure 2.25). The landslide was found to cover an area of approximately 22,920 m² and about 322,700 m³ slide volume.

Figure 2.25 : Watawala Landslide after Failure (Rajaratnam & Bhandari, 1994)

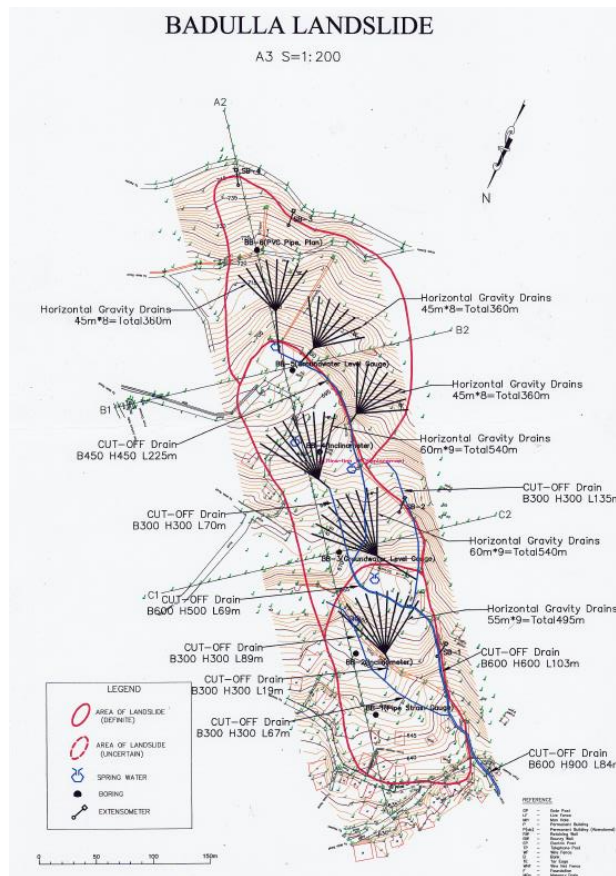
Subsurface and surface drainage improvement was applied as mitigation measures in order to maintain the stability of the slope by keeping ground water table at lower levels. Considering the geometry of the slope and landslide area, sub horizontal gravity drains were installed in an radial orientation at different levels covering the entire landslide mass (Figure 2.29).

Figure 2.29 : Plan View of Mitigation Measures of Badulusirigama Landslide

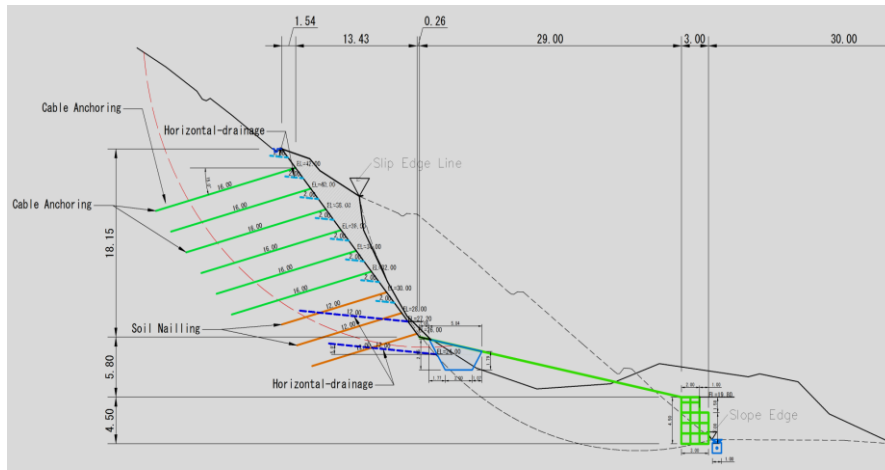
Stage construction with proper sequence was adopted to maintain the stability of the slope during construction. Soil nailing and anchoring was done simultaneously with the excavation of the slope. Excavation for toe retaining structure was done after stabilizing the upper slope. The installation of sub horizontal gravity drains were done last after completing all the grouts work in the nailing to prevent any grout intrusion through the interconnected relict joints. Figure 2.30 shows the mitigation measures applied for slope strengthening.

Figure 2.30 : Mitigation Measures of Welipenna Landslide (Idirimanna, 2016)

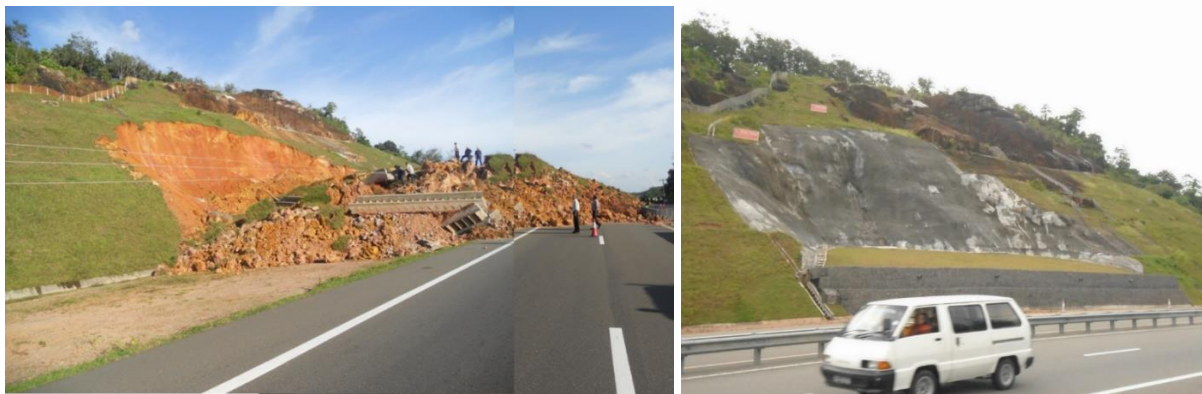
Figure 2.31 shows the conditions just after failure (a) and after the rectification (b).

(b) After Failure (a) After Rectification
Figure 2.31 : Failure at Welipenna on Southern Expressway (Idirimanna, 2016)

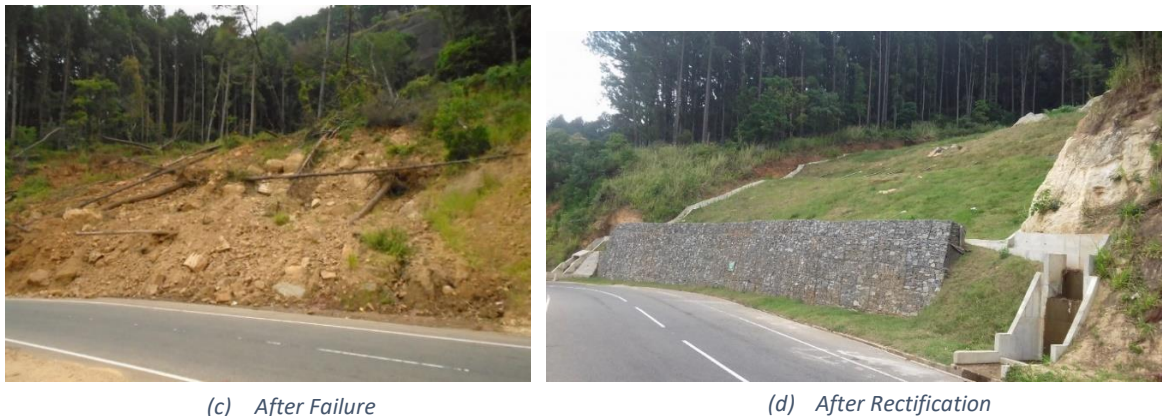
In some locations (Location 08 and Location 18) Gabion walls were used as toe retaining structures along with drainage measures. In Location 08 failures has propagated and propagated further back (Figure 2.32 (a)), and original design had to be revised to adopt the new scope. Gabion wall was constructed at the toe to support loose materials in the landslide body. Compaction of top soil layers and landscaping was done to reduce infiltration and prevent water stagnation. Berm drains connected to cascade drains were used to rapid discharge of rain water away from the landslide body. Turfing was done on the slope to prevent erosion. Sub horizontal gravity drains were installed at berm levels and toe level to lower the ground water table. Scar of 1 m – 2 m height at the crest was cut back into 55° angle. With all these mitigation measures required safety margin was achieved. Slope after mitigation is presented in Figure 2.32 (b) **Error! Reference source not found..**

Figure 2.32 : Kandy – Mahiyangana Road Location 08

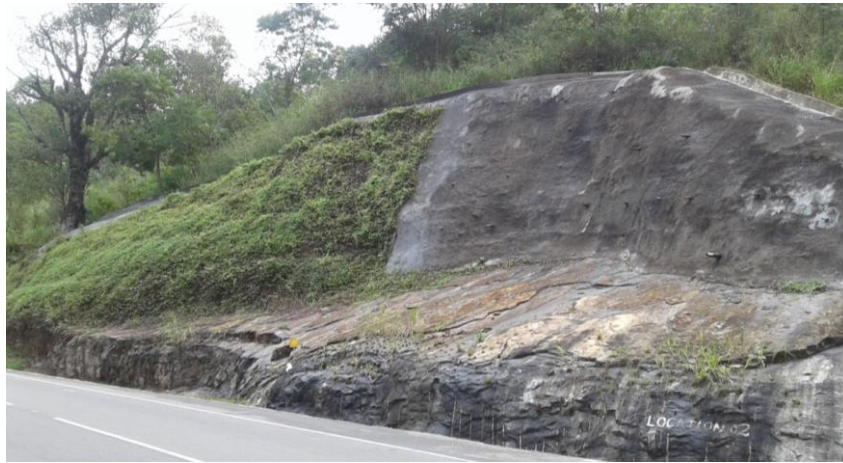
Figure 2.33 : Mitigation Measures with Soil Nailing, Drains and Facing with Shotcreting and Vegetation

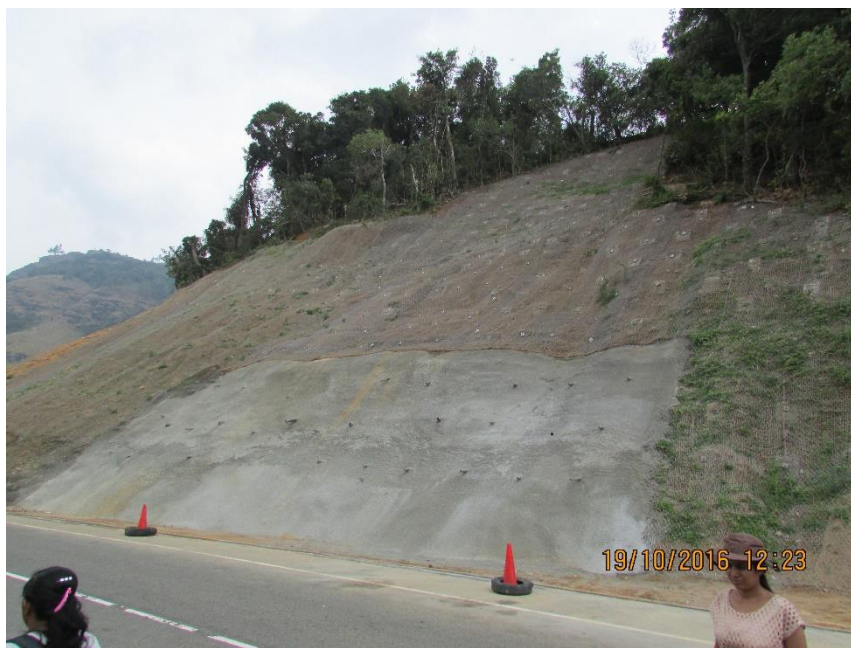
Figure 2.34 shows a typical location with soil nailing, drains and surface protection with individual concrete pillow, high tensile wire mesh and vegetation as mitigation measures

Figure 2.34 : Mitigation Measures with Soil Nailing, Drains and Facing with Individual Pillows Connected by High Tensile Wire Mesh, and Vegetation

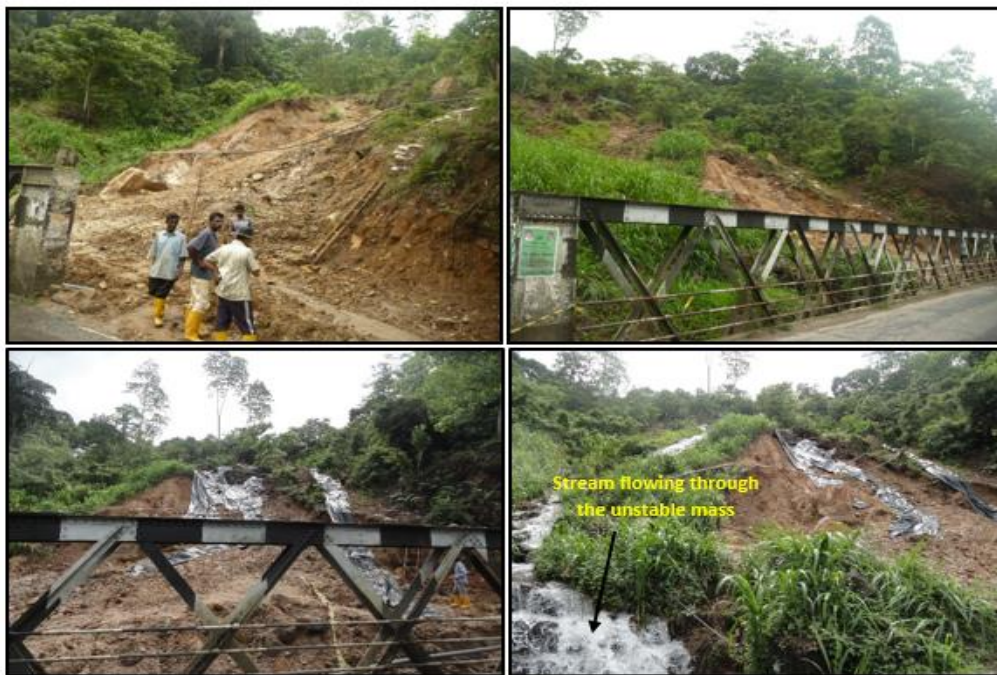
A mass movement had occurred on 22nd June 2014 followed by the excavation works at the toe of the soil slope (Figure 3.2). Excavation had been done for the proposed widening of the bridge. It was reported that there was no rain at the time of failure, but it has been further activated with continuous heavy rain received few days later into the area. According to information received from the community living in the area and the field evidence, numbers of other cutting failures had occurred within the area during rainy seasons. Geomorphological features at the site indicates that there had been a landslide earlier (Figure 3.3). Several tension cracks have been developed in the middle and head part of the landslide and some boulders were slightly moved towards the road side as shown in Figure 3.4.

Figure 3.2 : Landslide occurs on 22nd June 2014 (National Building Research Organisation, 2014)

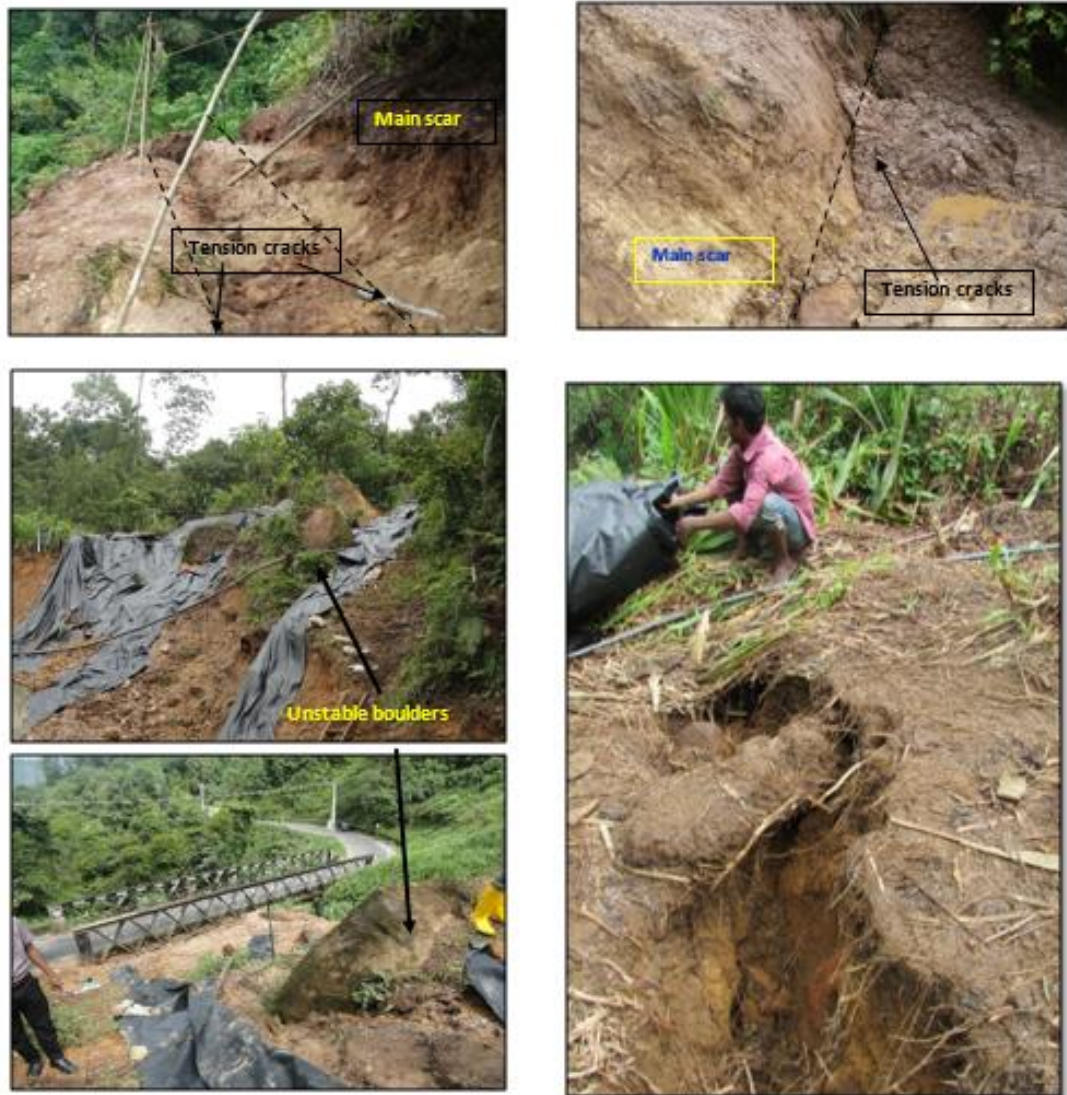
Figure 3.4 : Tension cracks and unstable boulders (National Building Research Organisation, 2014)

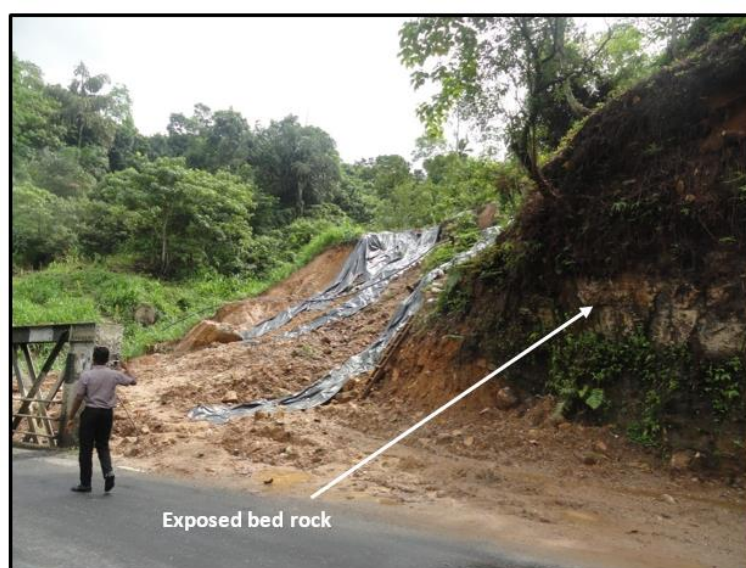
The landslide area is generally underlain by highly crystalline metamorphic rock of Highland complex (HC). The Highland complex rocks (ages 2.0-3.4 Ga) metamorphosed to granulite grade is the centrally located, NE-SW trending belt comprising mainly Charnockitic Gneisses and Granulites, Metasediments, Basic Granulites, Gneisses and Migmatites. The metasediments include Quartzites, Marbles, Pelitic Gneisses and Garnet-Sillimanite-Schist (Khondalites). The rock found at the adjacent hill can be identified as highly fractured Charnockitic gneiss with thick quartzite layers as shown in Figure 3.5.

Figure 3.5 : Exposed bed rock (National Building Research Organisation, 2014)

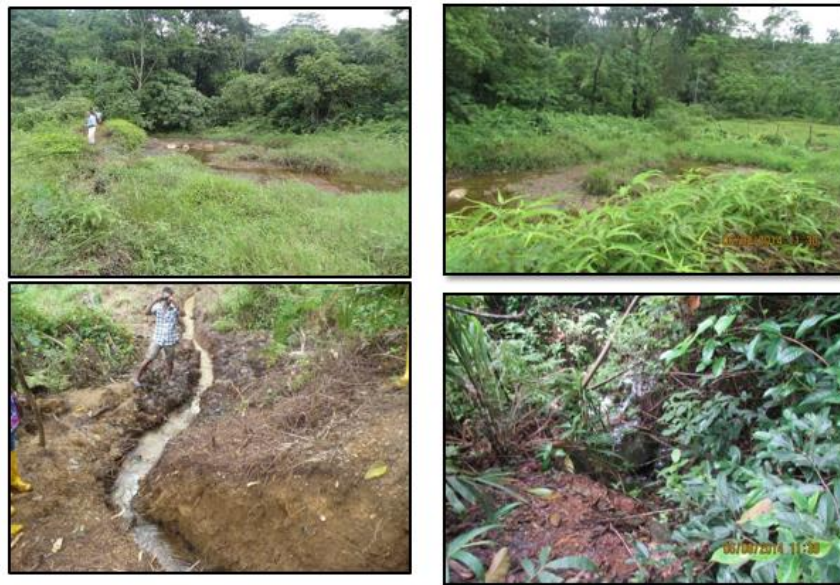
Figure 3.6 : Water log at marshy land and streams (National Building Research Organisation, 2014)

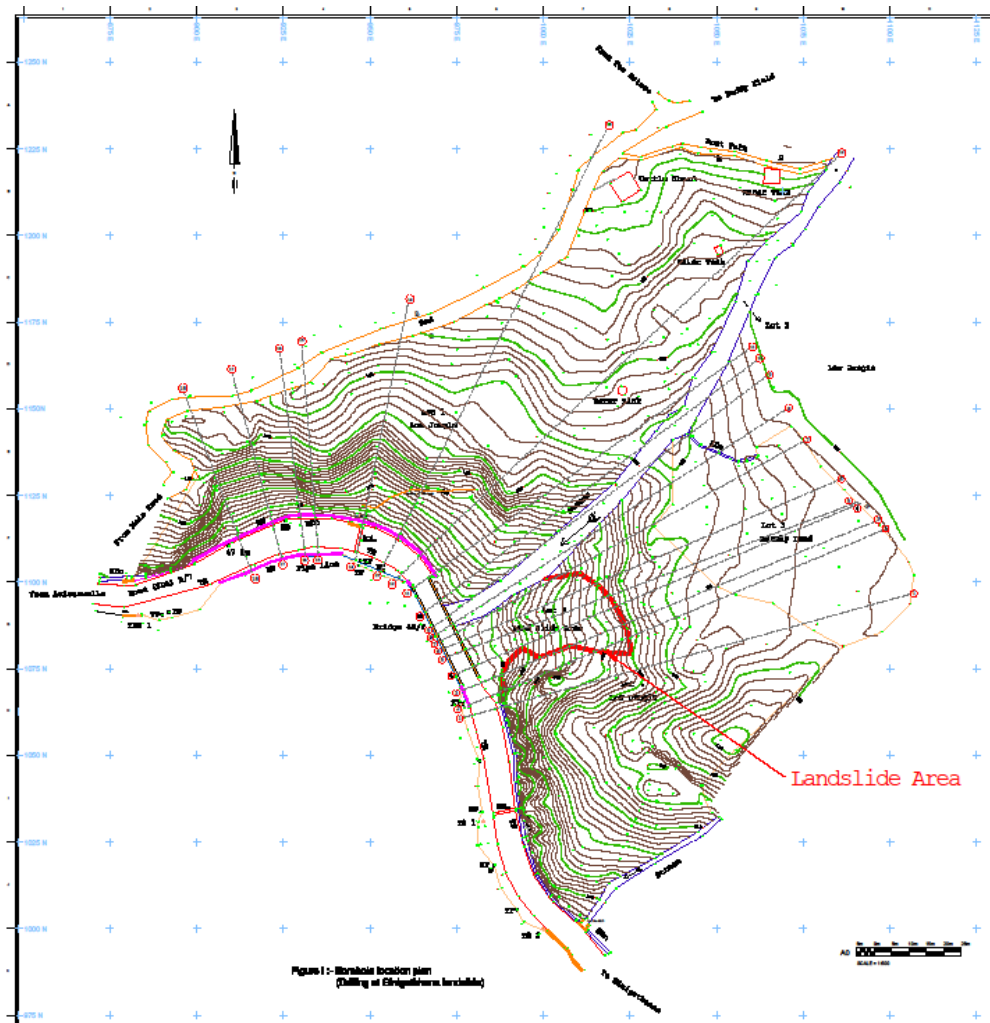
Figure 3.7 : Survey Map (National Building Research Organisation, 2016)

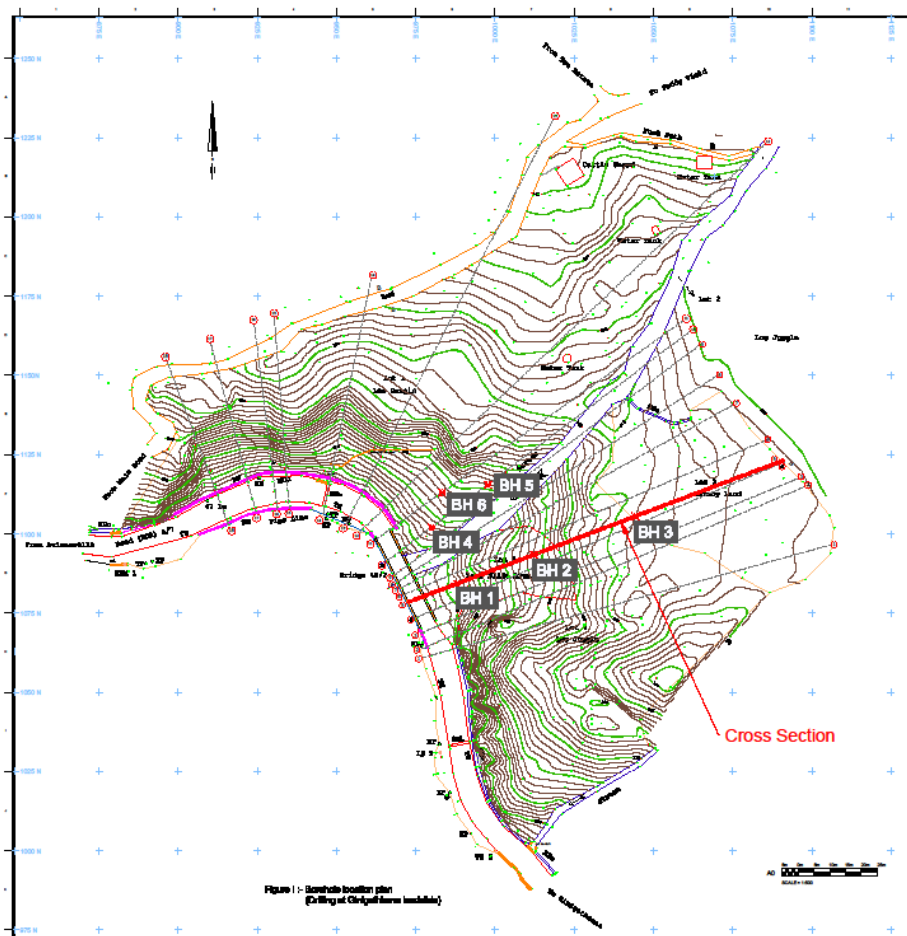
Figure 3.8 : Boreholes Locations Map and Cross Section
