**ENHANCEMENT OF THE STABILITY AT THE SITE
OF AN ANCIENT LANDSLIDE IN A ROAD CUTTING
WITH DRAINAGE AND REINFORCEMENT – CASE
HISTORY AT GINIGATHHENA**

M.Eng. in Foundation Engineering and Earth Retaining Systems

Department of Civil Engineering

University of Moratuwa

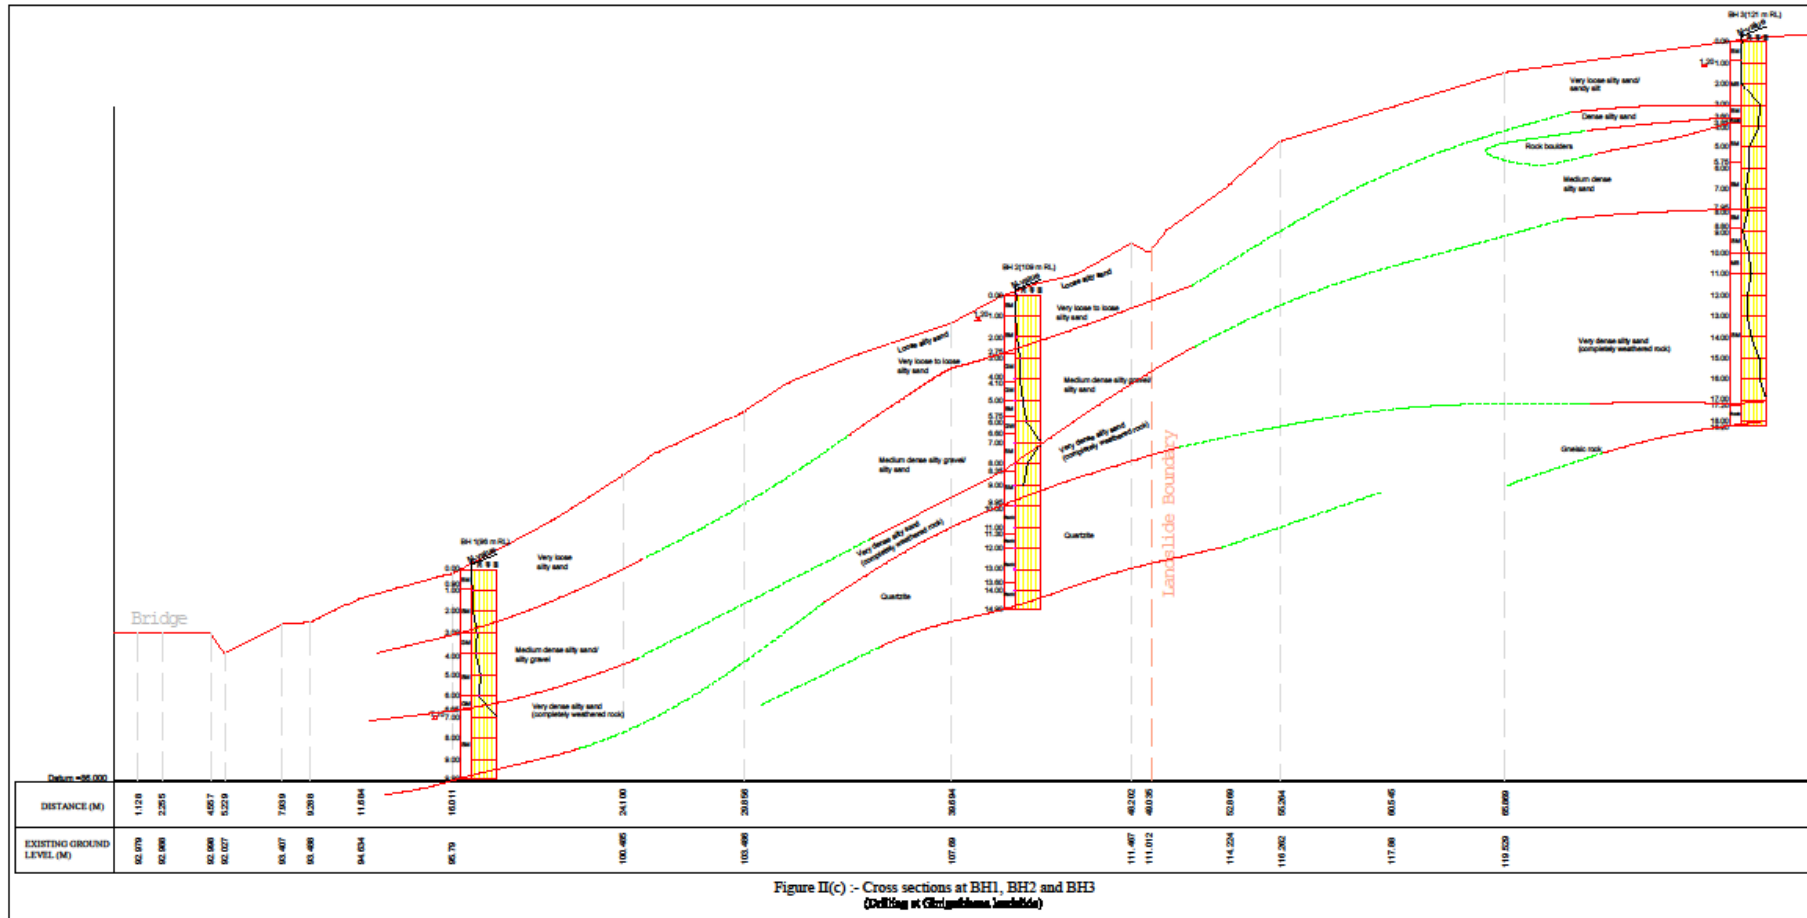
Figure 3.9: Subsoil Profile from Field Investigation (National Building Research Organisation, 2014)

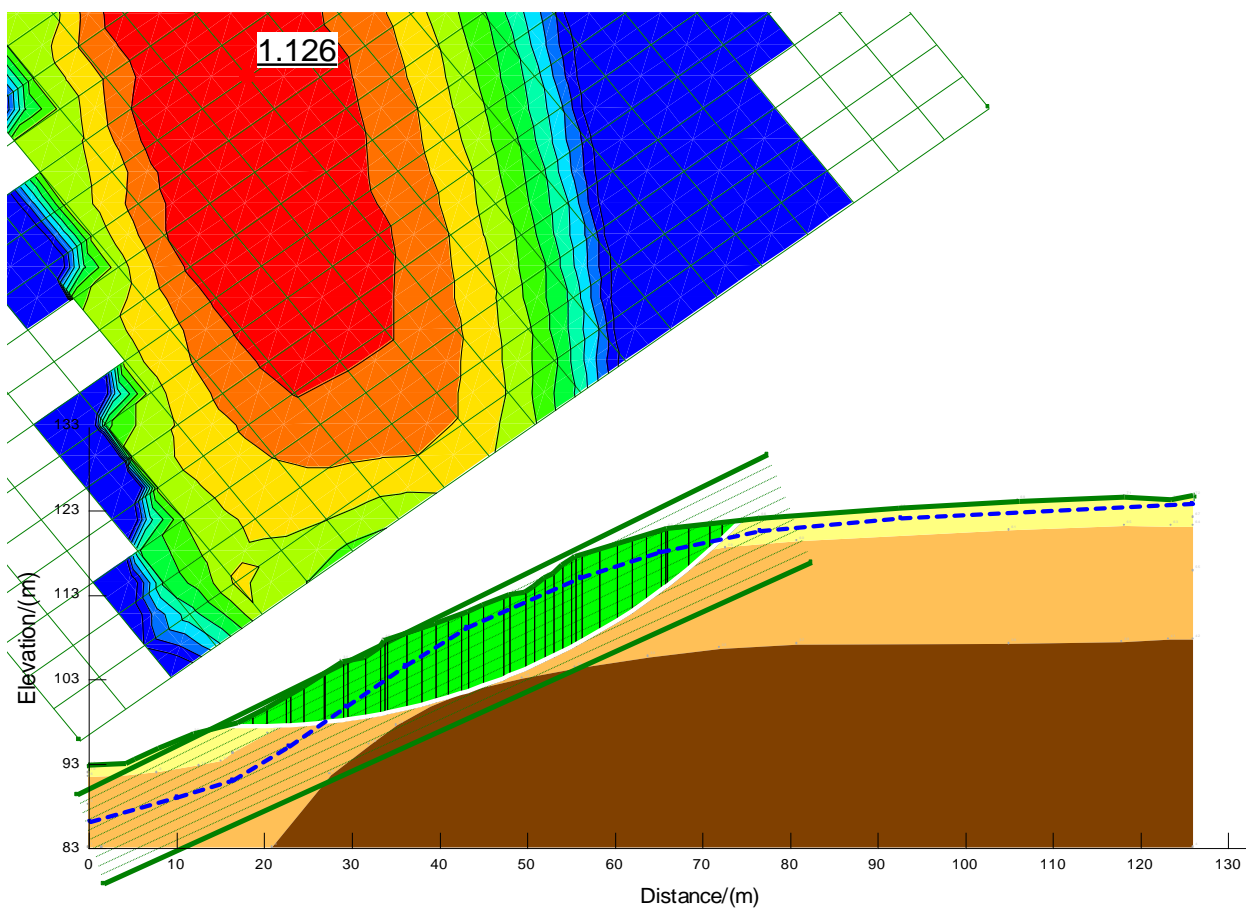
Figure 3.11 : Stability of the Natural Slope Prior to and Excavation

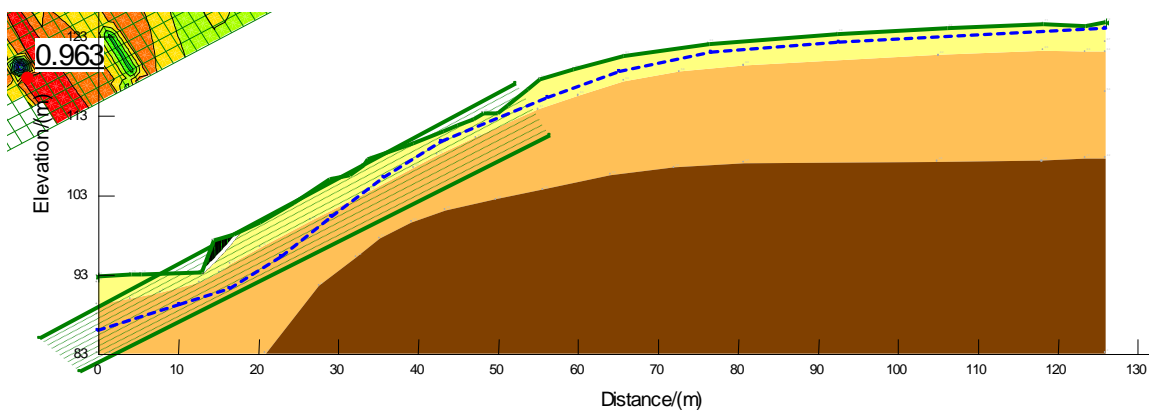
Figure 3.13 : Stability of the Slope after First Failure

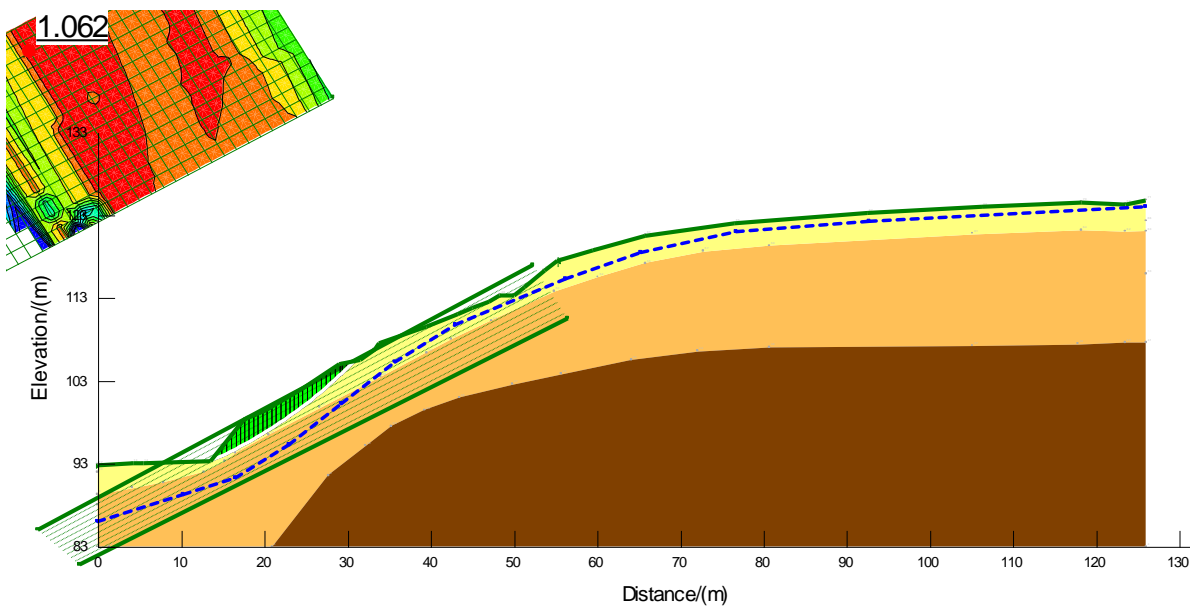
Figure 3.14 : Stability of the Slope after Second Failure

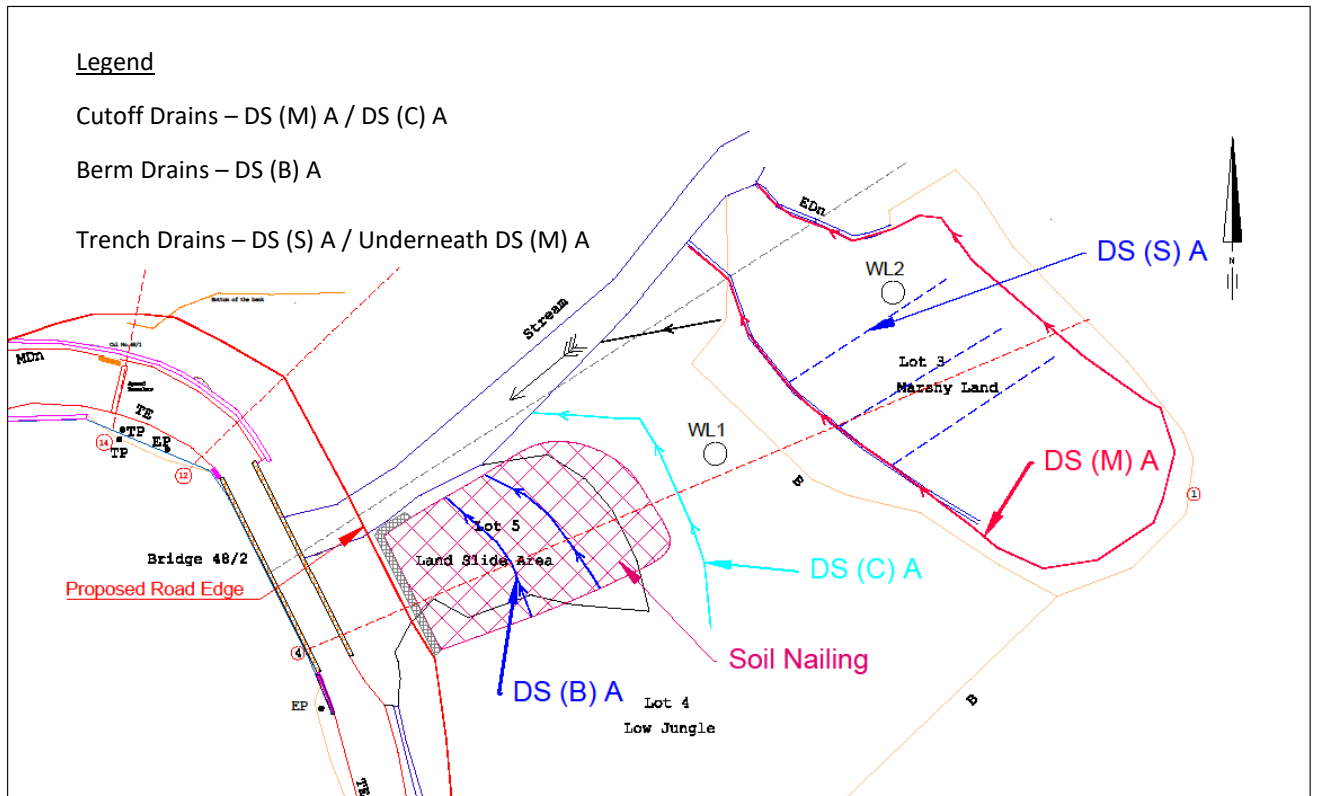
Figure 3.15 : Plan view of proposed mitigation measures

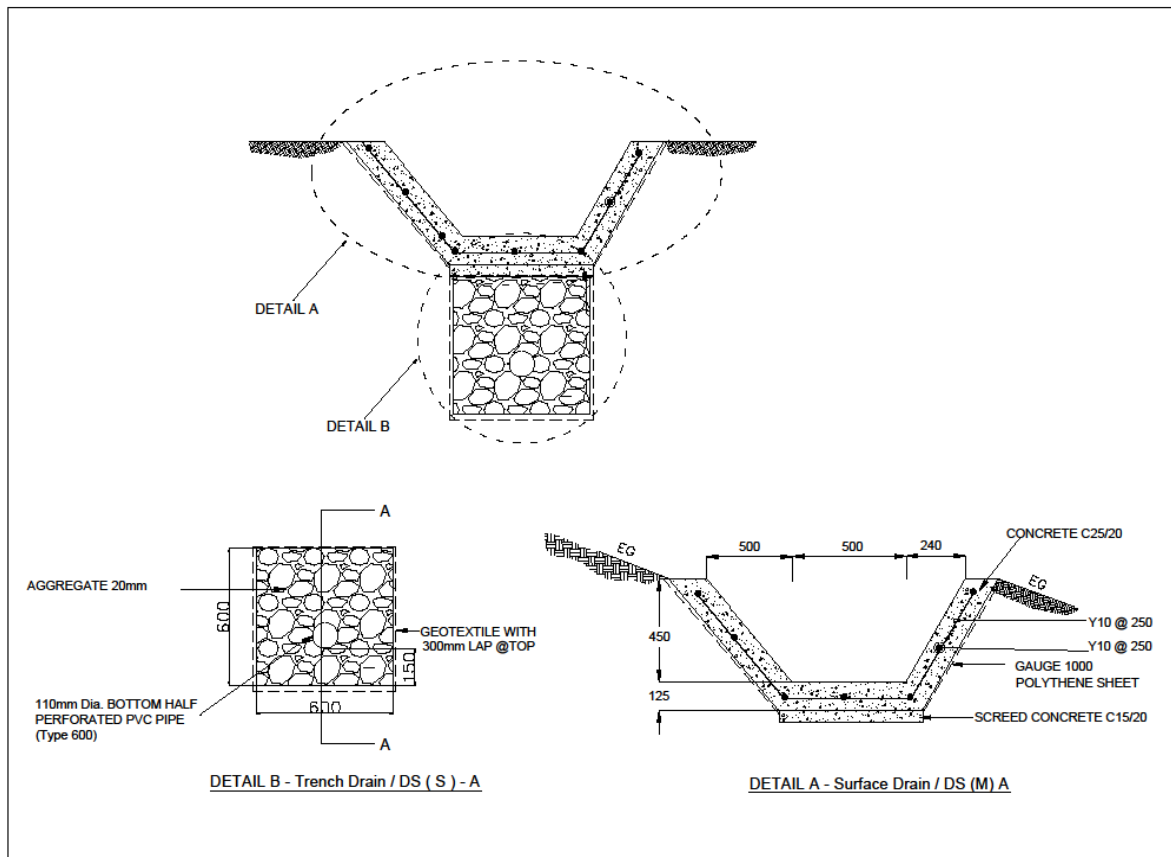
Figure 3.16 : Detail of surface and trench drain

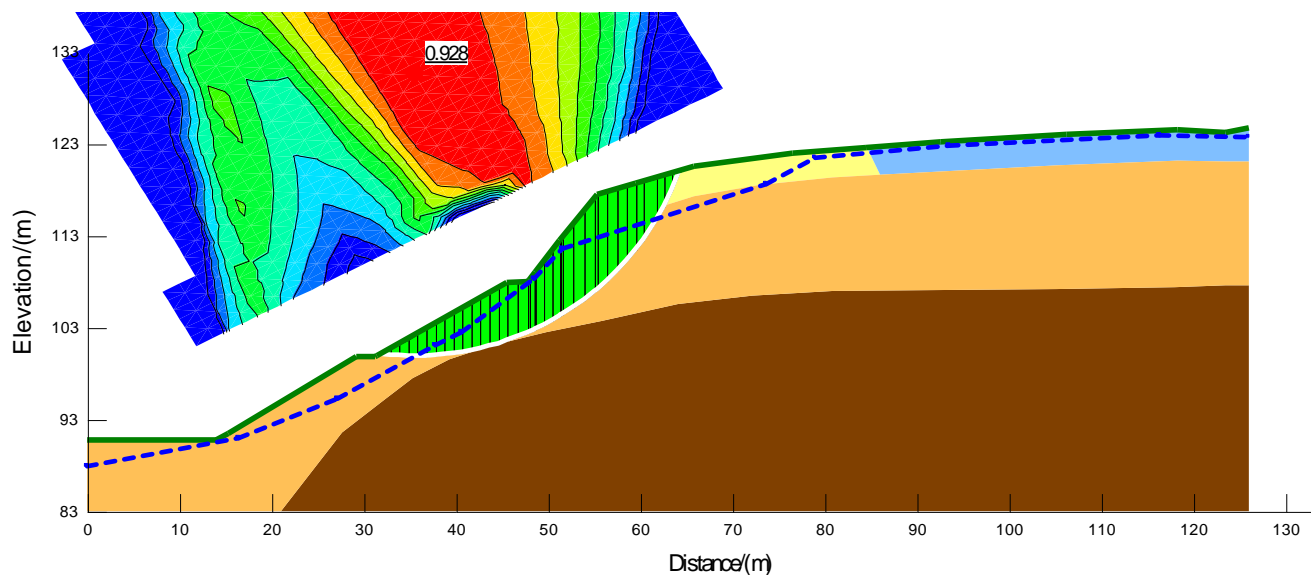
Figure 3.17 : Slope Stability Analysis – Geometry Modification with High GWT

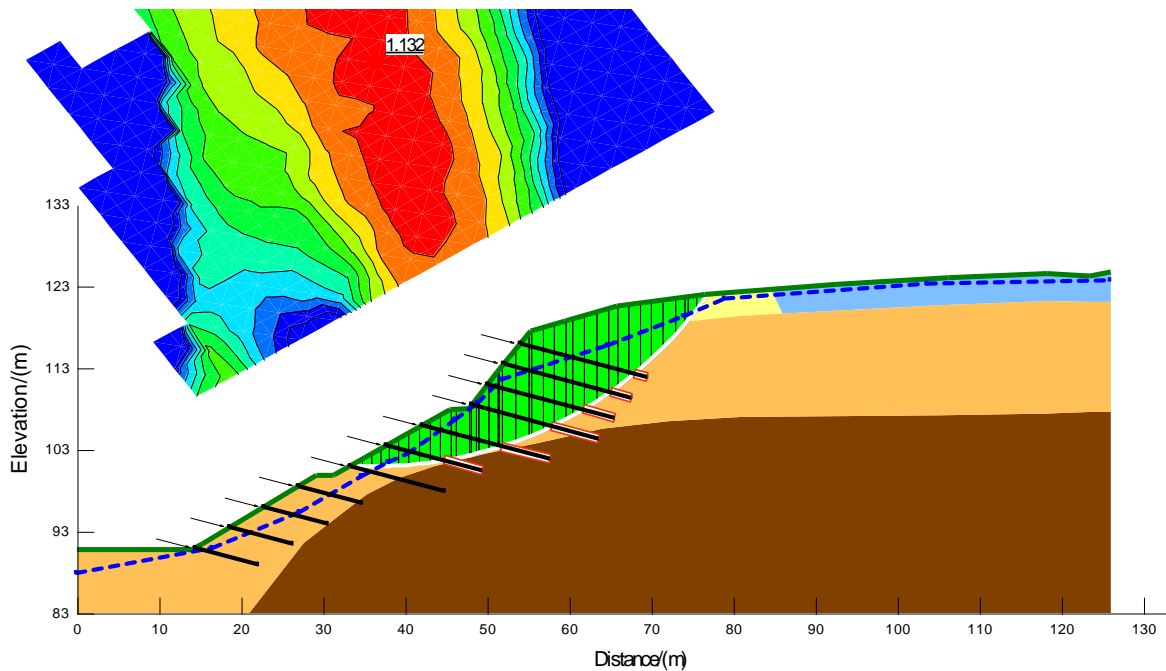
Figure 3.19 : Slope Stability Analysis of Nailing System with High GWT

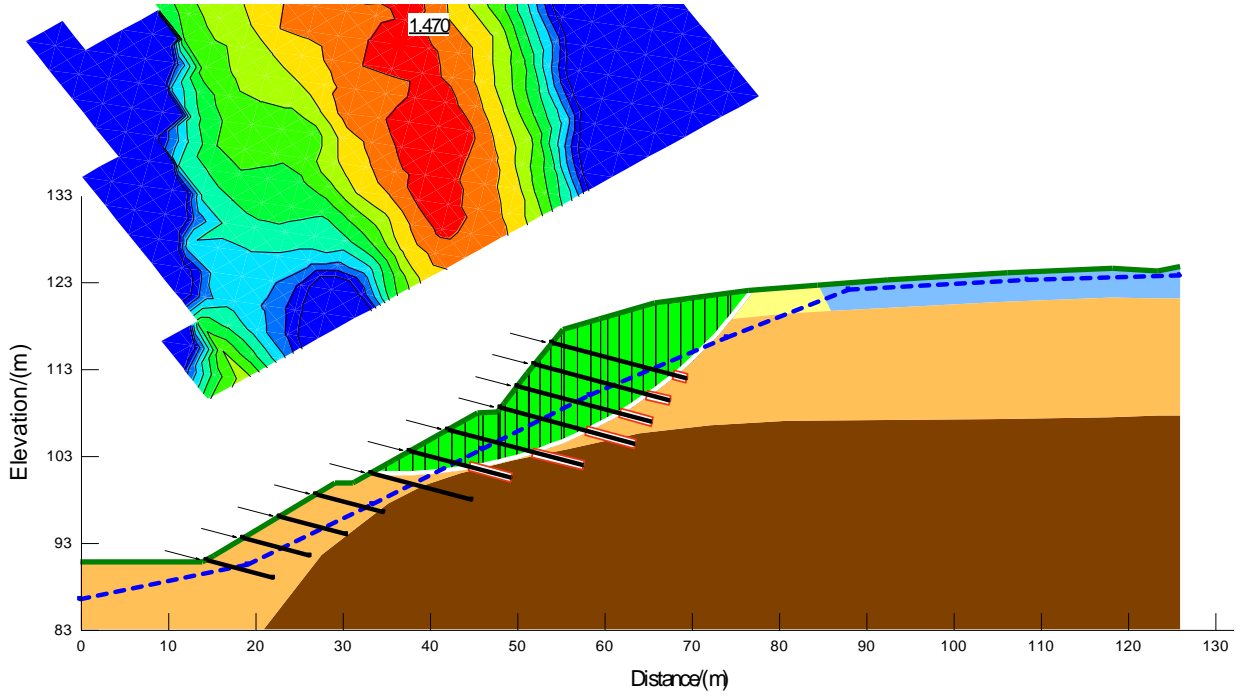
Figure 3.20 : Slope Stability Analysis of Nailing System with Low GWT

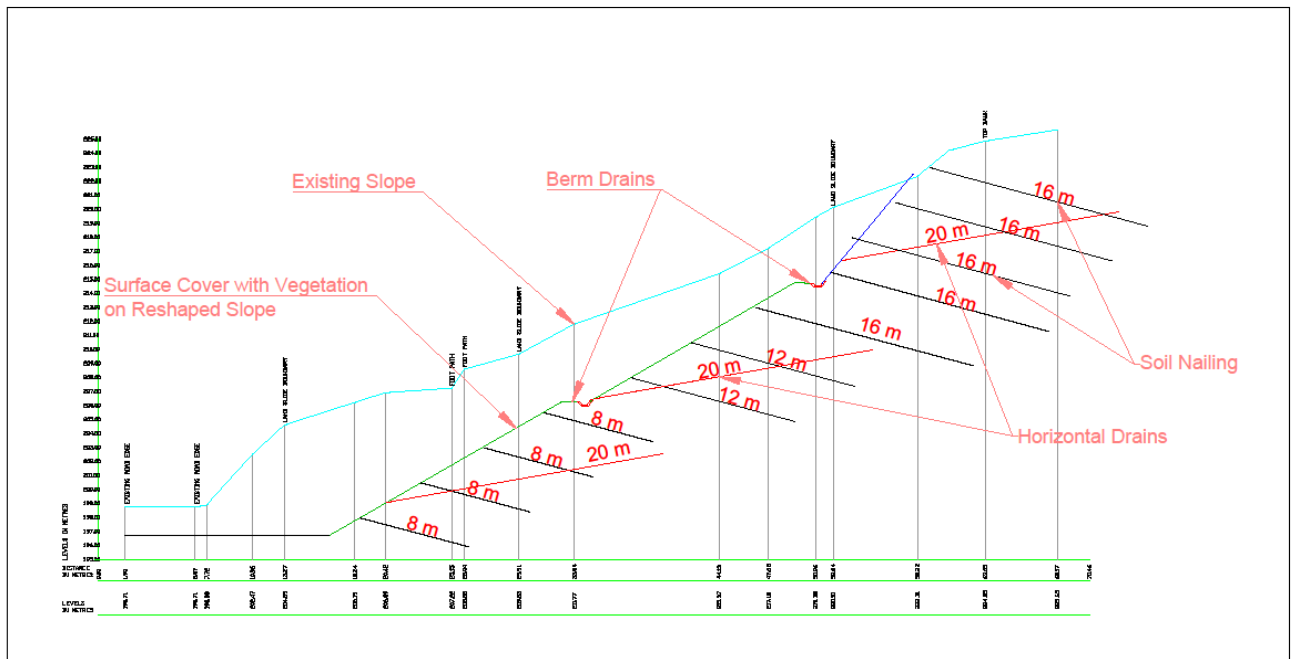
Figure 3.21 : Cross section of proposed mitigation measures

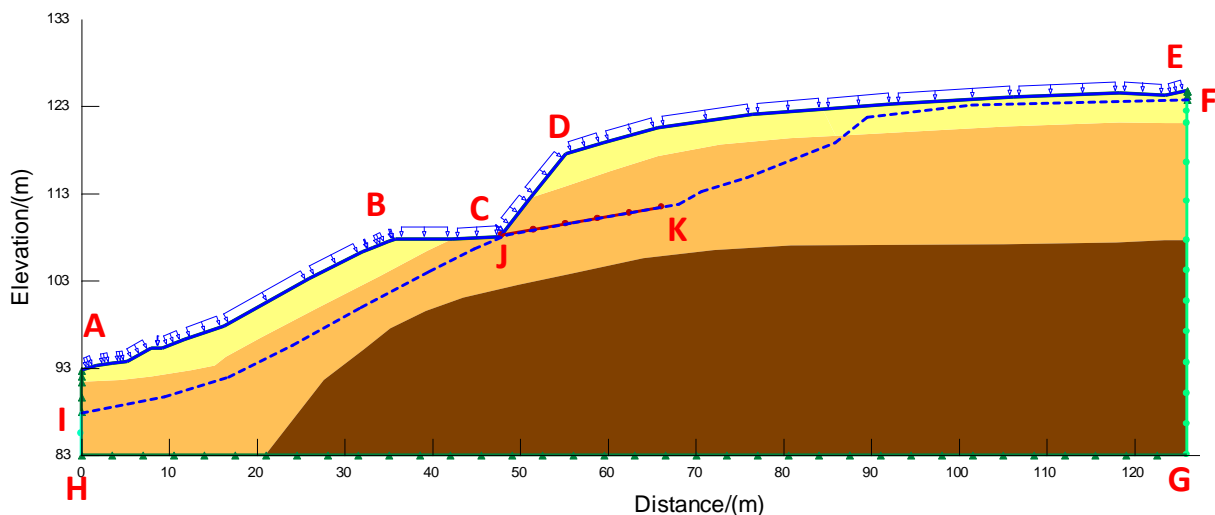
Figure 4.3 : Slope geometry with sub soil profile and boundary conditions

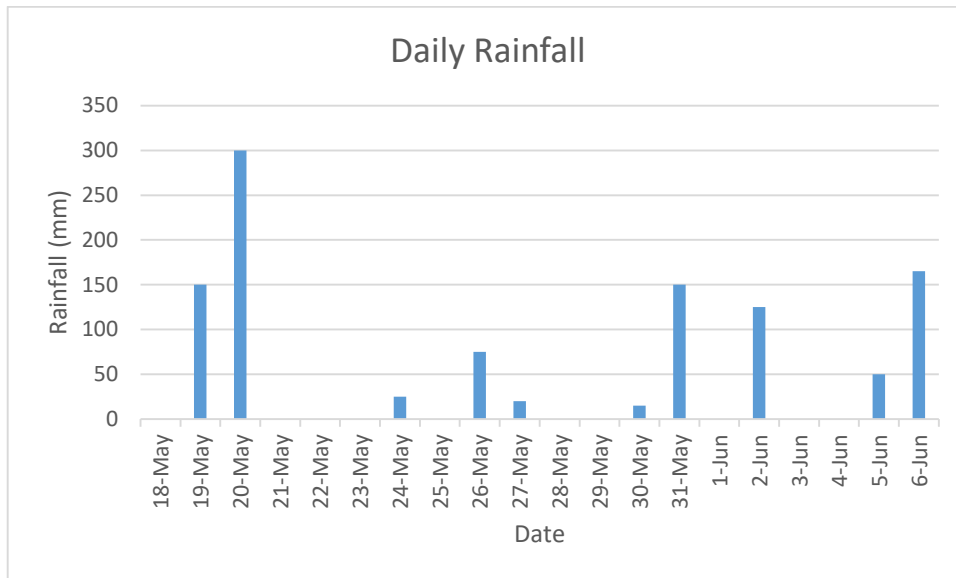
Figure 4.4 : Daily rainfall record form 18th May 2018 to 06th June 2018

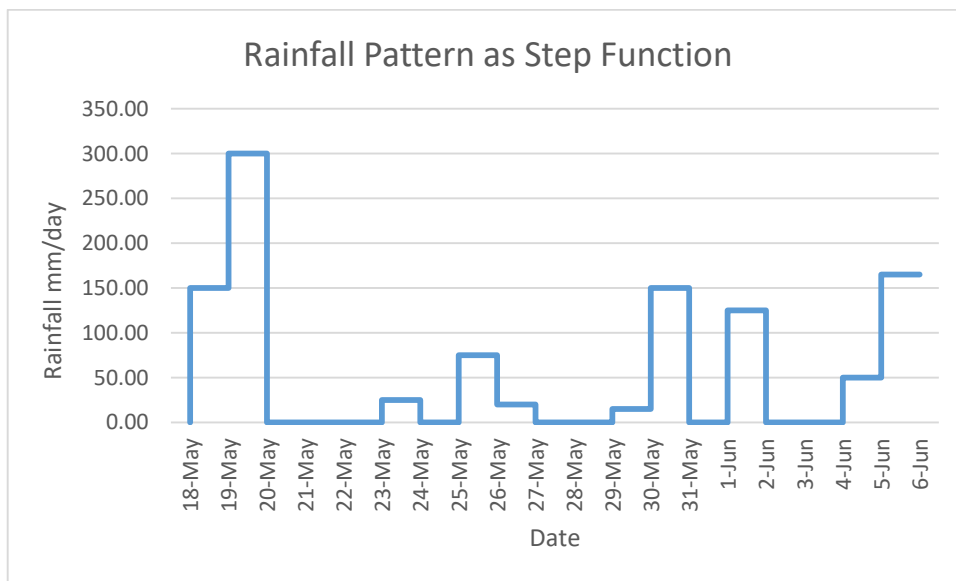
Figure 4.5 : Rainfall pattern used for model verification

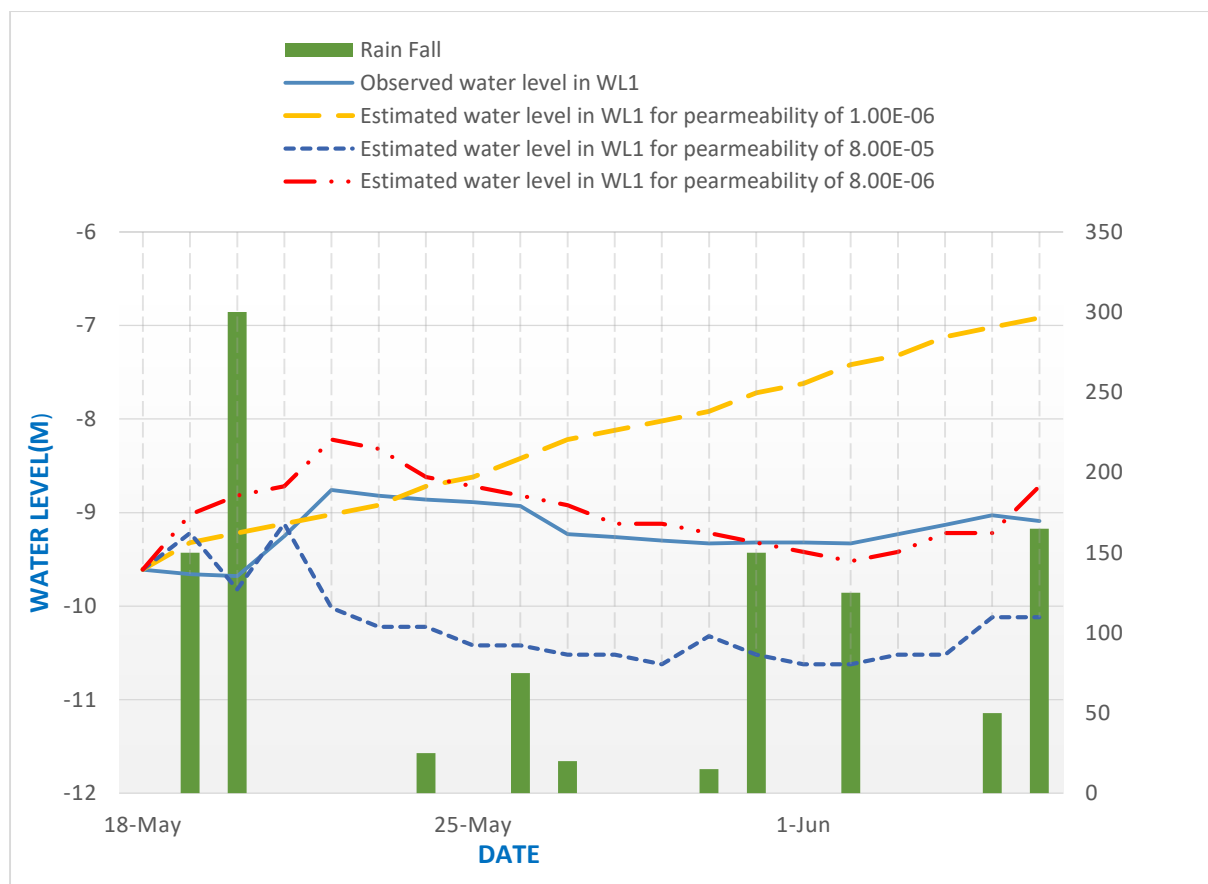
Figure 4.6 : SEEP/W Model verification

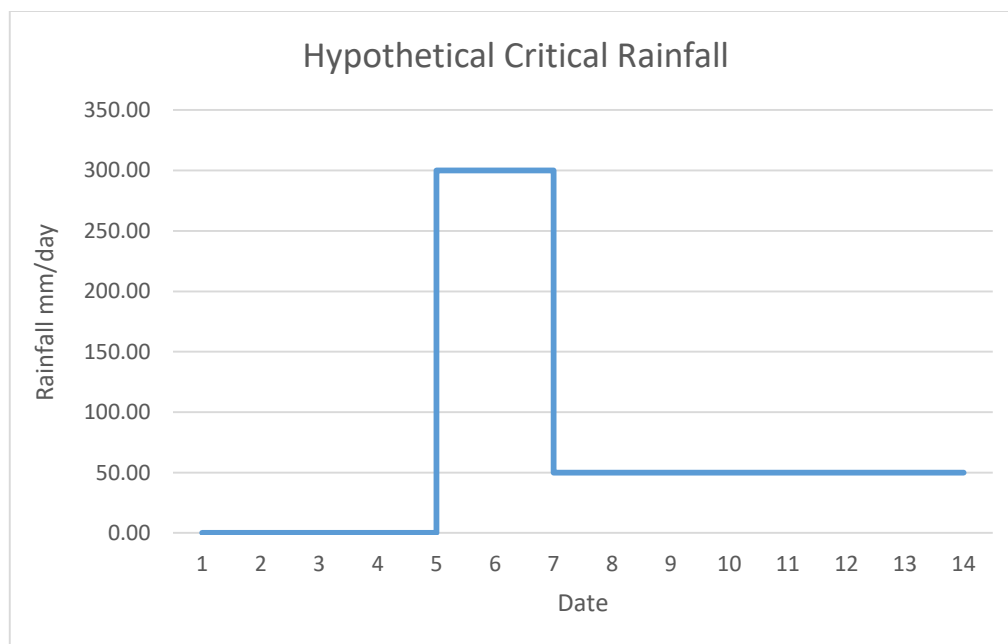
Figure 4.7 : Critical rainfall pattern for the analyses

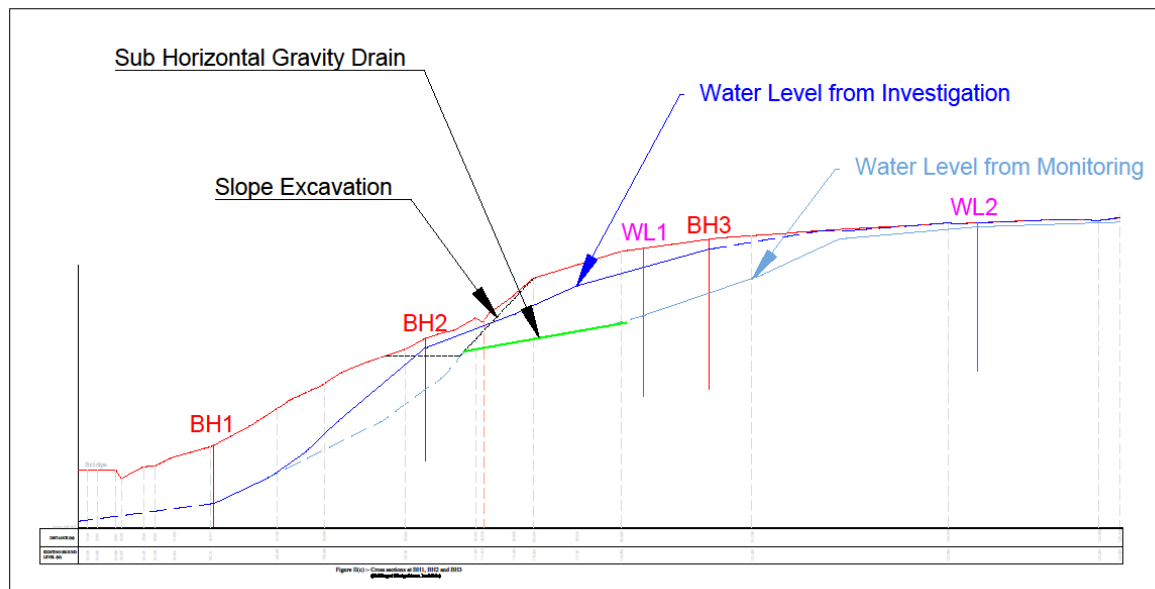
Figure 4.8 : Water levels comparison from geotechnical investigation and field monitoring

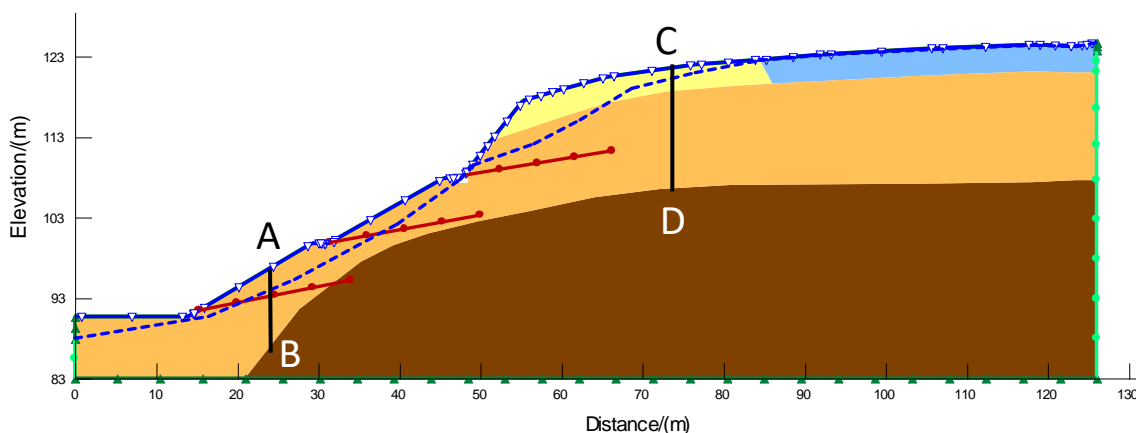
Figure 4.9 : Initial ground water level for the analysis without trench drains

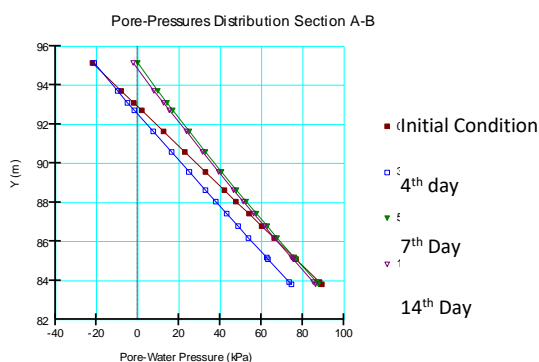
Figure 4.17 : Pore-Pressure Distribution at Section A-B with No Drains

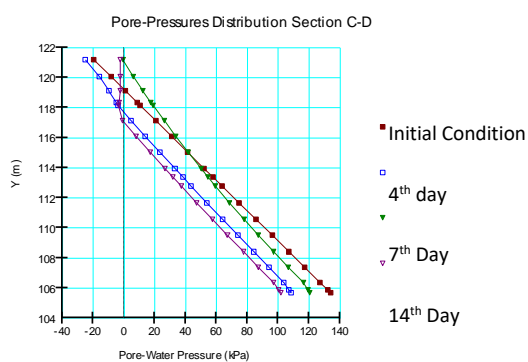
Figure 4.18 : Pore-Pressure Distribution at Section C-D with No Drains

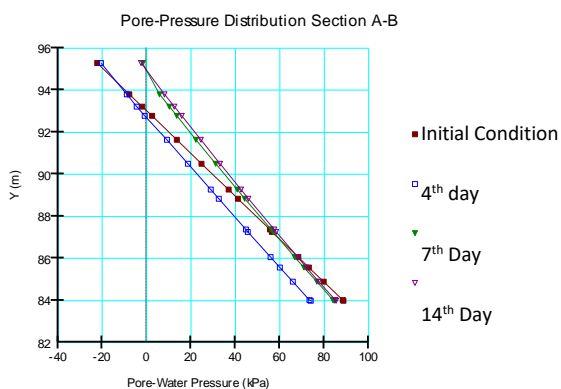
Figure 4.19 : Pore-Pressure Distribution at Section A-B with Surface Drains

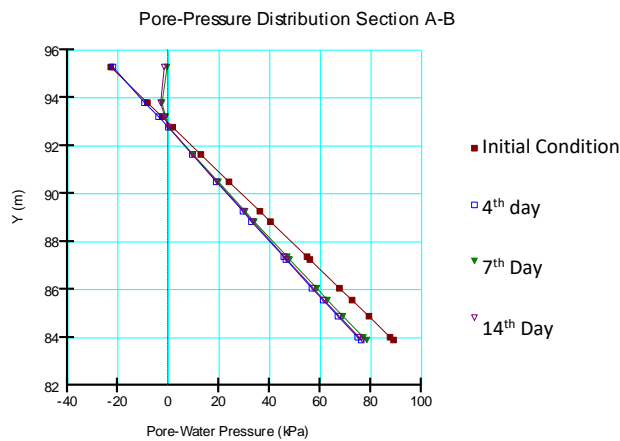
Figure 4.21 : Pore-Pressure Distribution at Section A-B with Surface and Subsurface Drains

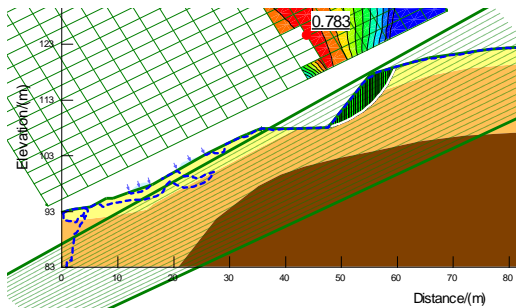
Figure 4.23 : Analysis without Drains and without Nails – Stage 1

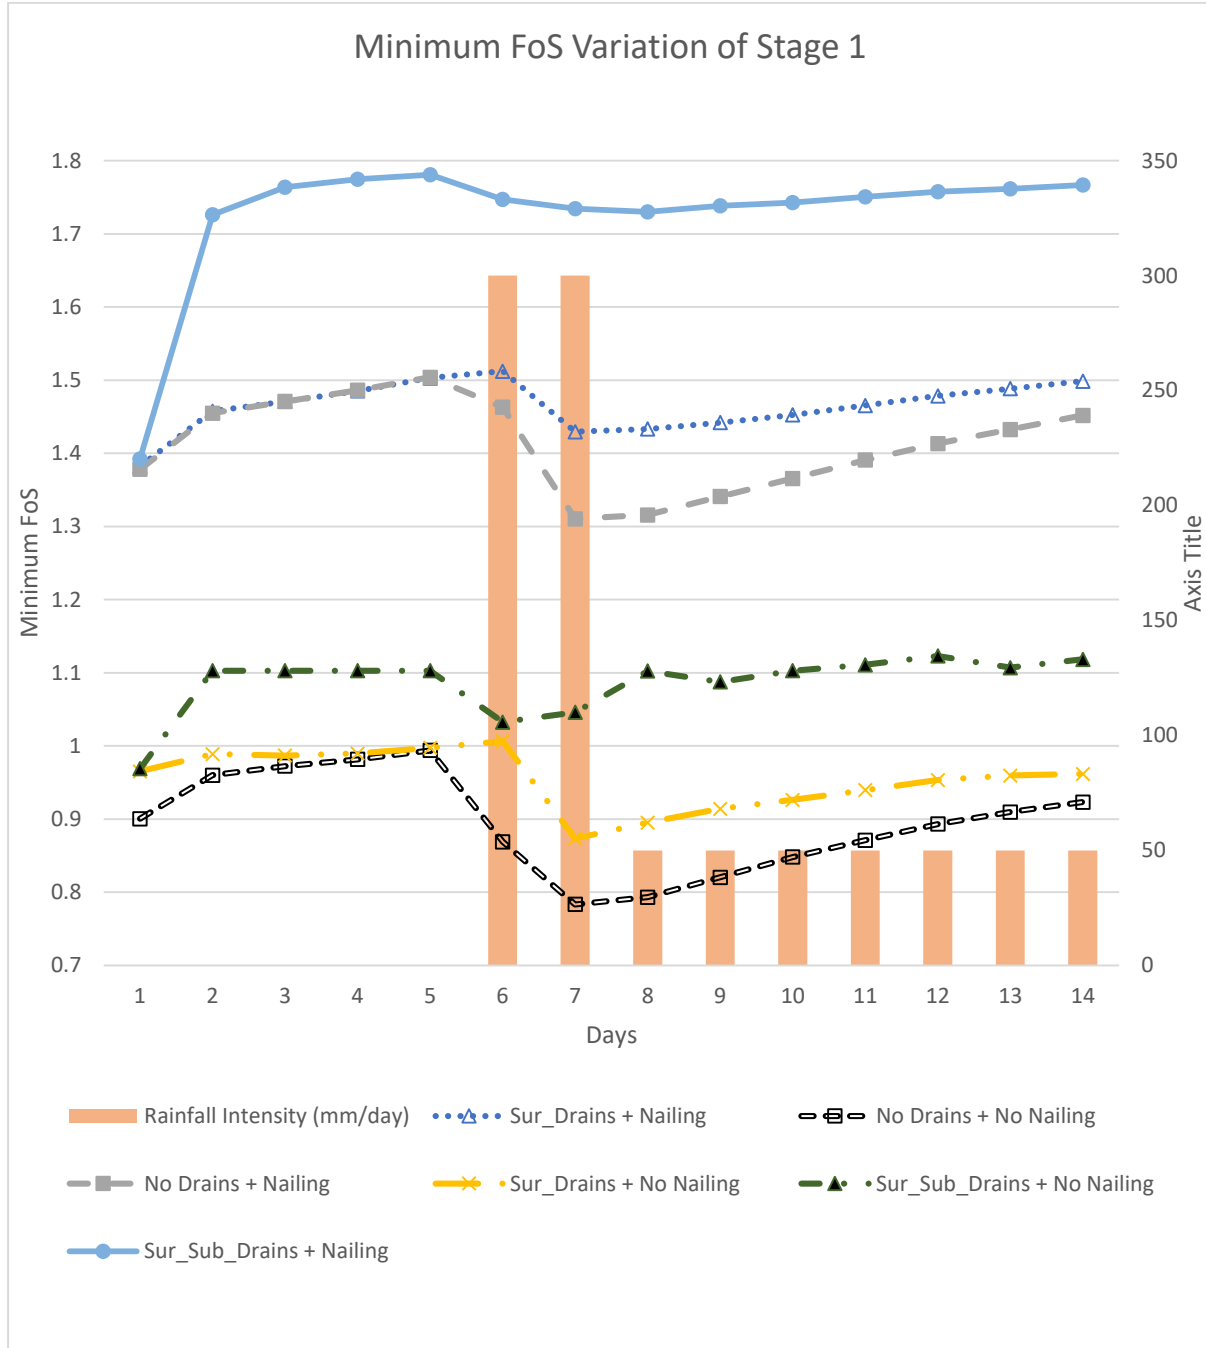
Figure 4.27 : Minimum FoS Variation at Stage 1

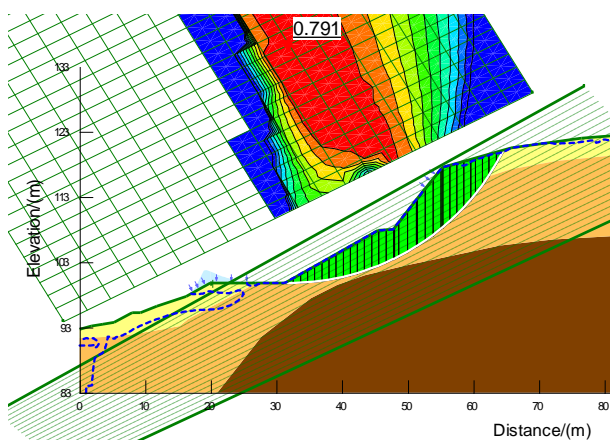
Figure 4.28 : Analysis without Drains and without Nails – Stage 2

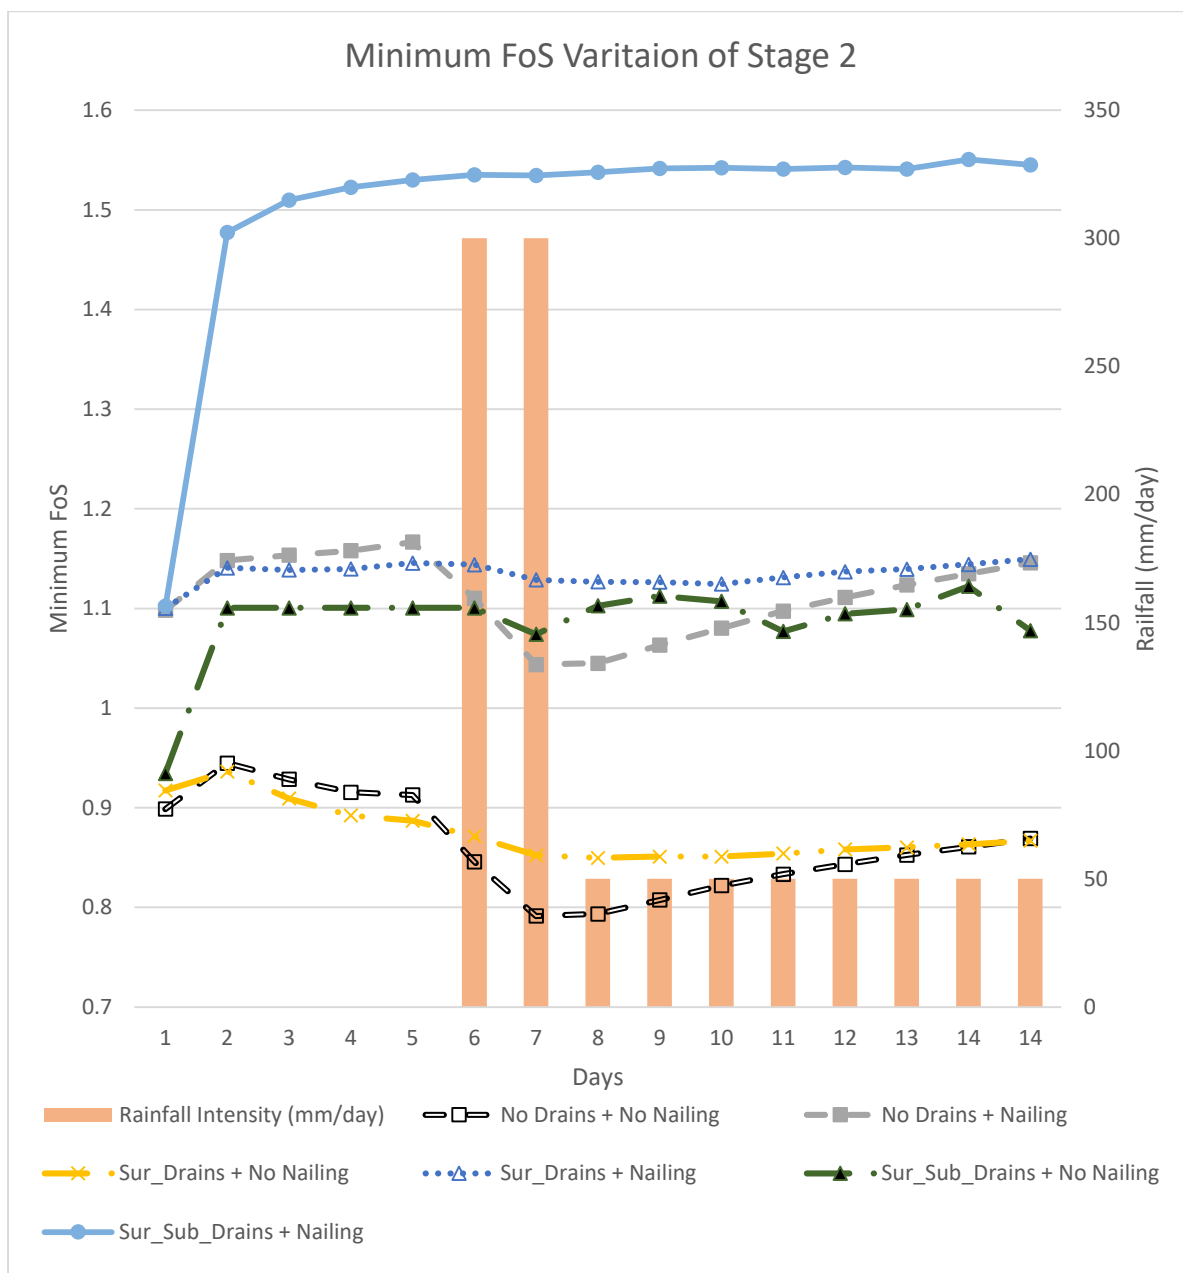
Figure 4.32 : Minimum FoS Variation at Stage 2

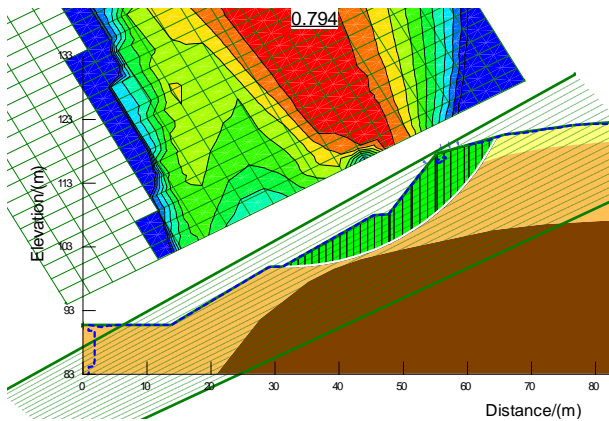
Figure 4.33 : Analysis without Drains and without Nails – Stage 3

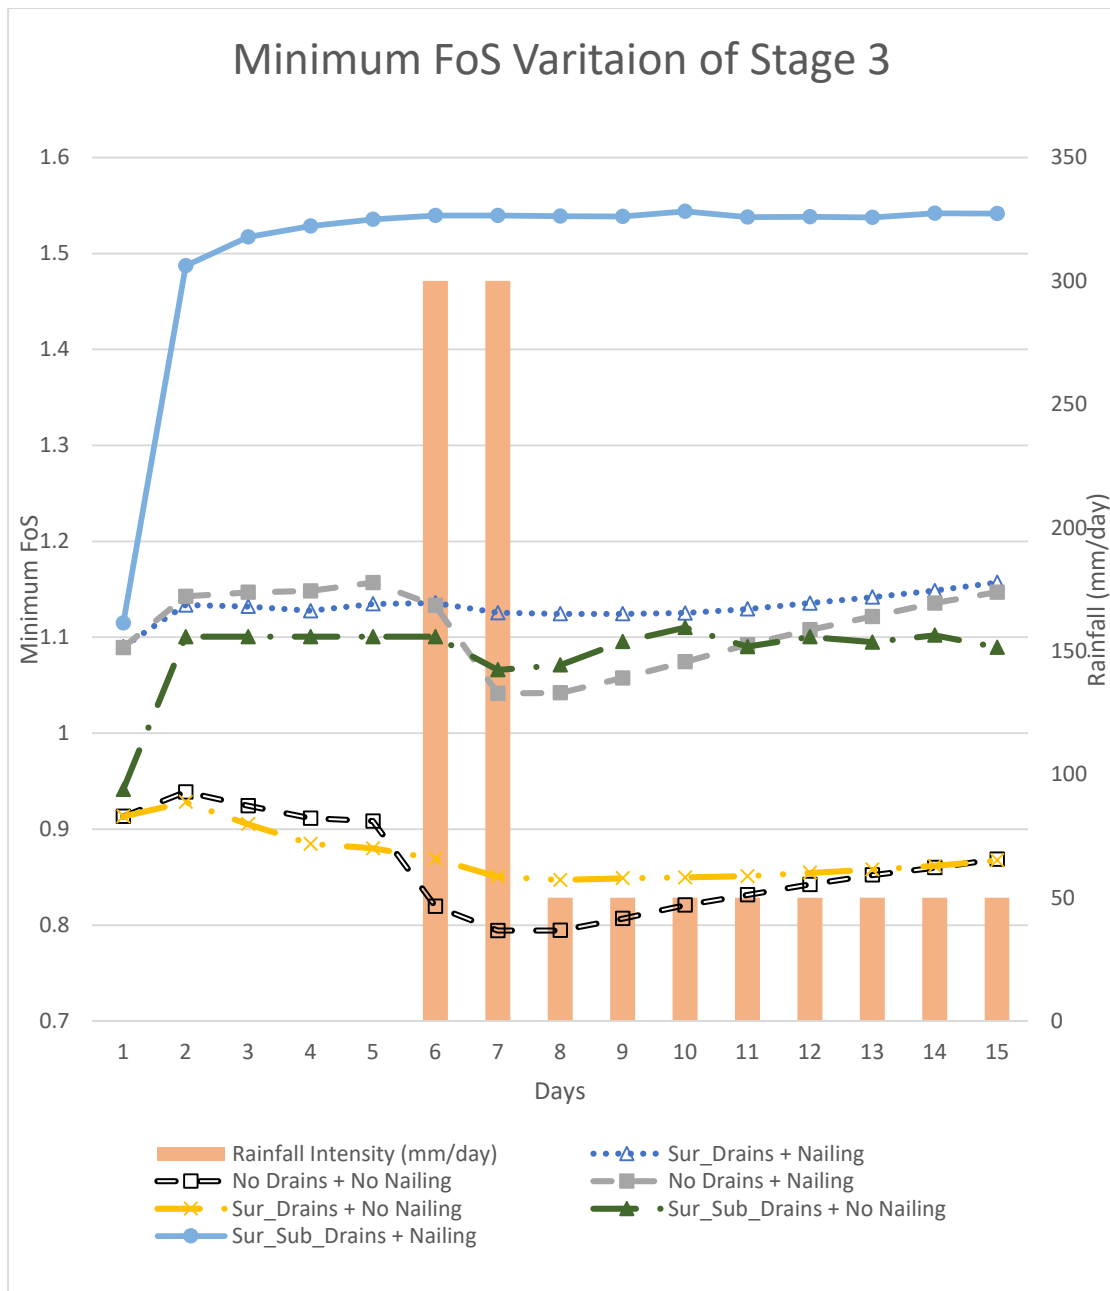
Figure 4.37 : Minimum FoS Variation at Stage 3

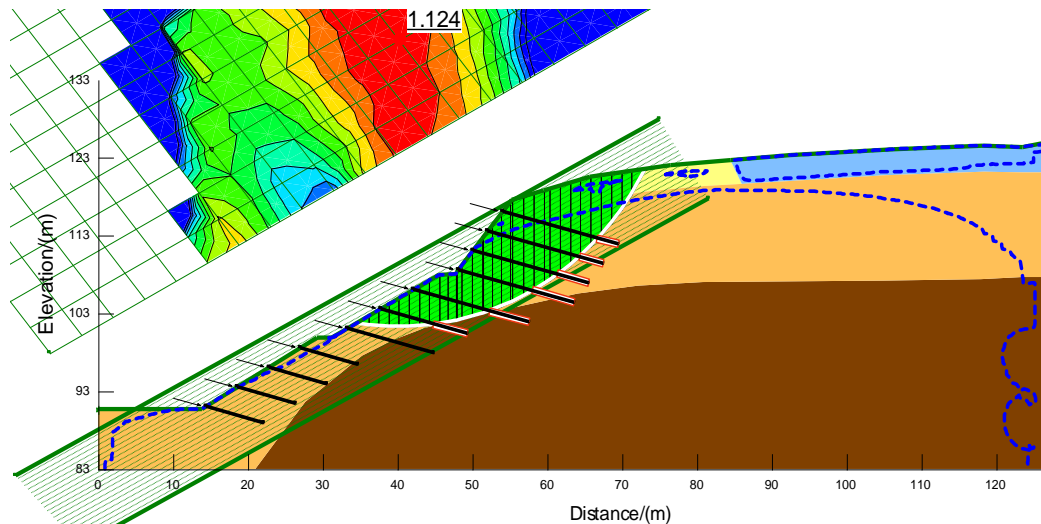
Figure 4.40 : Used Soil Nailing Design with Only Surface Drainage Improvement

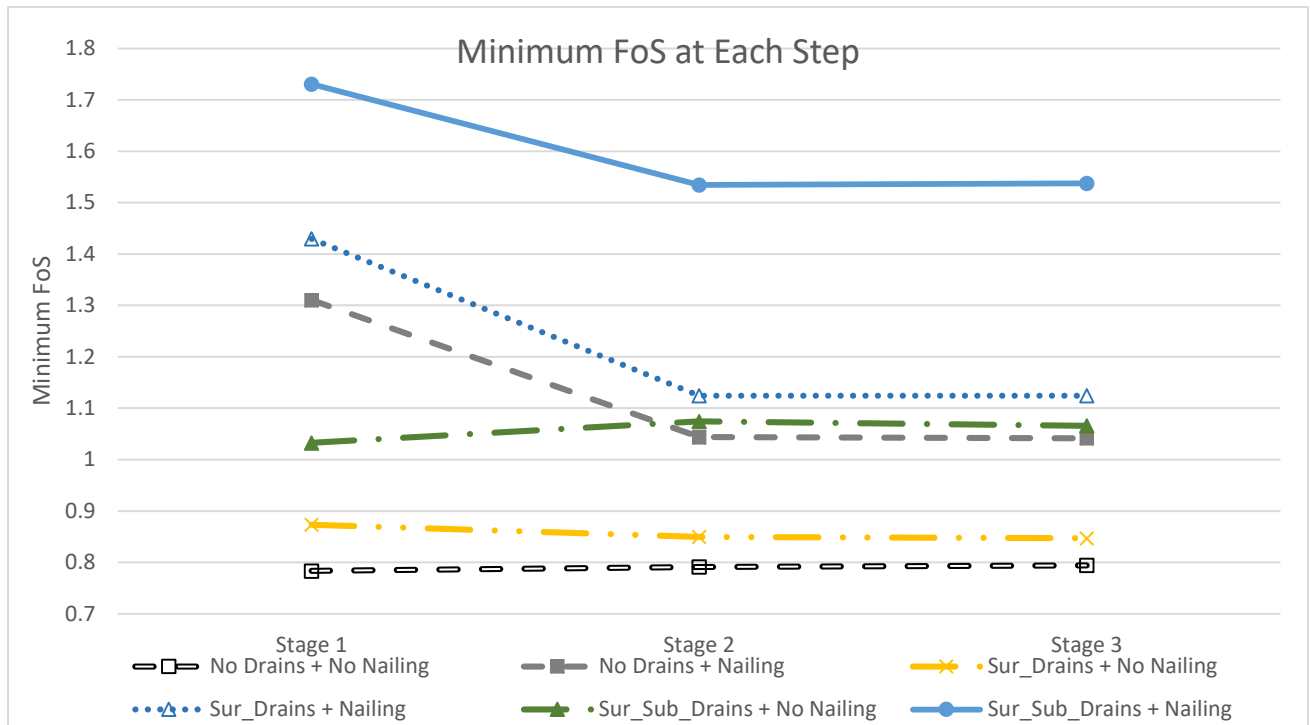
Figure 4.42 : Minimum values of minimum FoS at each Stage
