Reduction of Landslide Risk in Sri Lanka

Part 3 - Mitigation of Landslide Risk by
Drainage Measures- Case Histories from;
Southern Expressway, Watawala and
Budulusirigama

Time Capsule project of ISSMGE
Sri Lankan Geotechnical Society

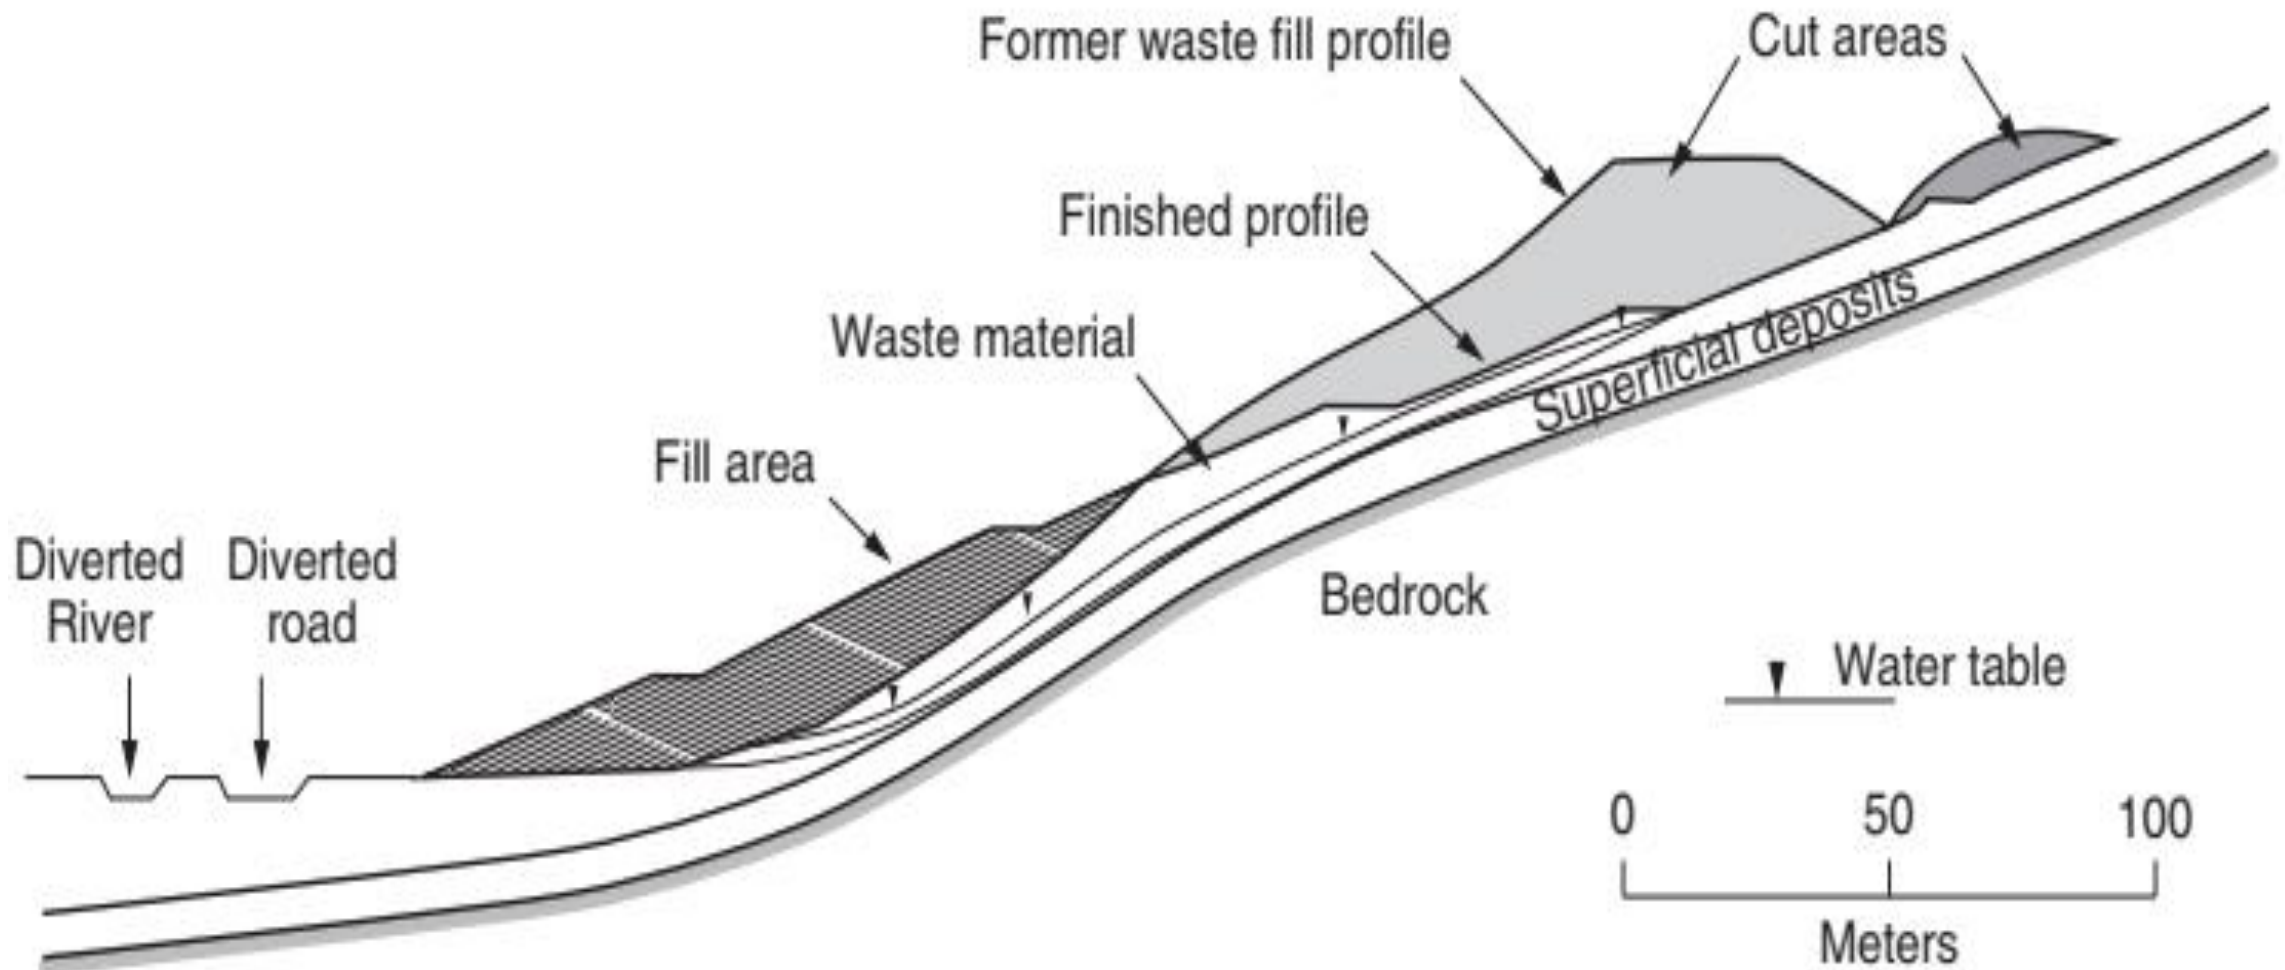
**Slope Stabilization by cut and Fill
(Modification of the slope geometry)**

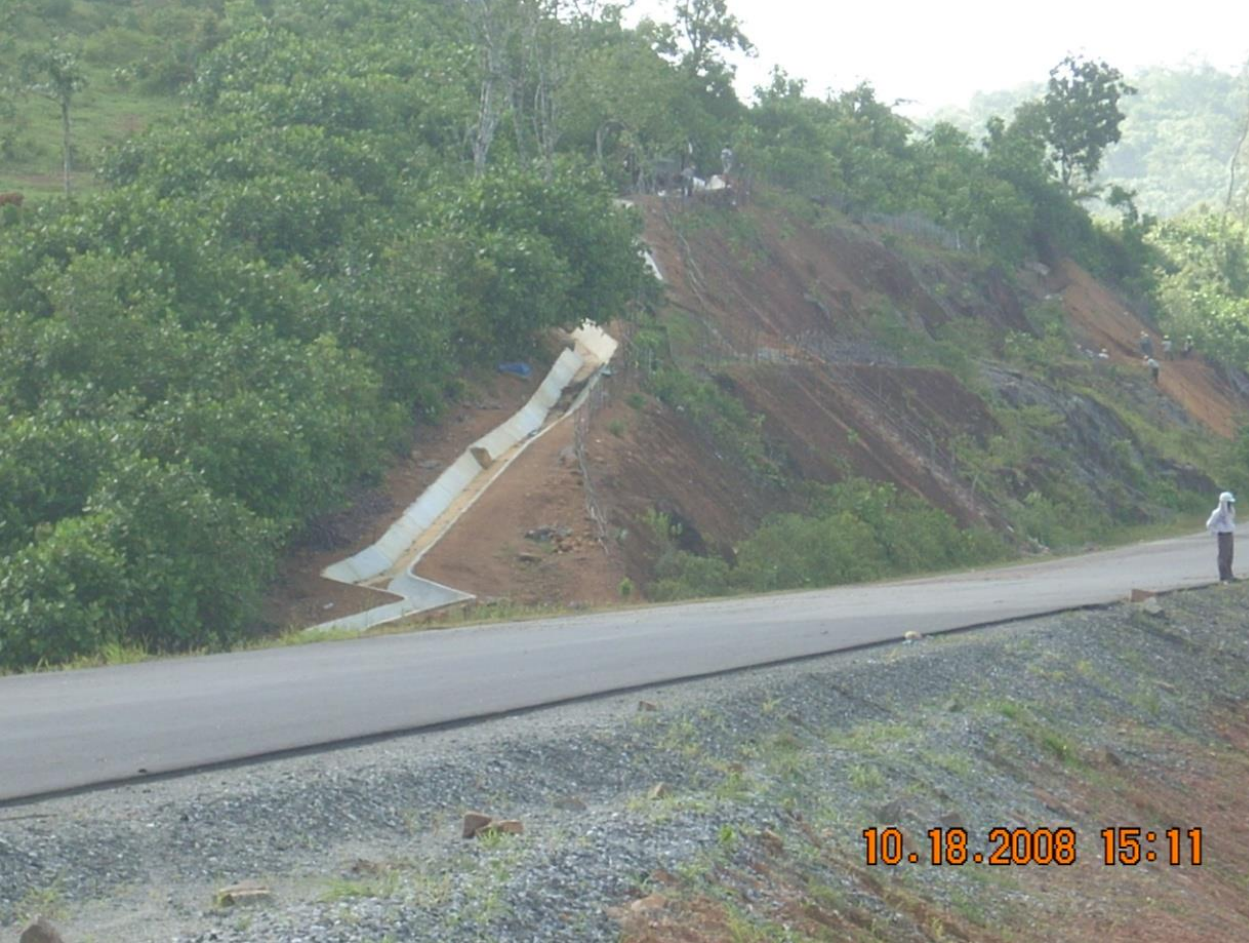
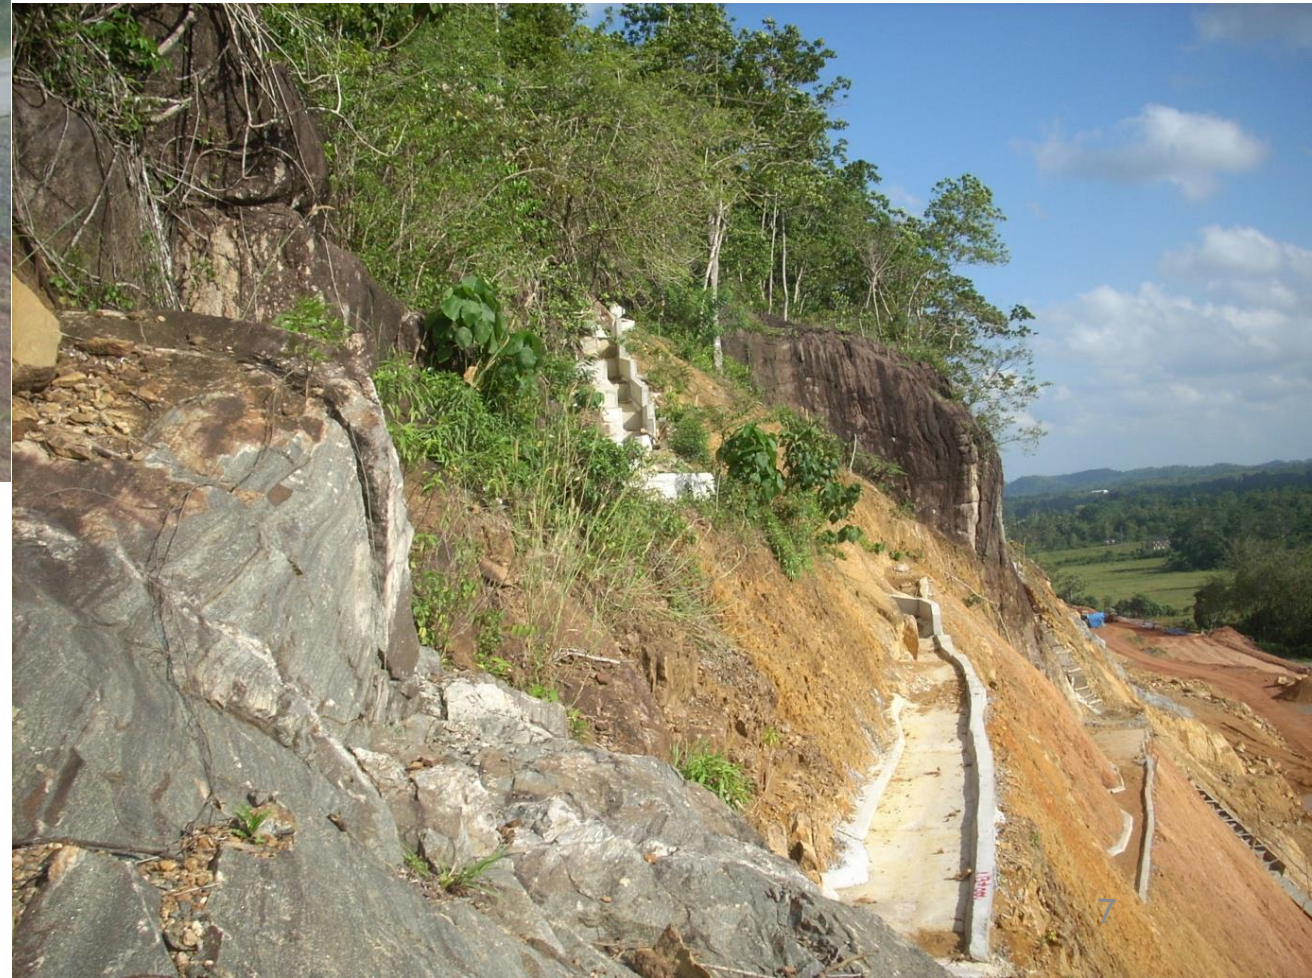
Cutoff Drains

Surface drainage should be enhanced by the construction of Cut off drains, berm drains.

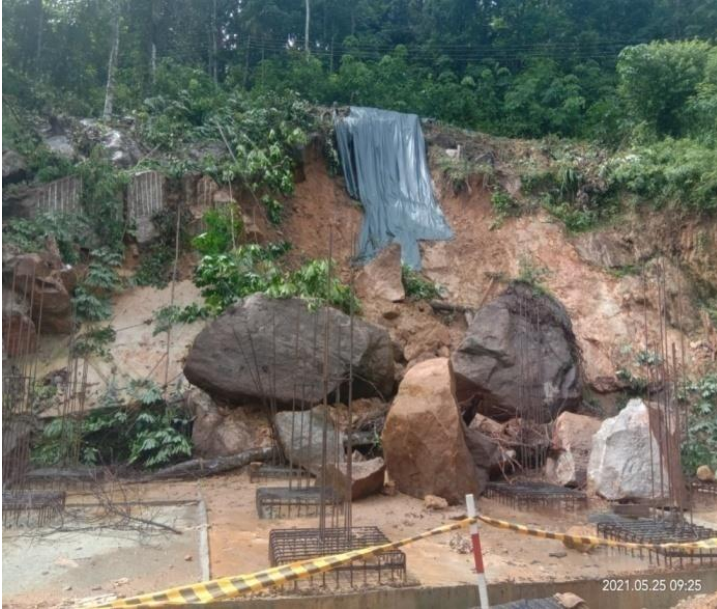
Cut off drain at the crest of the slope

- Has to be done with minimum cutting to prevent disturbance to the boulders at the crest

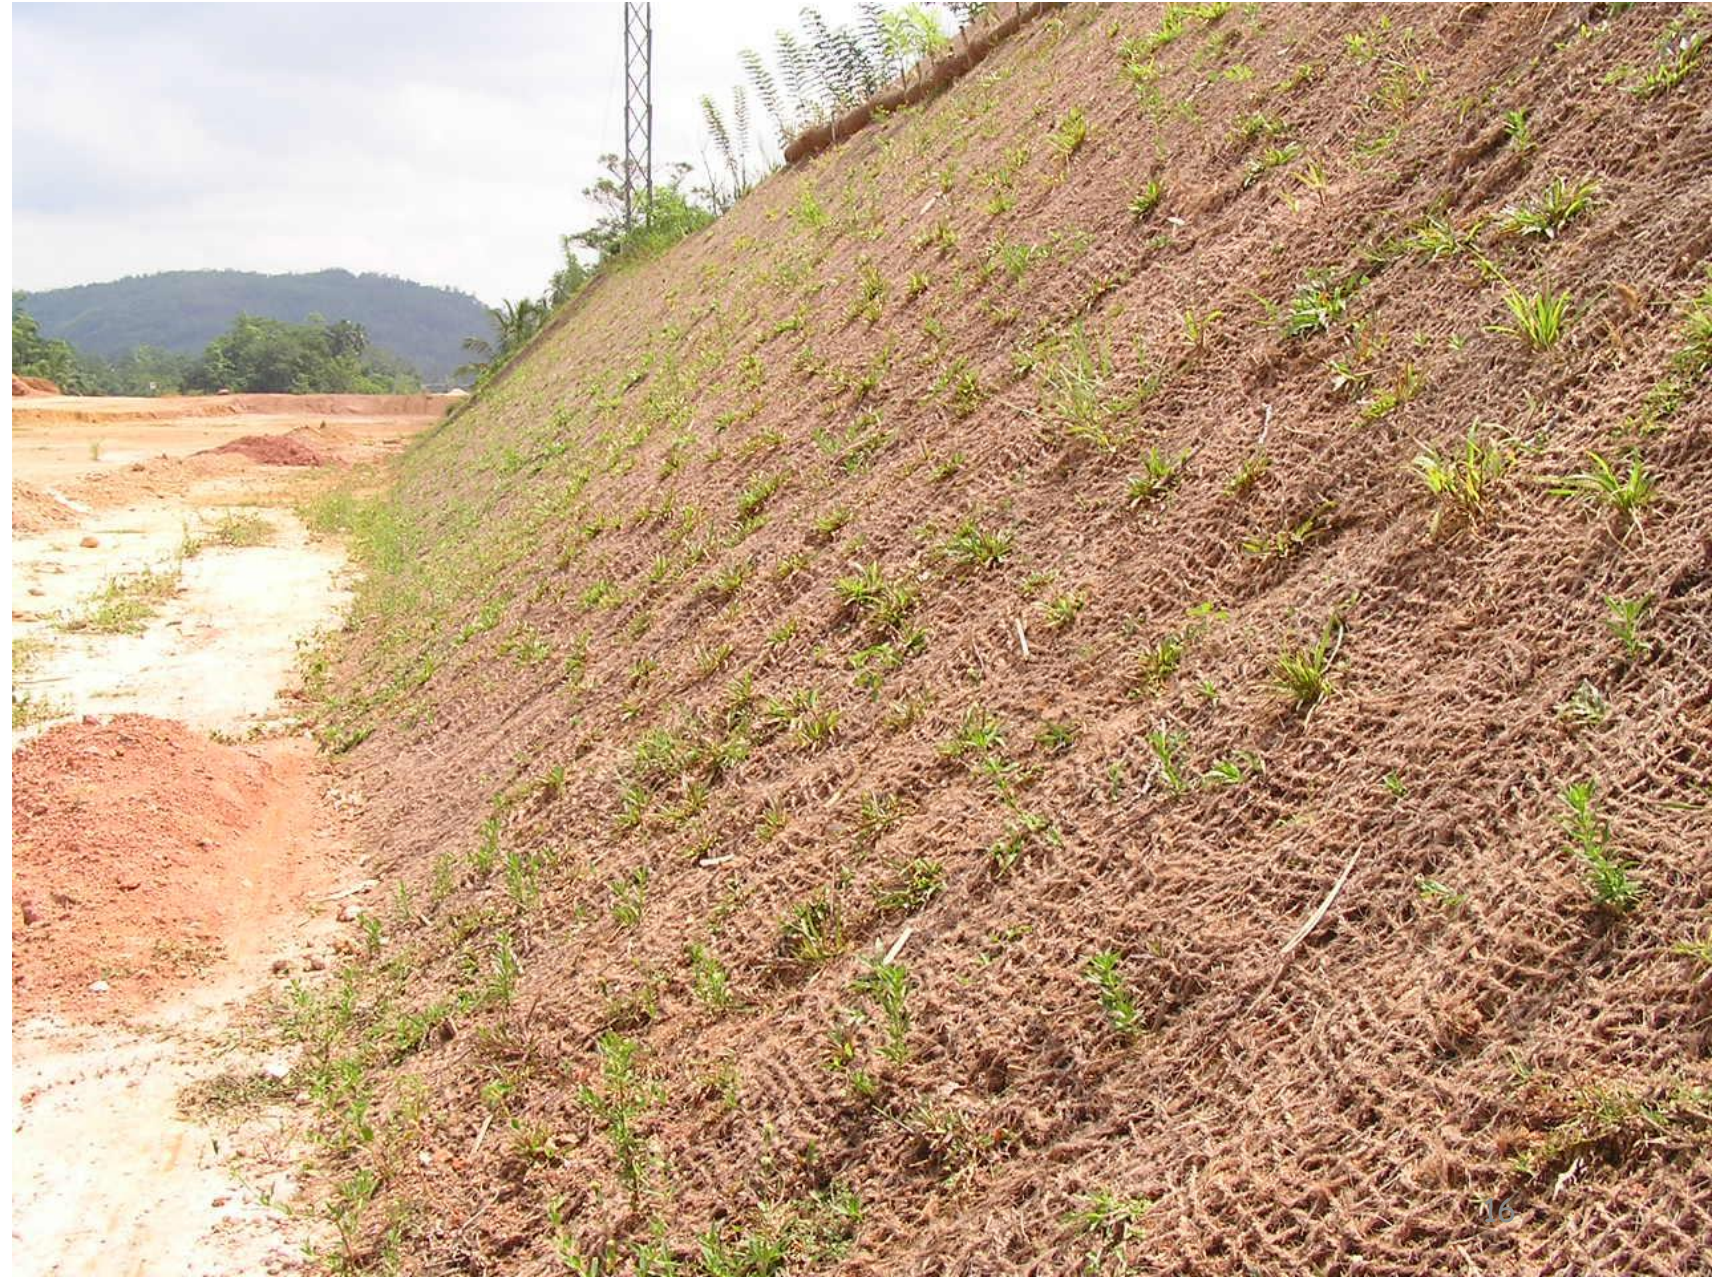
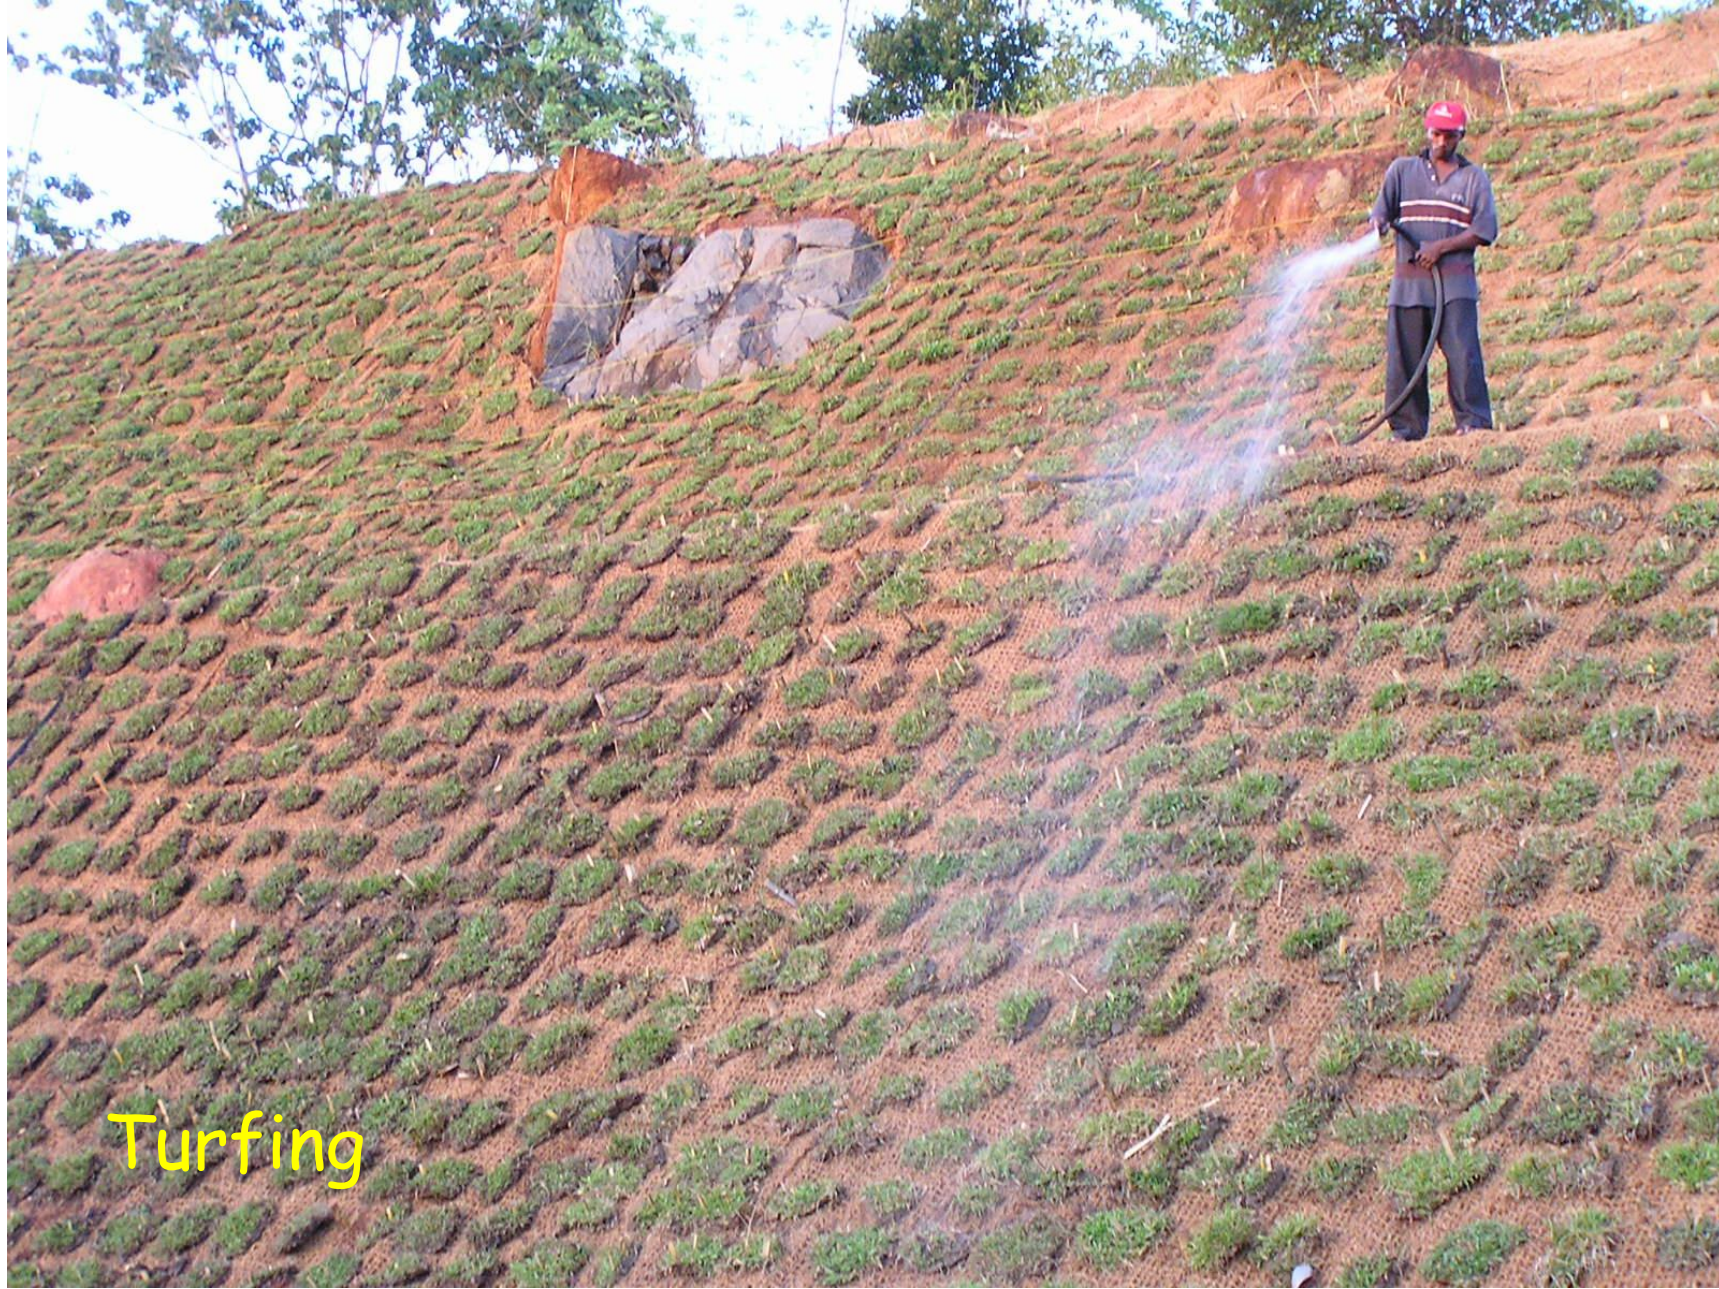
Hydro seeding protected
by coir mat

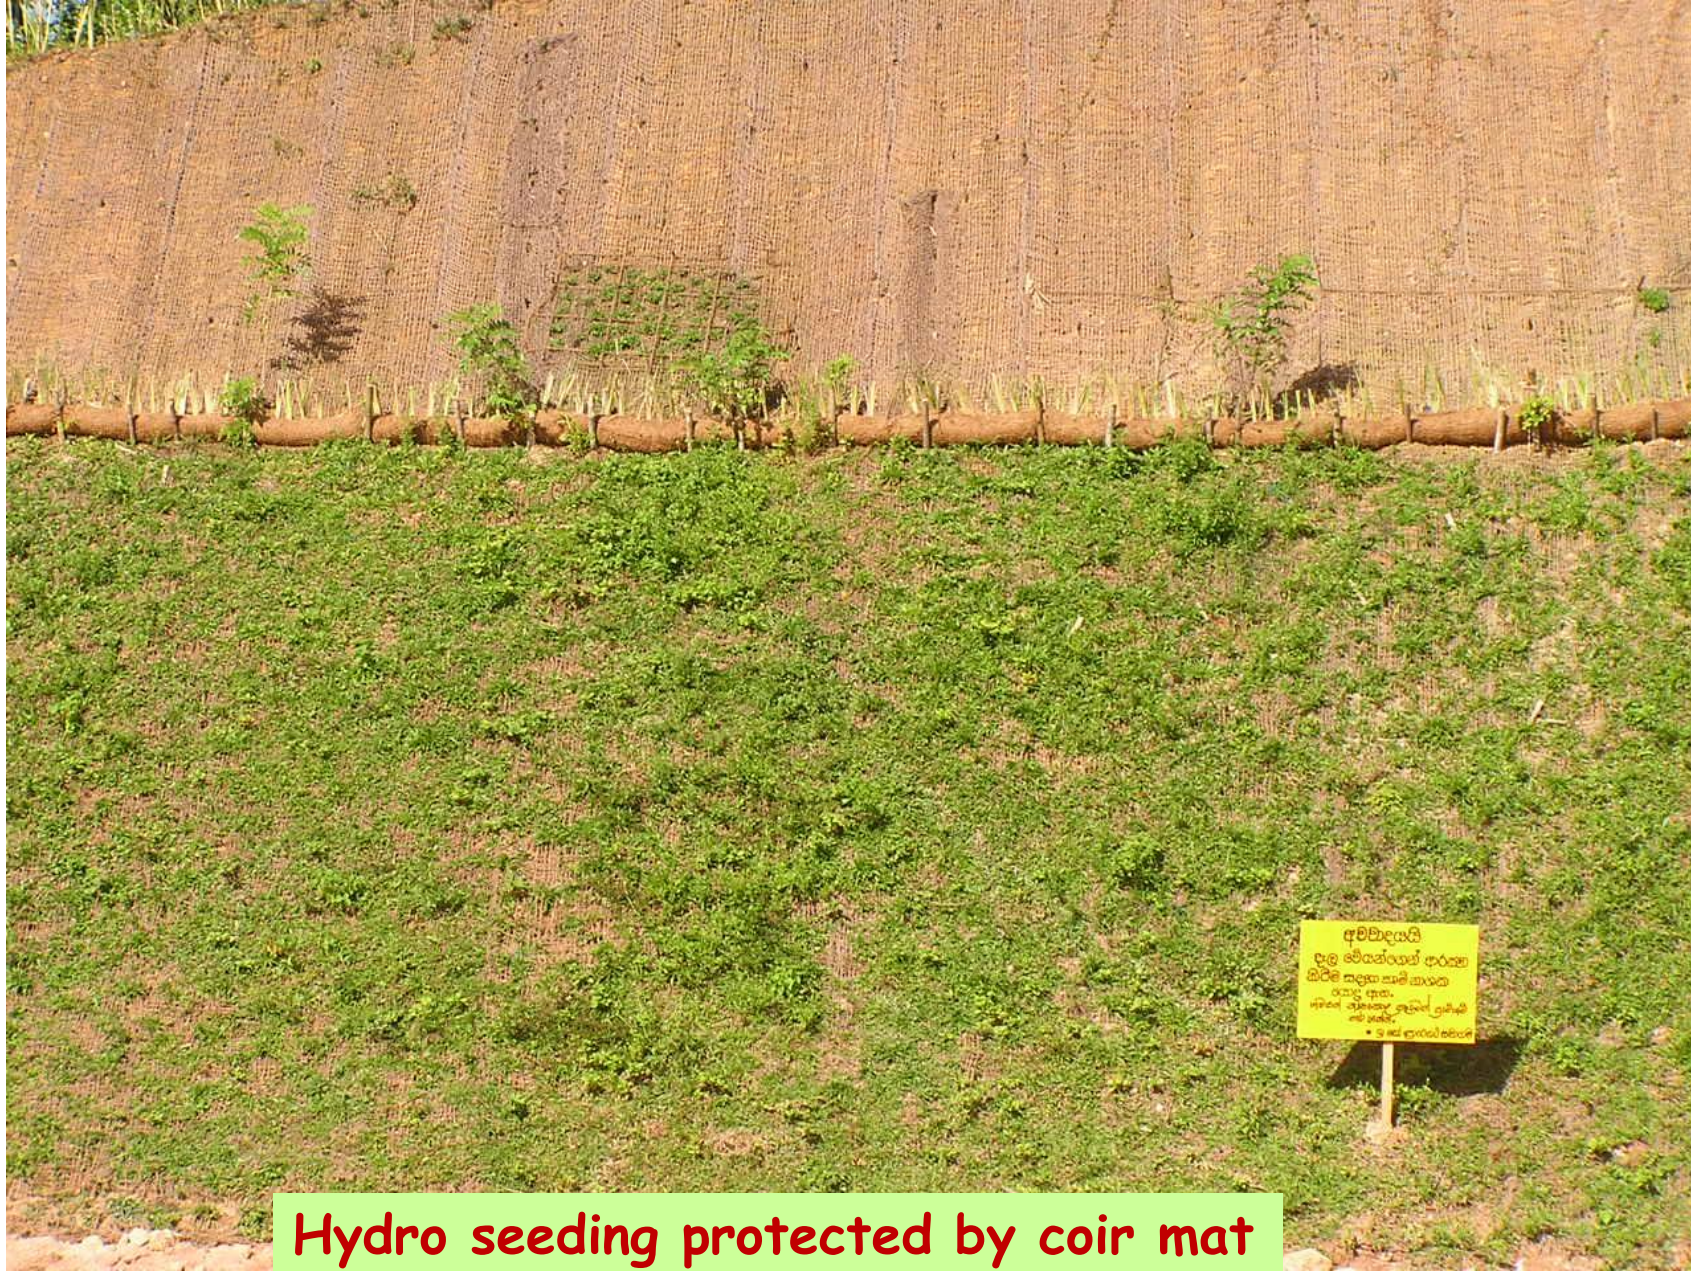
Turfing

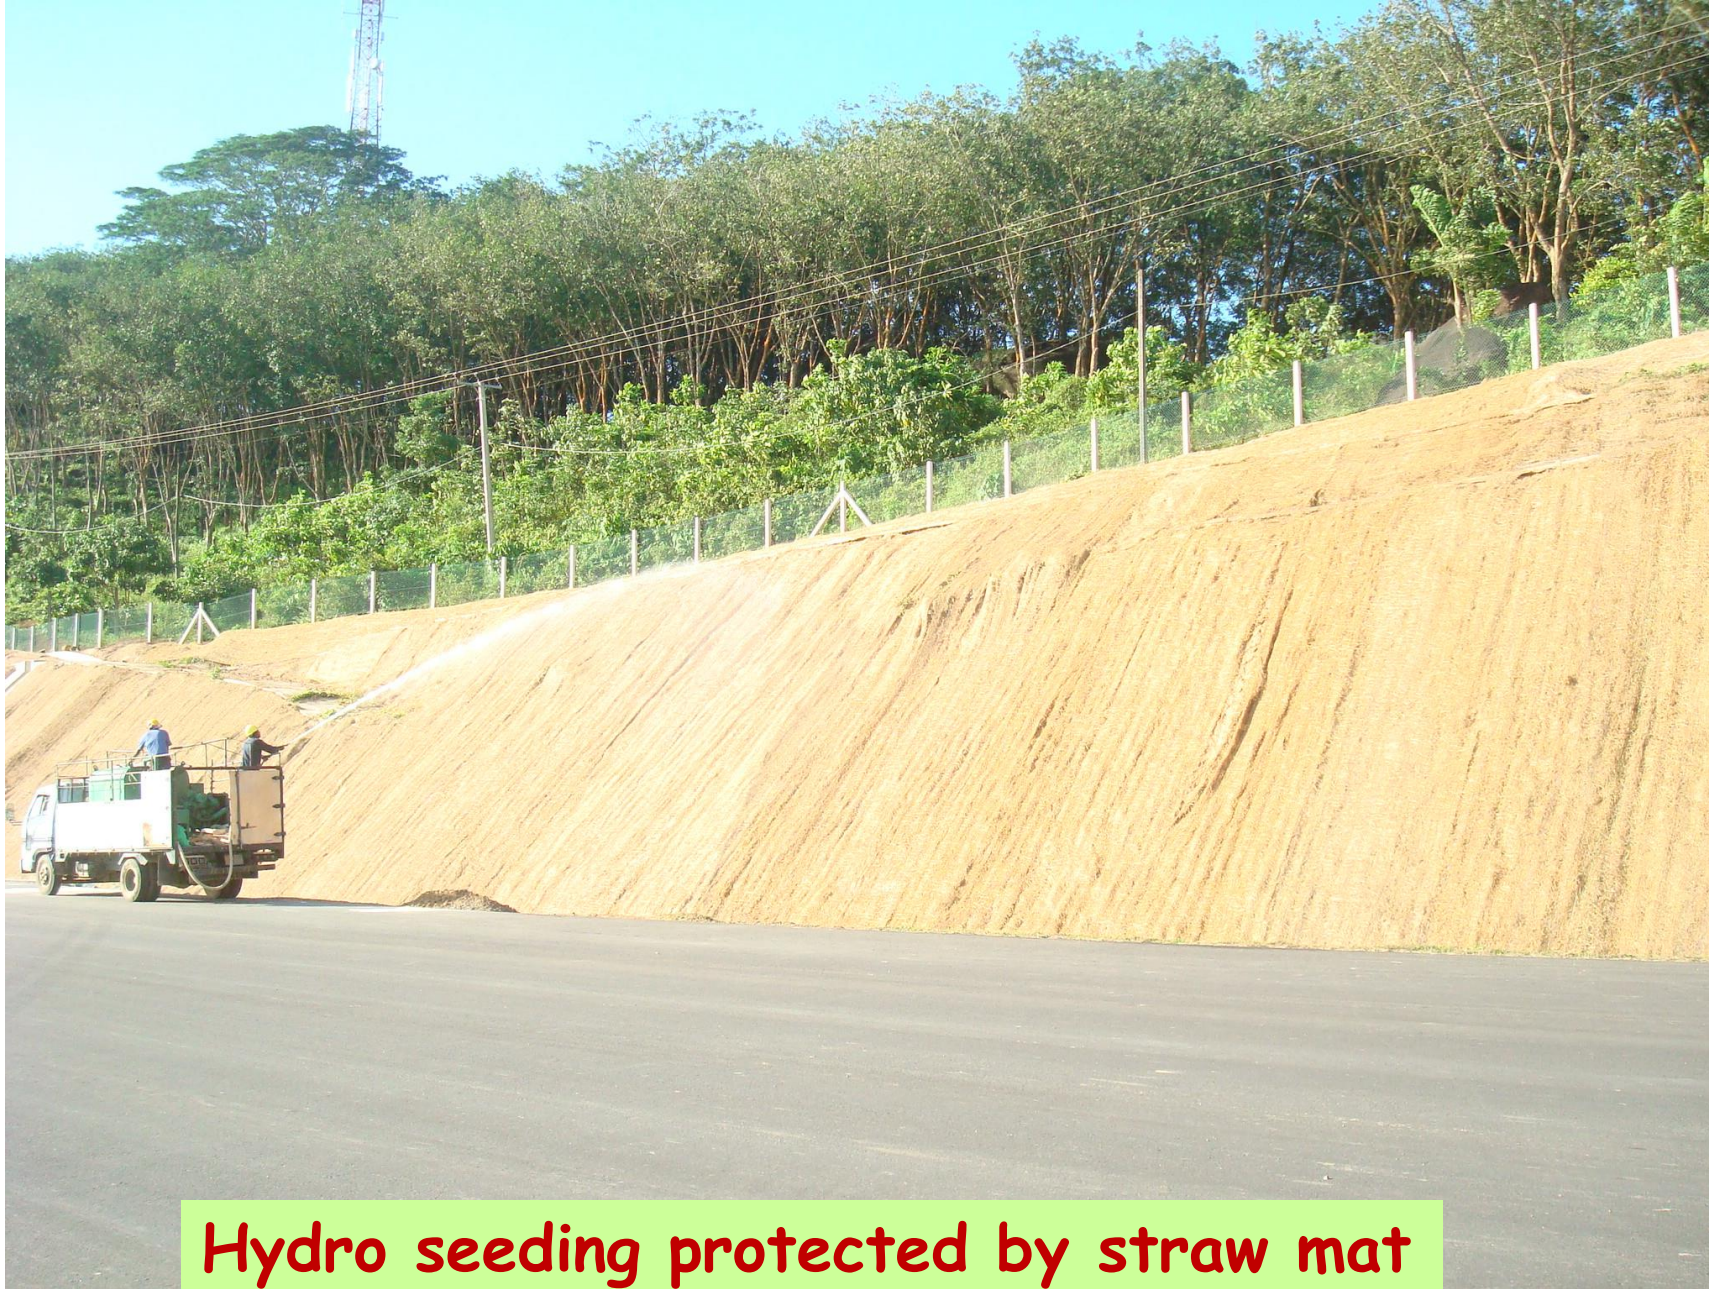
Hydro seeding protected by coir mat

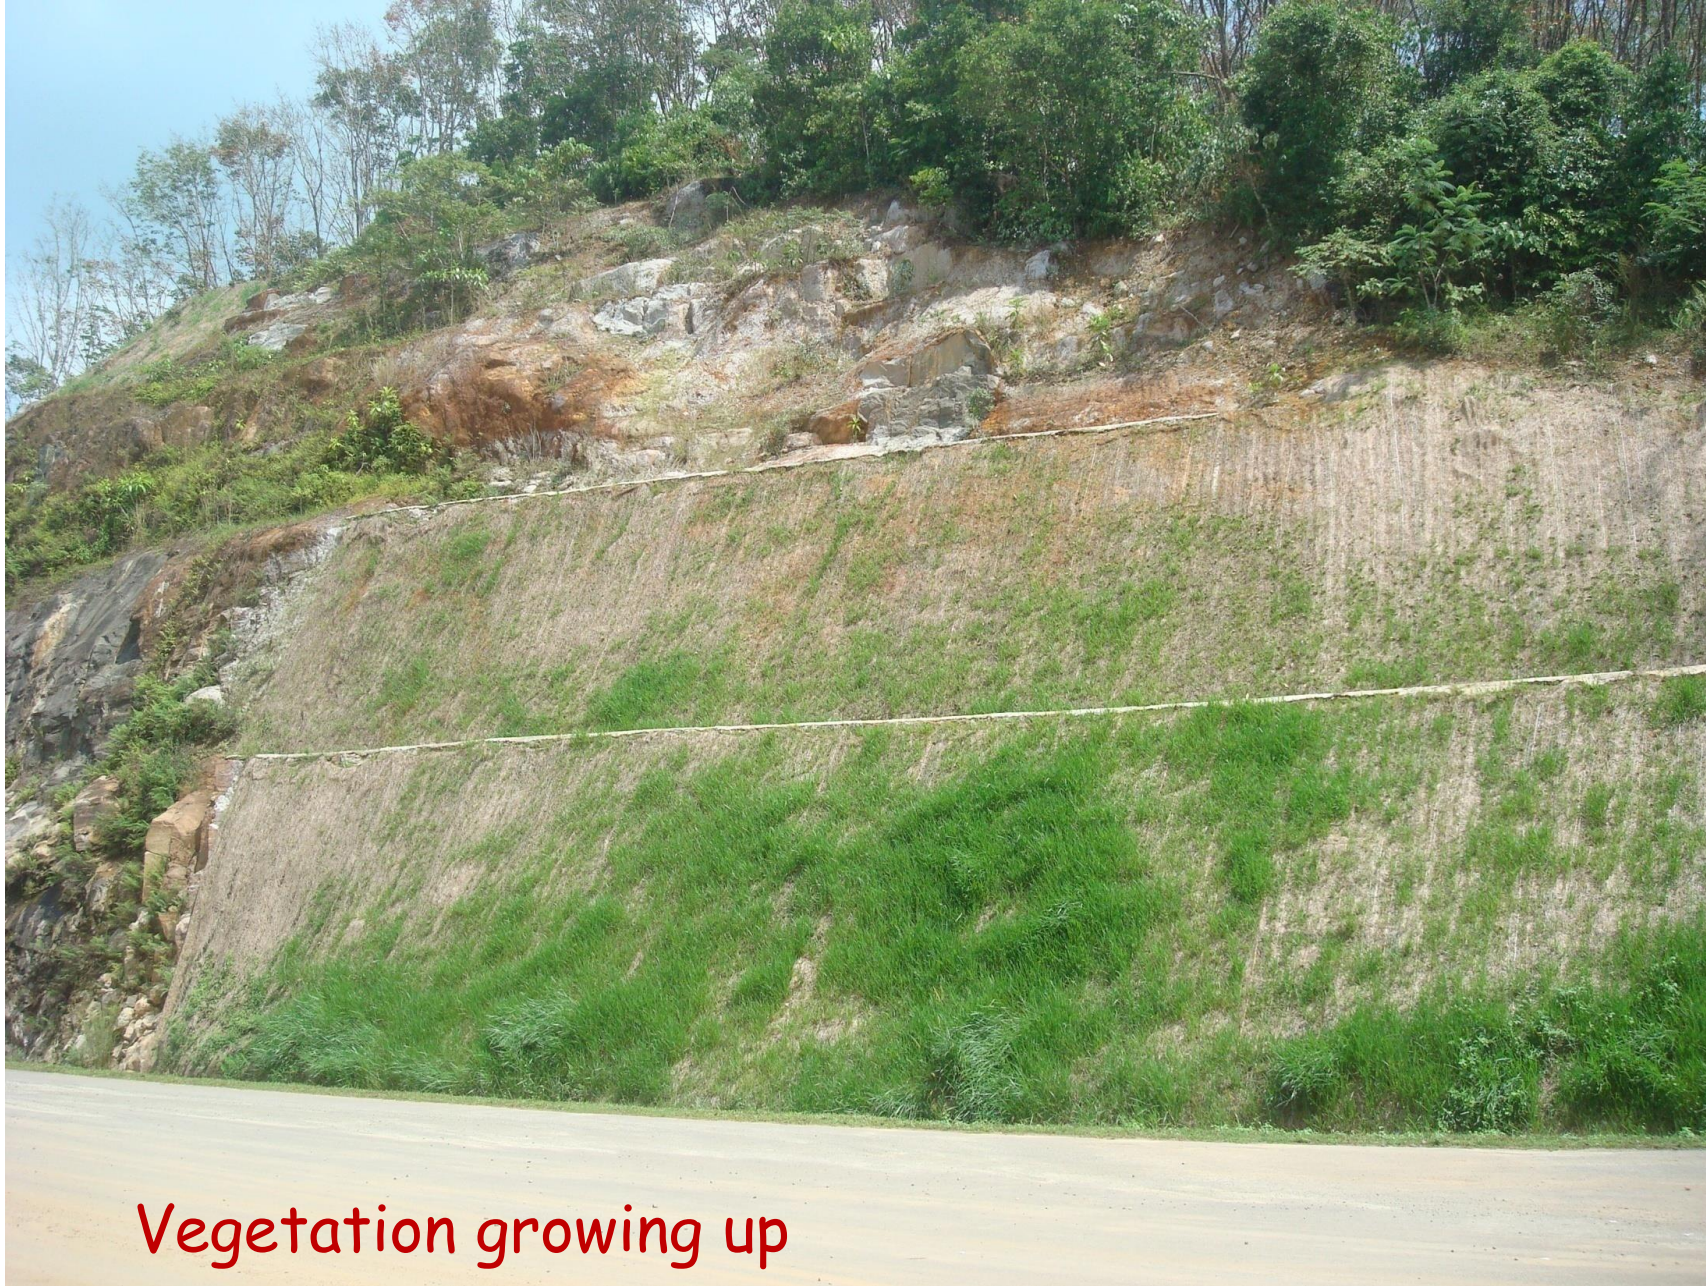
Hydro seeding protected by straw mat

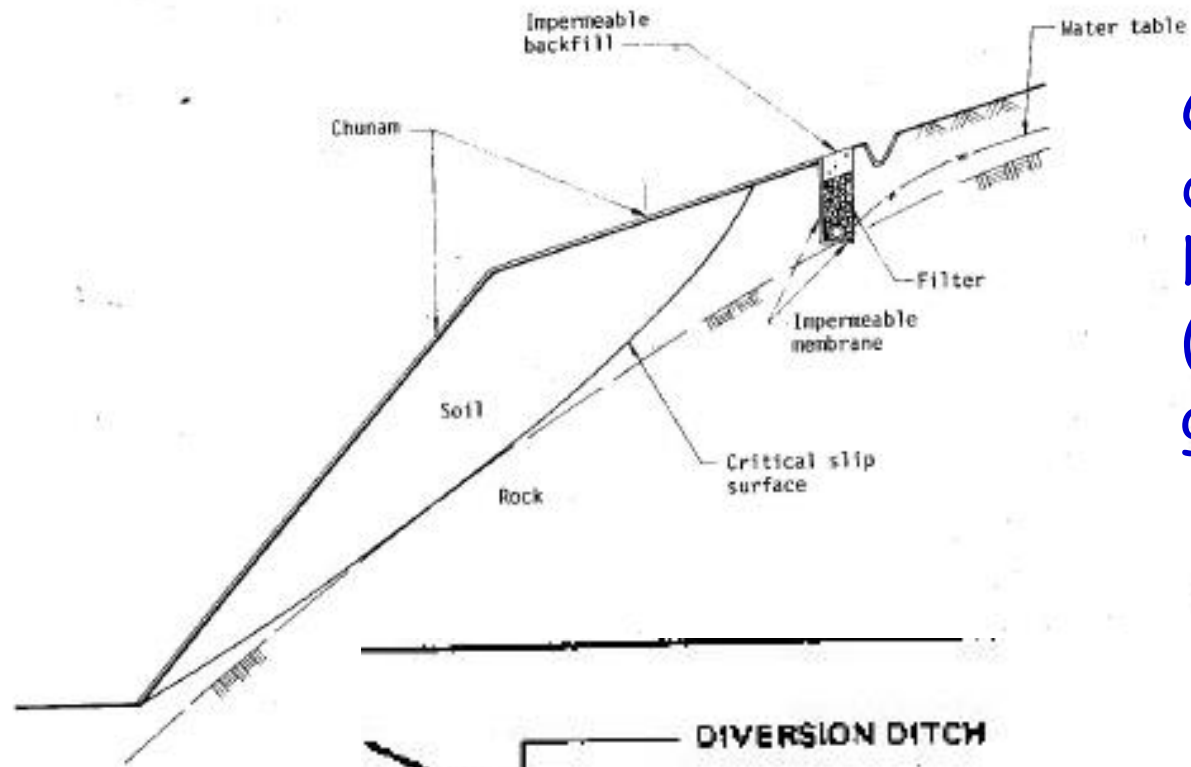
Combination of trench drains and sub horizontal drains. (water flow under gravity)

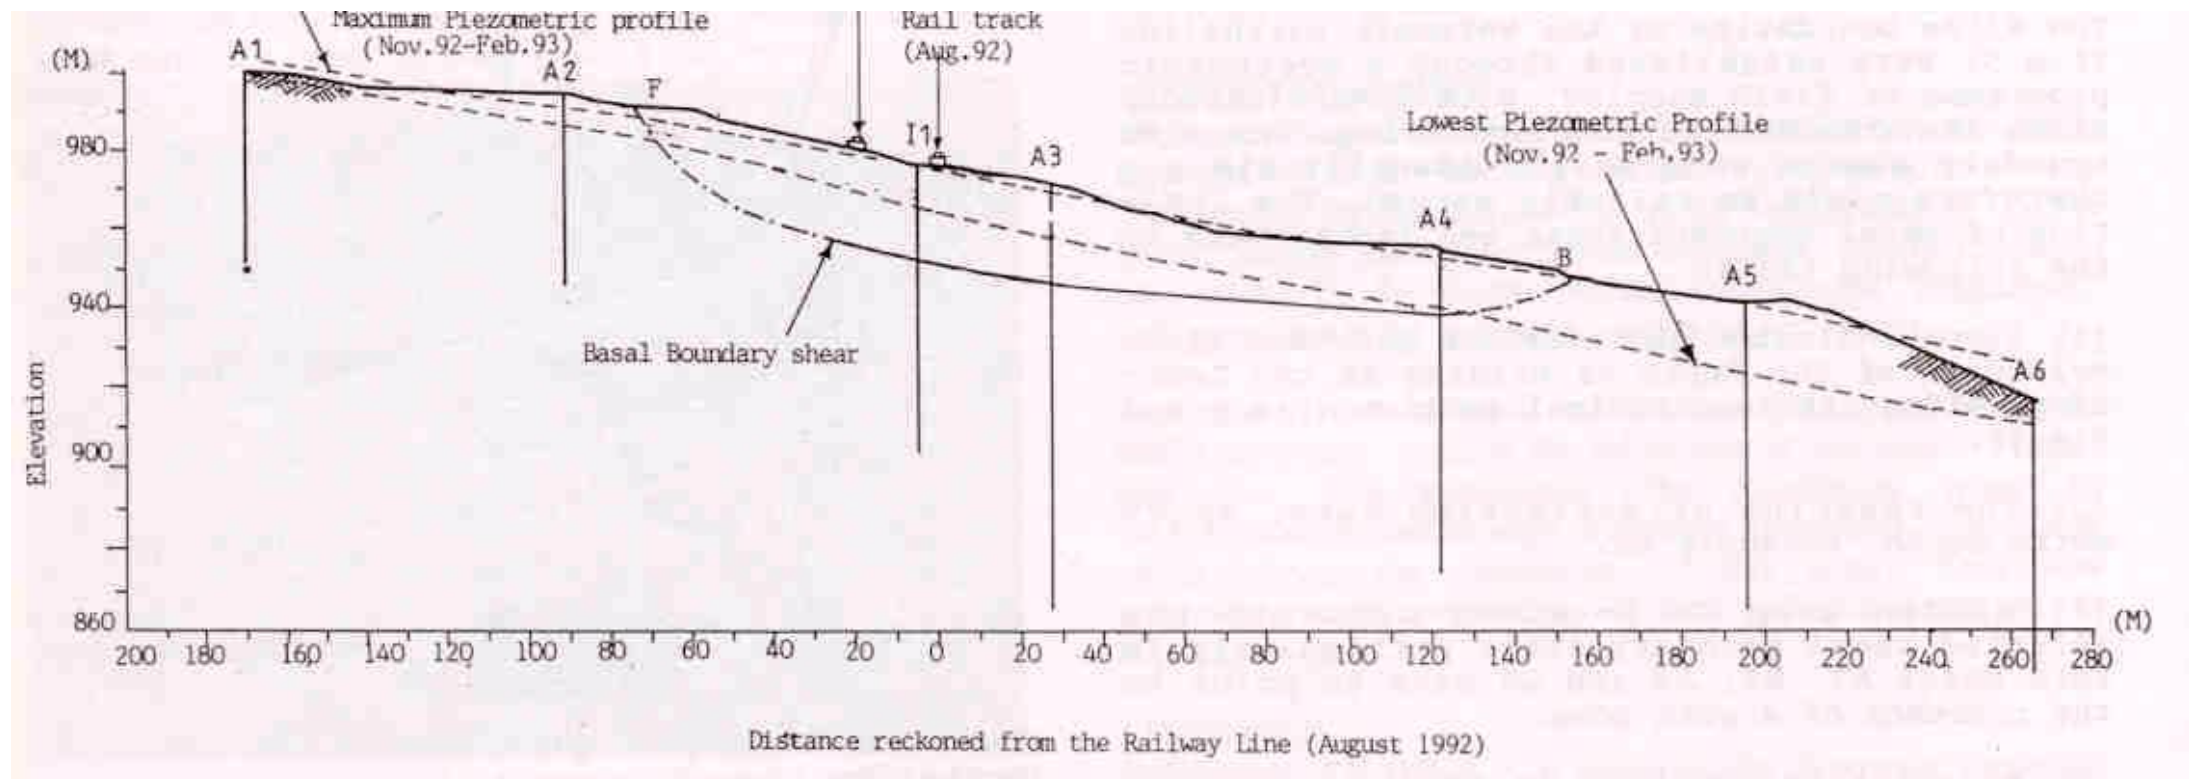
The Identified Slip Surface of the Watawala Landslide

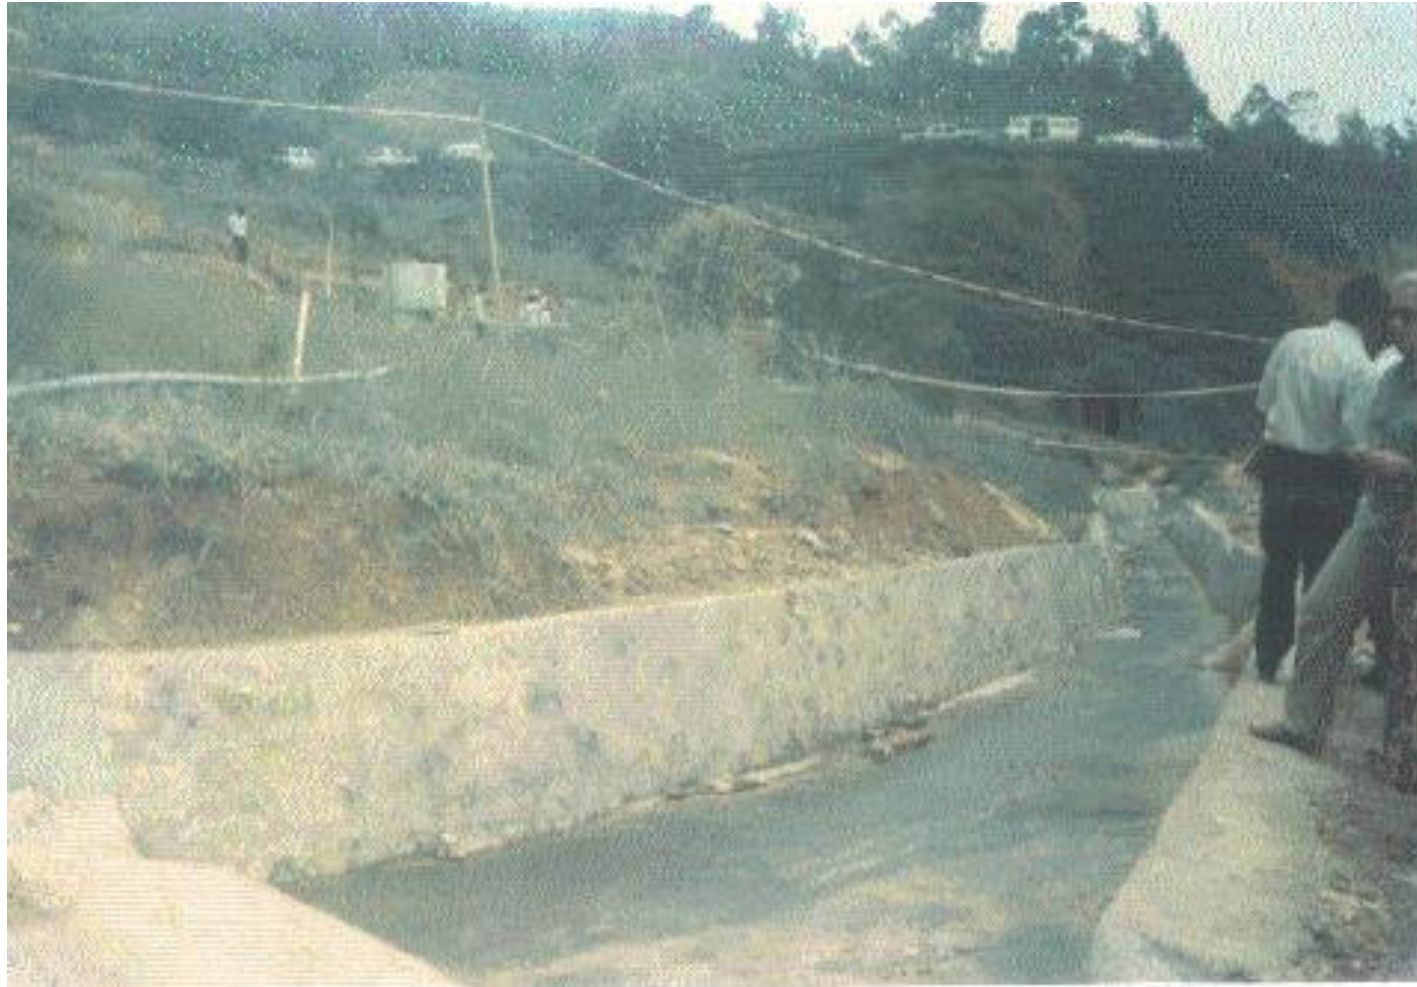
Improvement of surface drainage - this will minimise infiltration

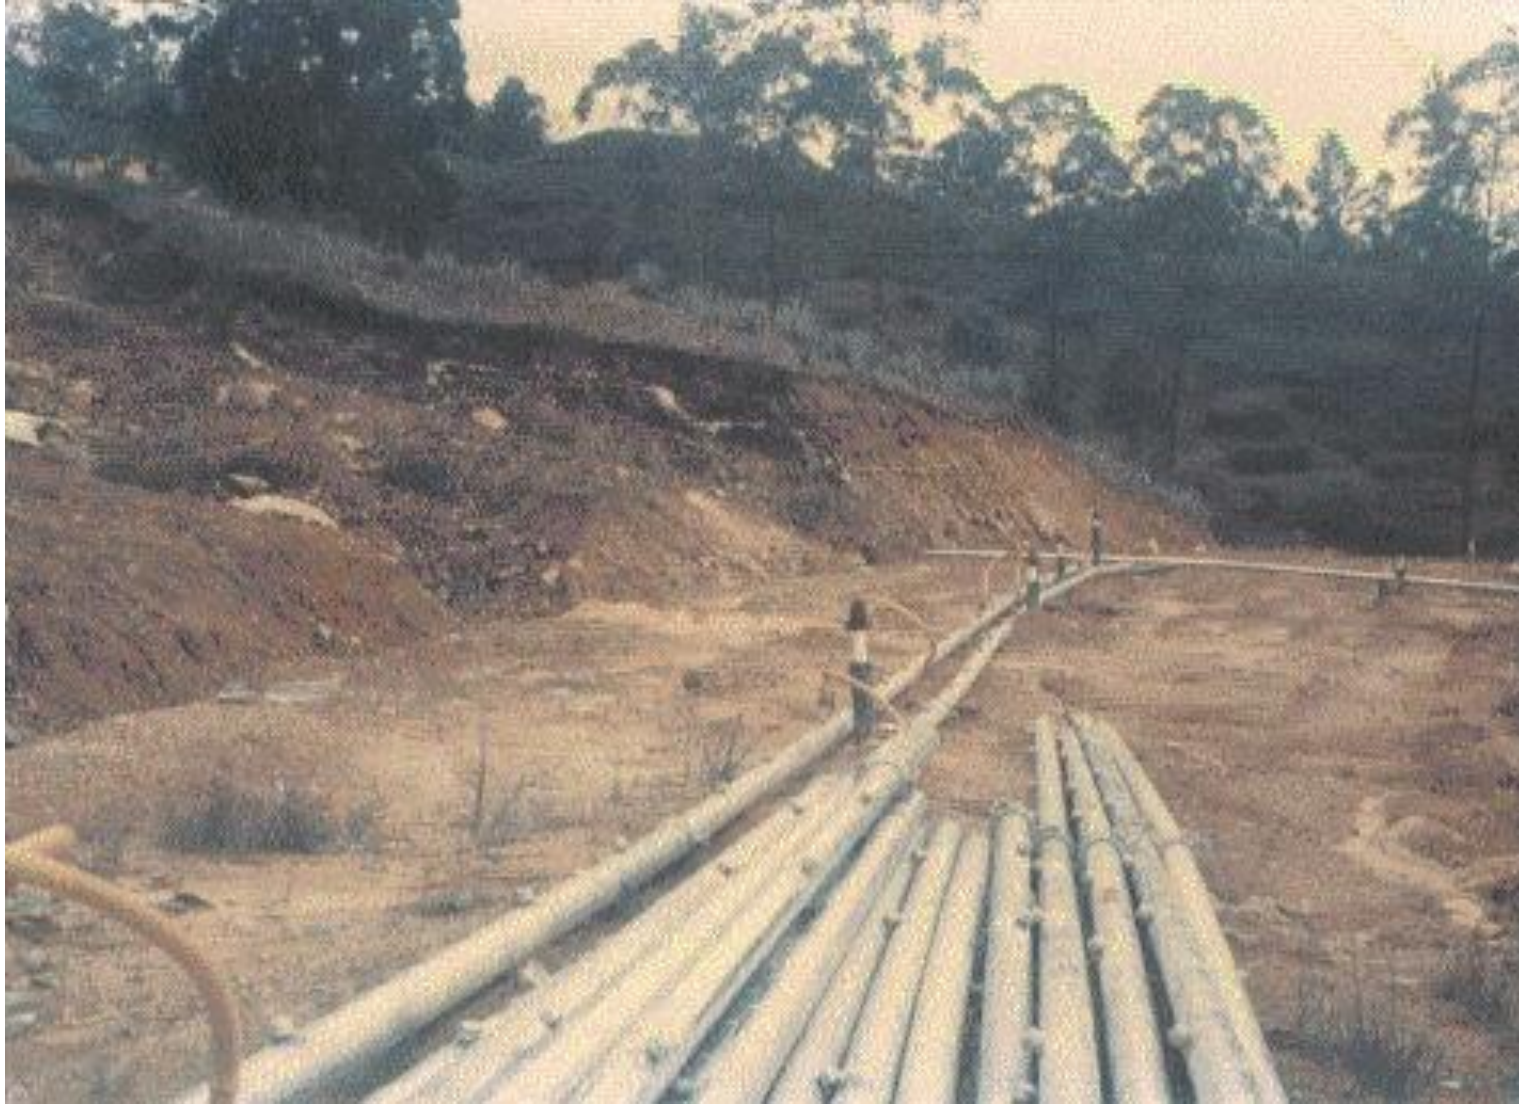
Eductors to pump out sub surface water

- Need to use electrical power-not a feasible continuous solution in the long term

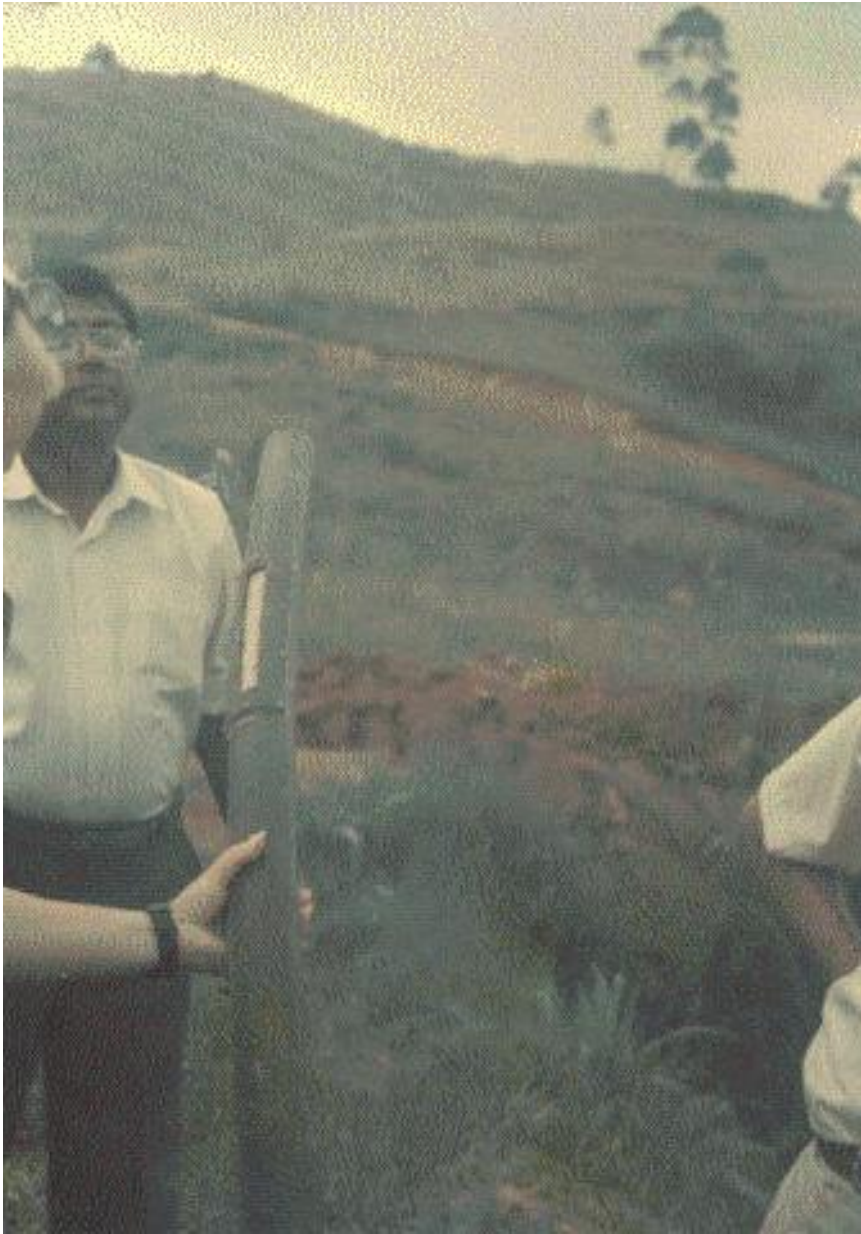
A typical HDPE pipe that could withstand a large strain (up to 800%). As such it will not break due to deformations in the soil. Pipes are with perforated section
