Reduction of Landslide Risk in Sri Lanka

Part 3 - Mitigation of Landslide Risk by
Drainage Measures- Case Histories from;
Southern Expressway, Watawala and
Budulusirigama

Time Capsule project of ISSMGE
Sri Lankan Geotechnical Society

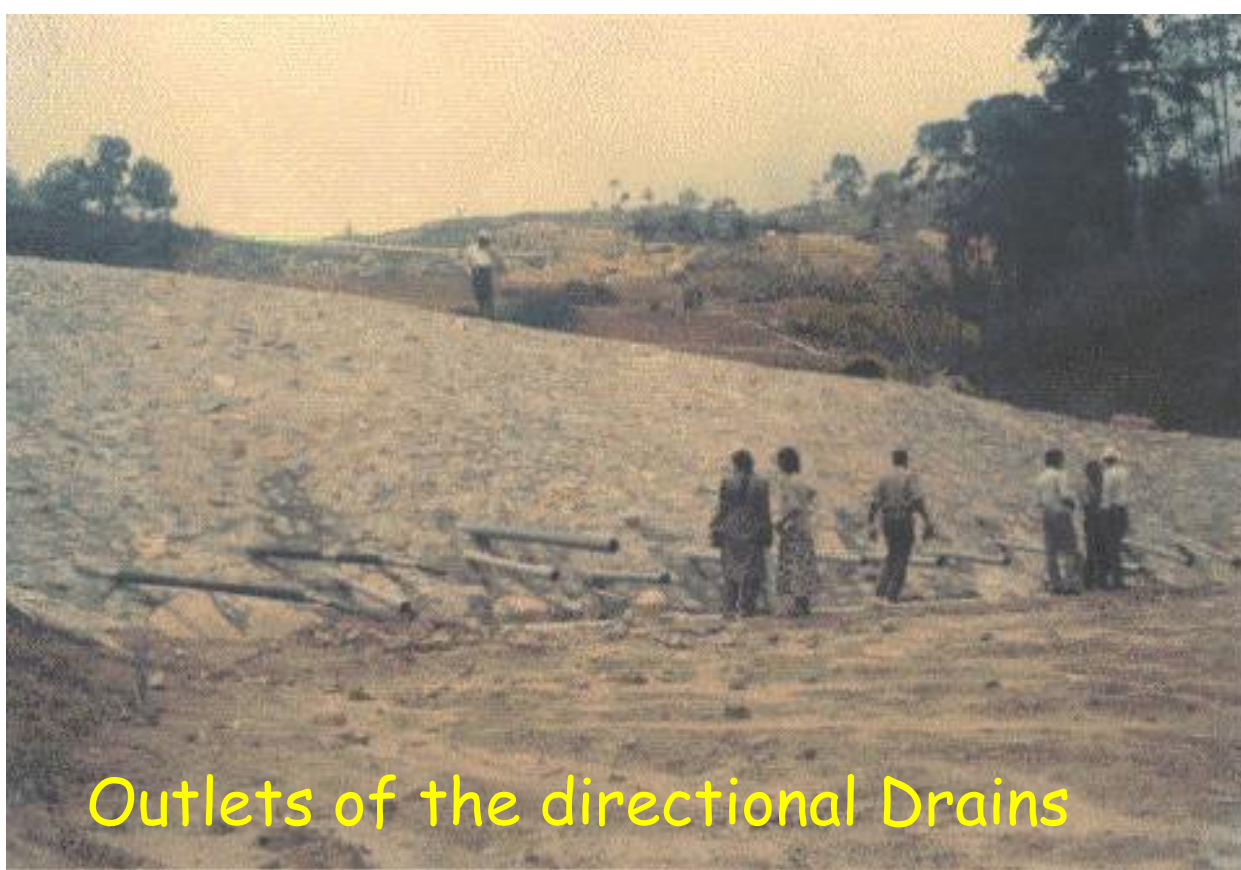
Outlets of the directional Drains

Pore water entering the pipe through the perforated segments can escape quickly under gravity. Thus there would be rapid pore pressure dissipation

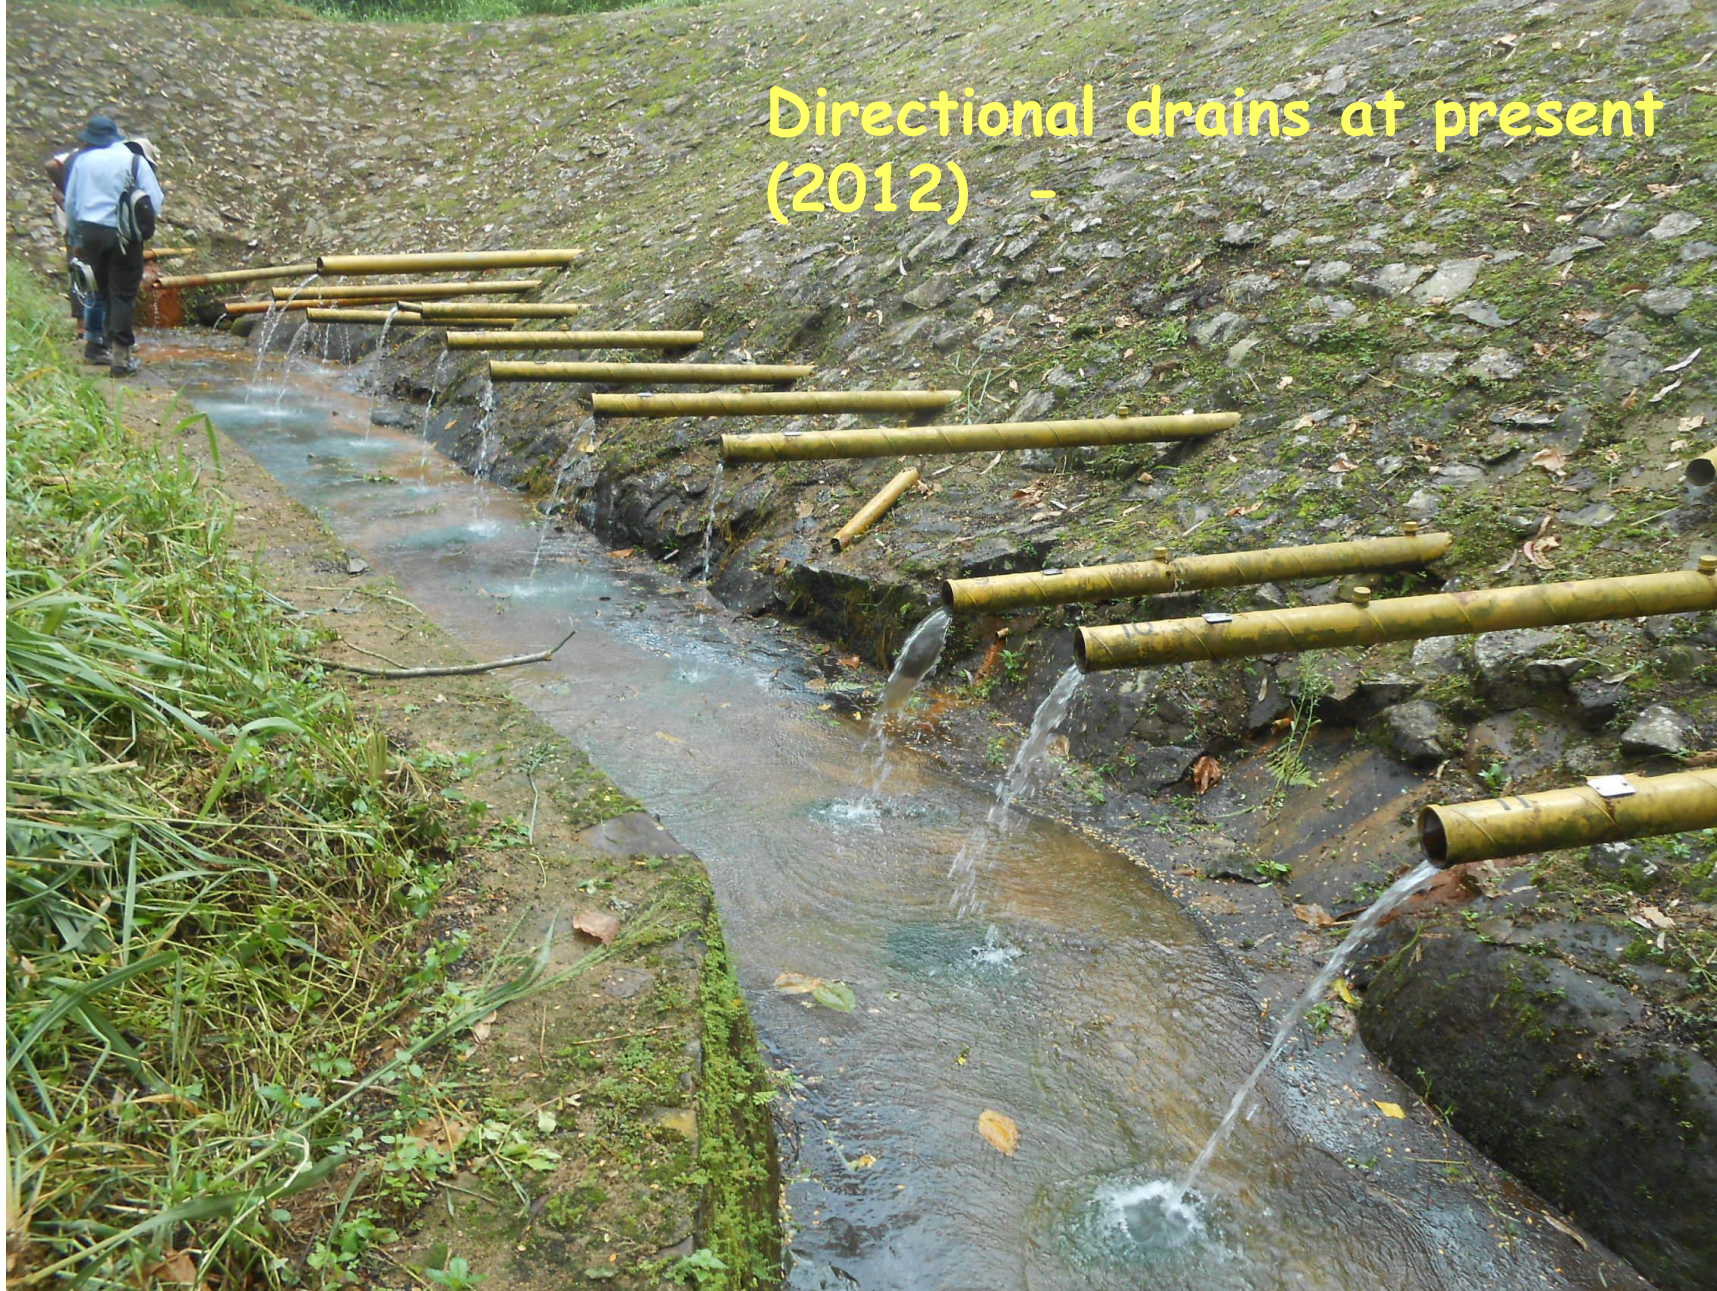
Directional drains at present (2012) -

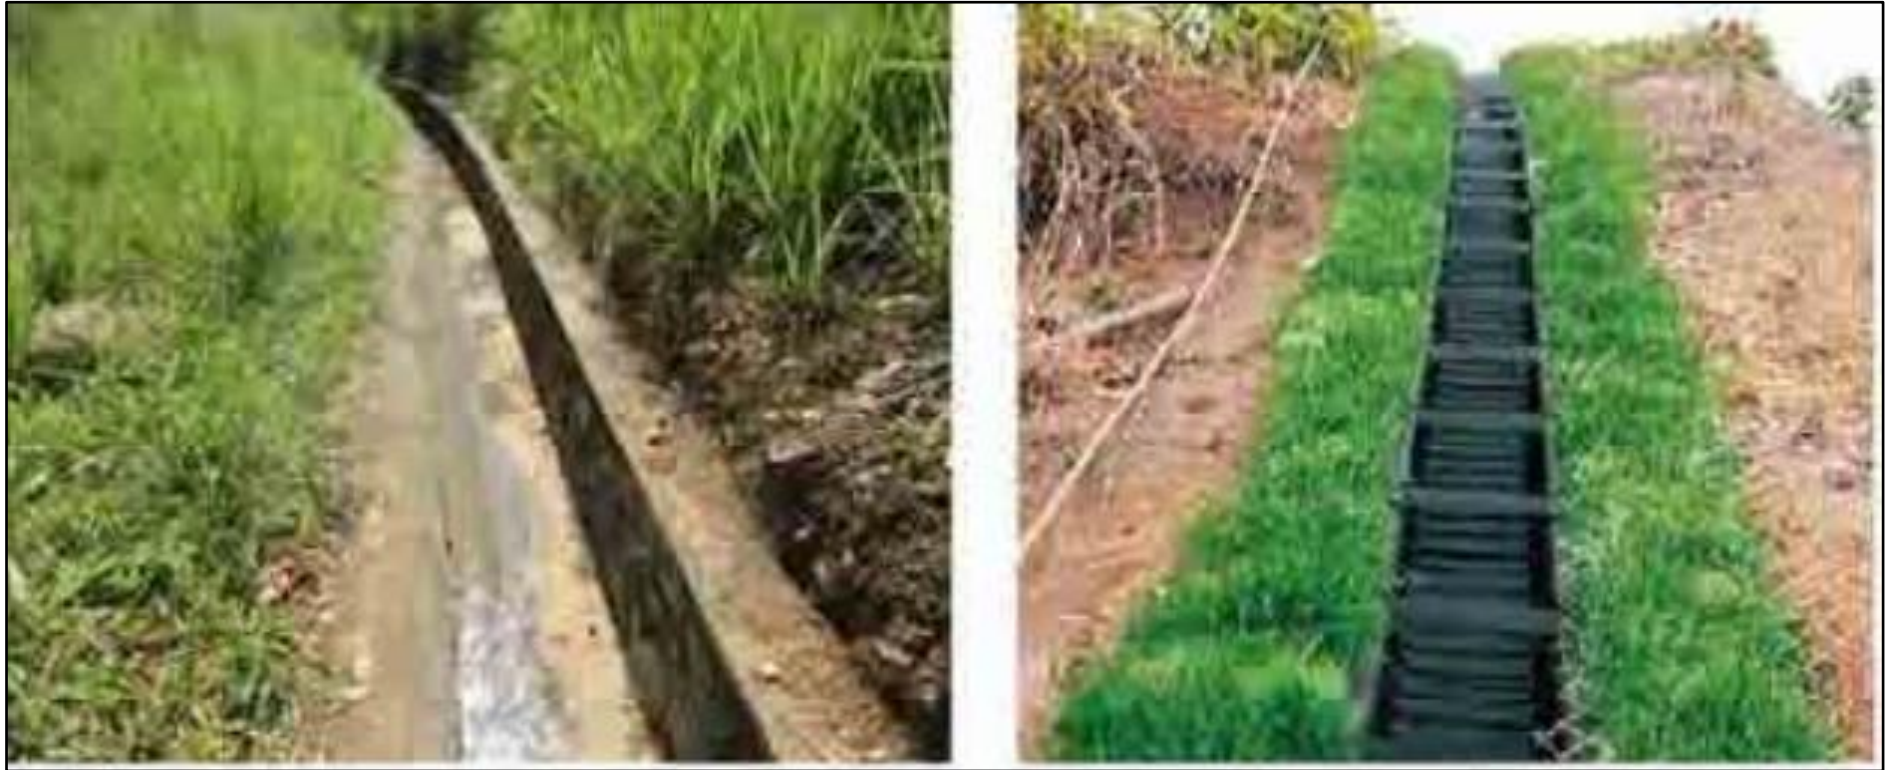
- The surface drainage ditches have been designed in align with natural channels to eliminate the infiltration and spring flow.
- The total length of the surface drainage ditches are 861 m.

Surface drainage measures (JICA Report, September 2015)

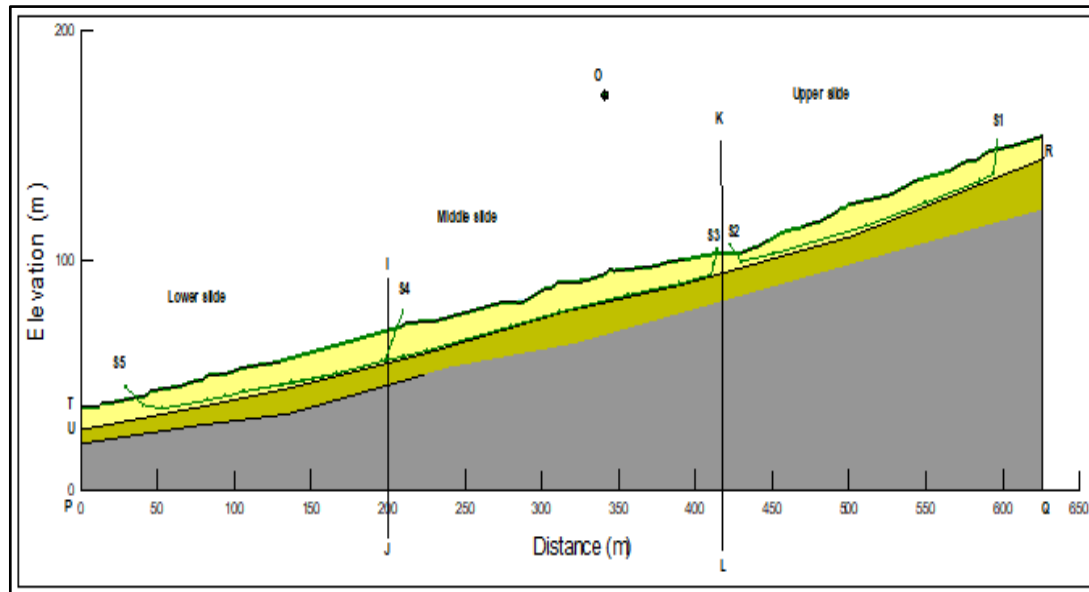
Two dimensional plane strain analysis (2D model): Limit Equilibrium approach

Assumed failure surface based on site investigation data

Two dimensional plane strain analysis with limit equilibrium approach

- The most critical cross section was identified using the site investigation data.
- Slip surfaces were fully specified (using the option available in the GEO SLOPE software) as per the data obtained from the site investigations and monitoring program
- Factor of safety of the respective slip surfaces, subjected to different conditions, were determined using the Spencer method which is valid for both circular and non-circular slip surfaces and accounts for both force and moment equilibrium

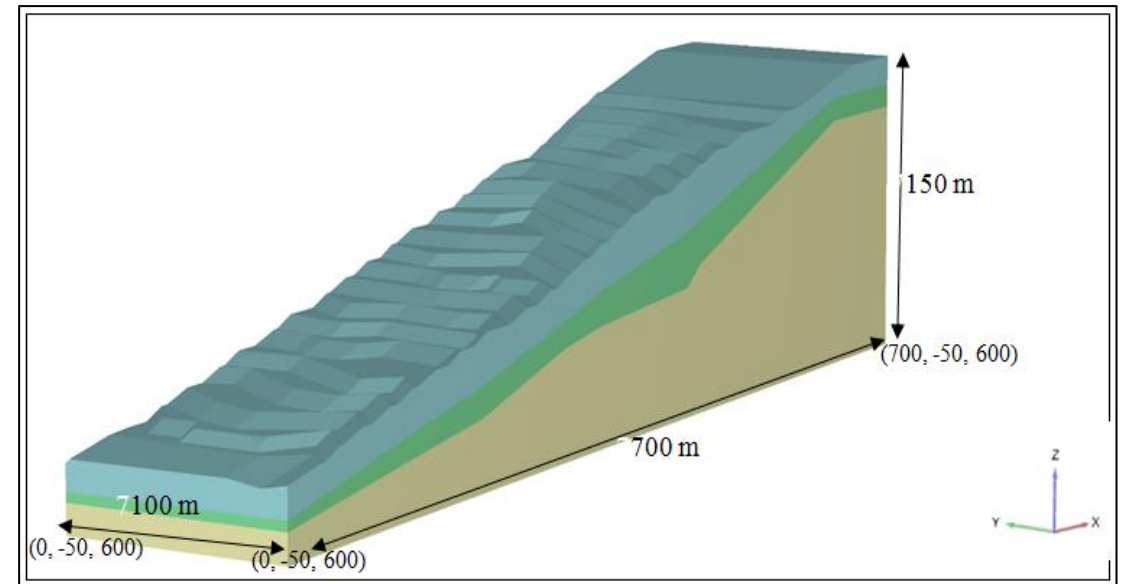
Three dimensional finite element model (3D model)

No assumptions of failure surface. Instead C-Phi reduction technique addresses for deformation and change in stresses

Three dimensional finite element analysis

- A real-scale 3D model of the slope was developed in PLAXIS 3D software using the site investigation and survey data
- The model represents the surface irregularities existing in the site
- Factor of safety of the slip surface was determined using the strength reduction approach available in the software

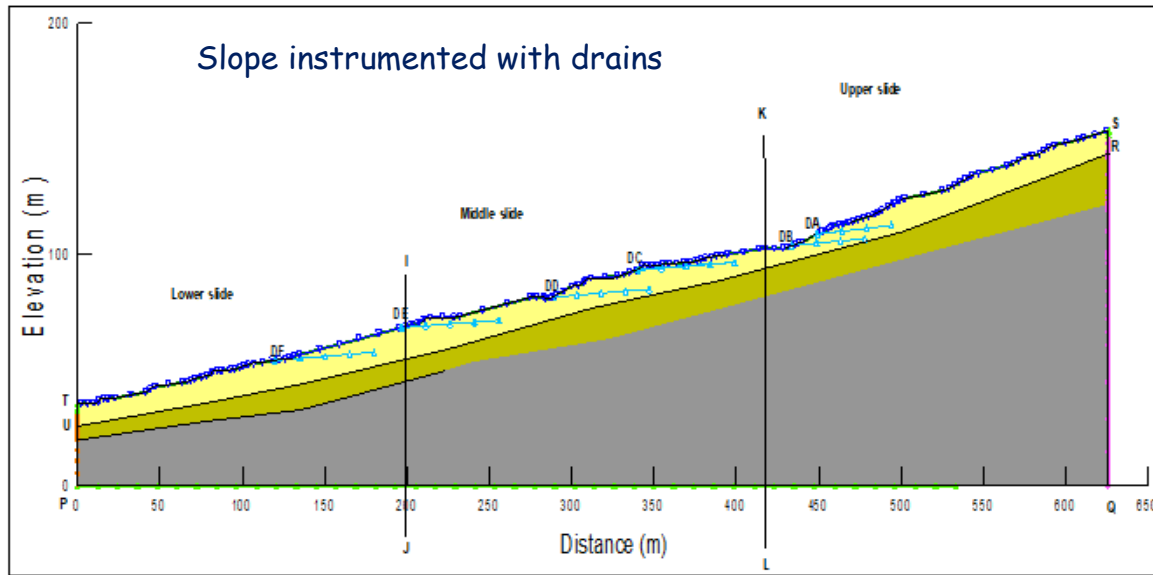
2D analysis : Summary of the analysis cases conducted

- Improvement of FoS with the construction of drains was assessed under three different construction sequences.
- Analyses were carried out for all four slip surfaces. (upper, middle, lower and a possible composite slip)

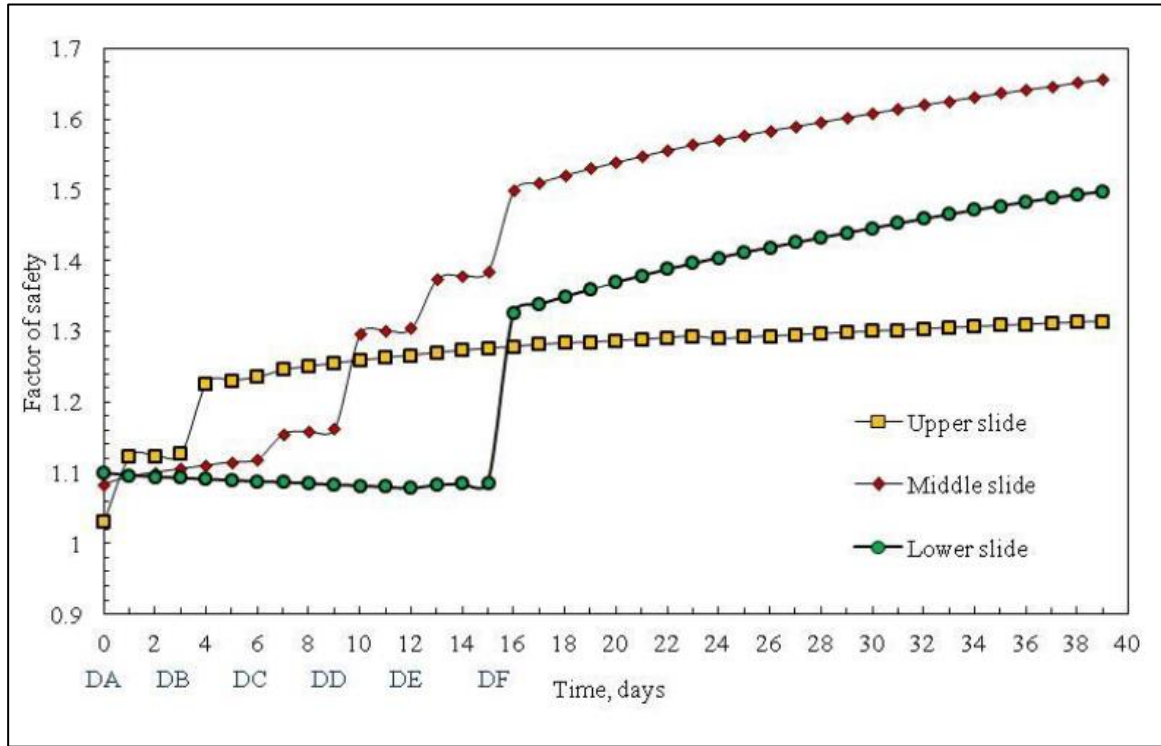
Variation of factor of safety under top down construction sequence

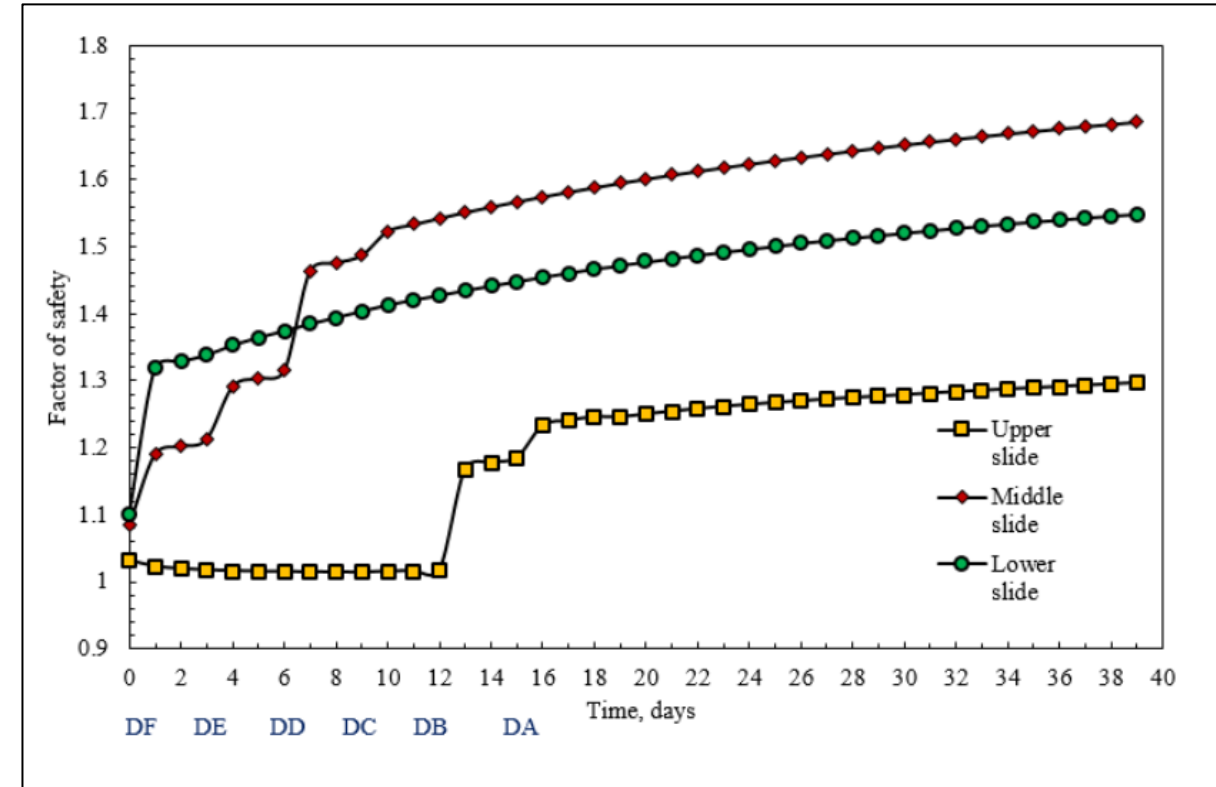
Variation of factor of safety under bottom up construction sequence

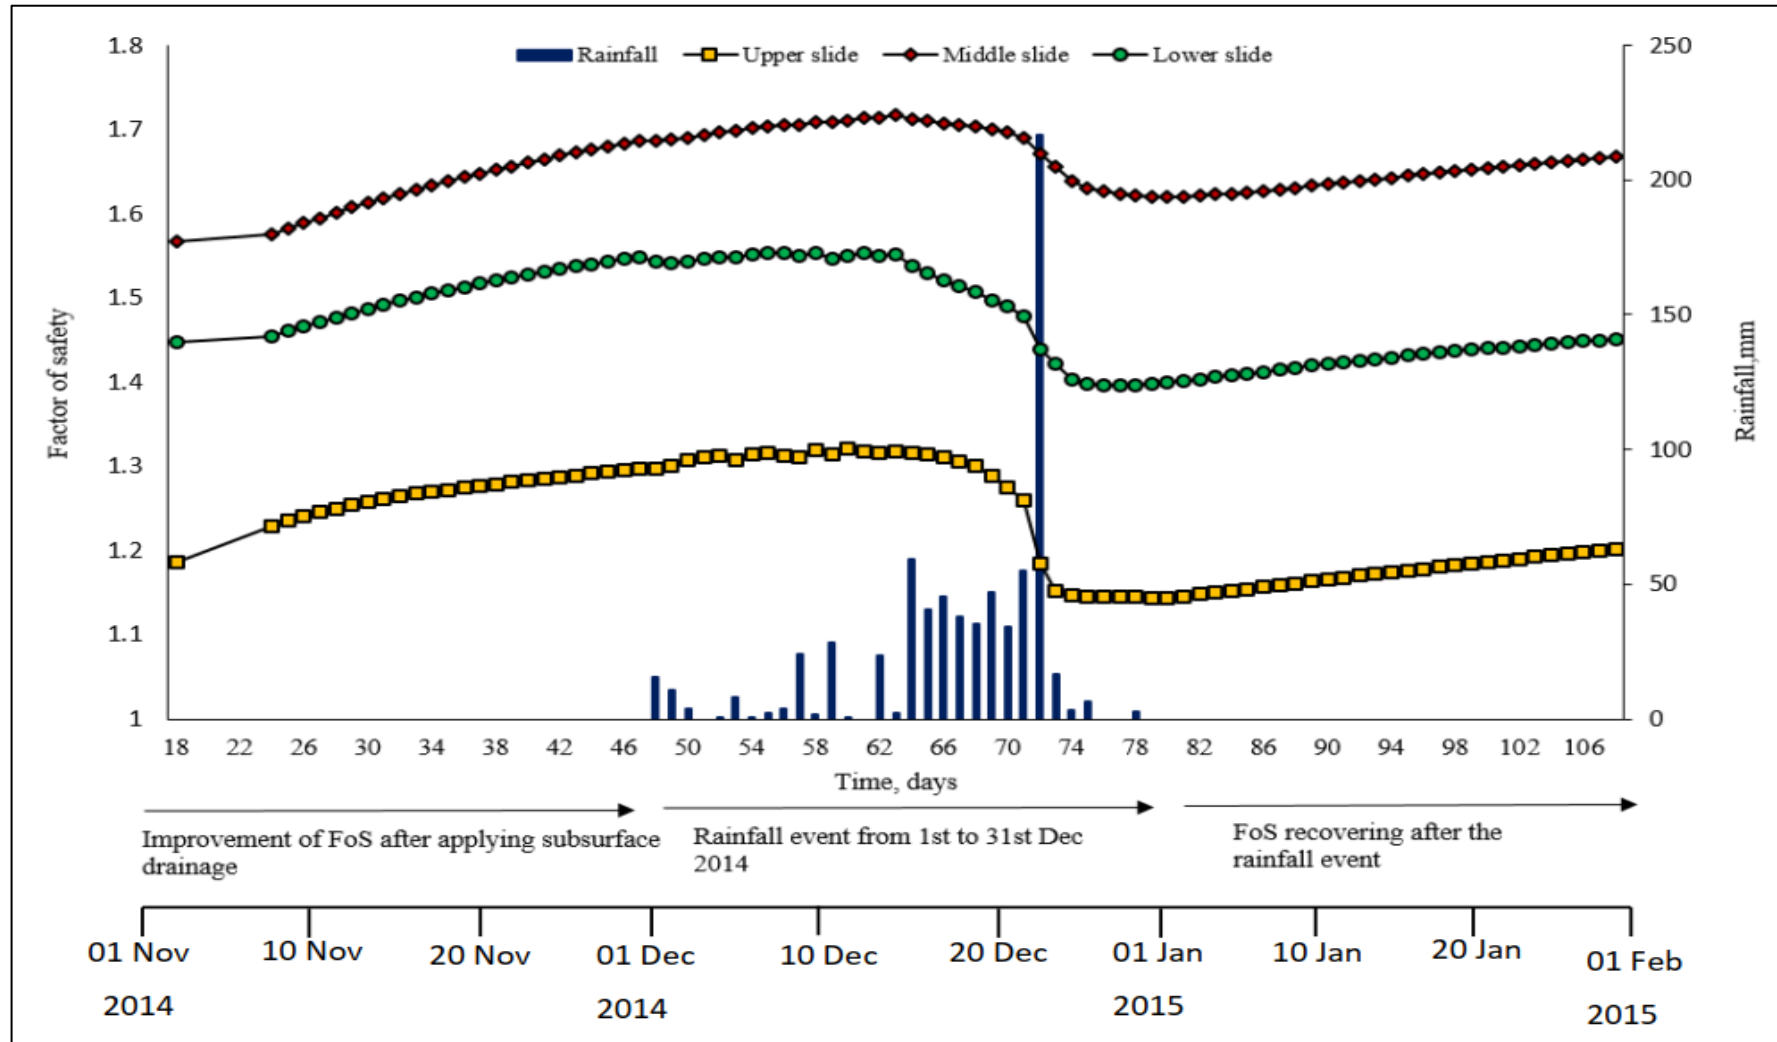
Variation of factor of safety of three rectified slides during a critical rainfall event

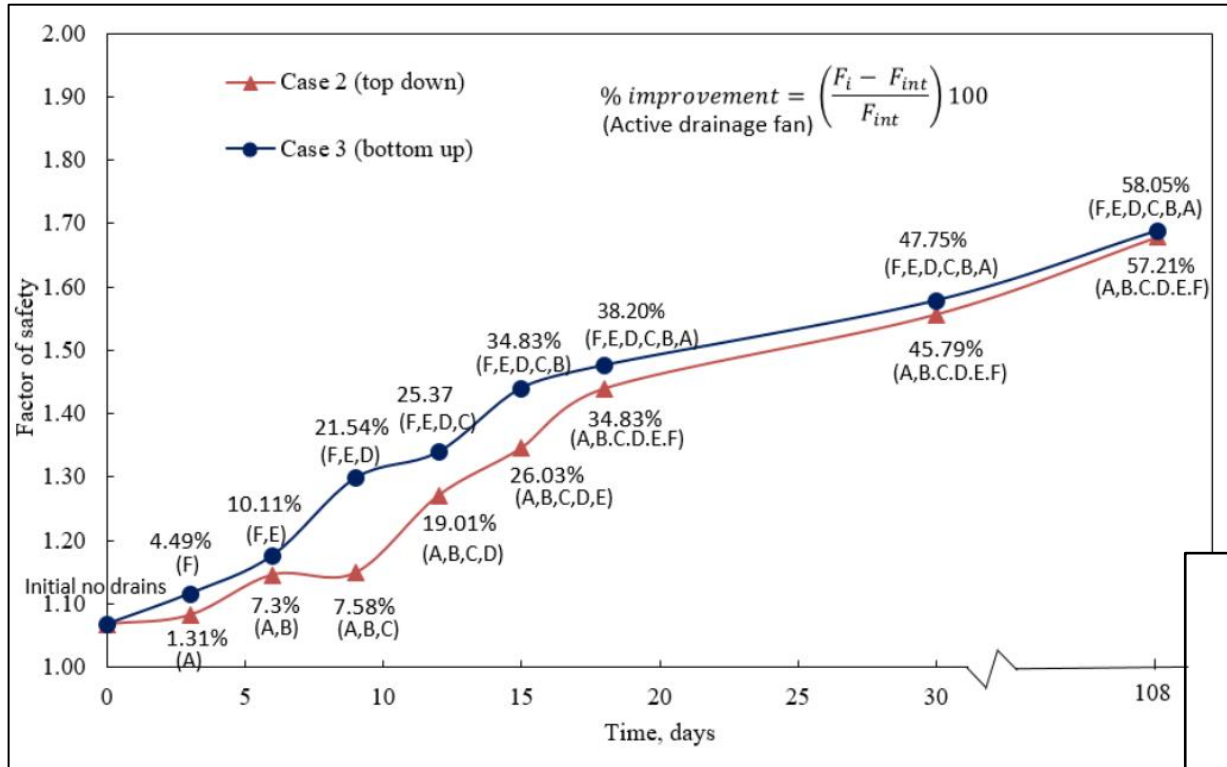
Factor of safety improvement for two different cases

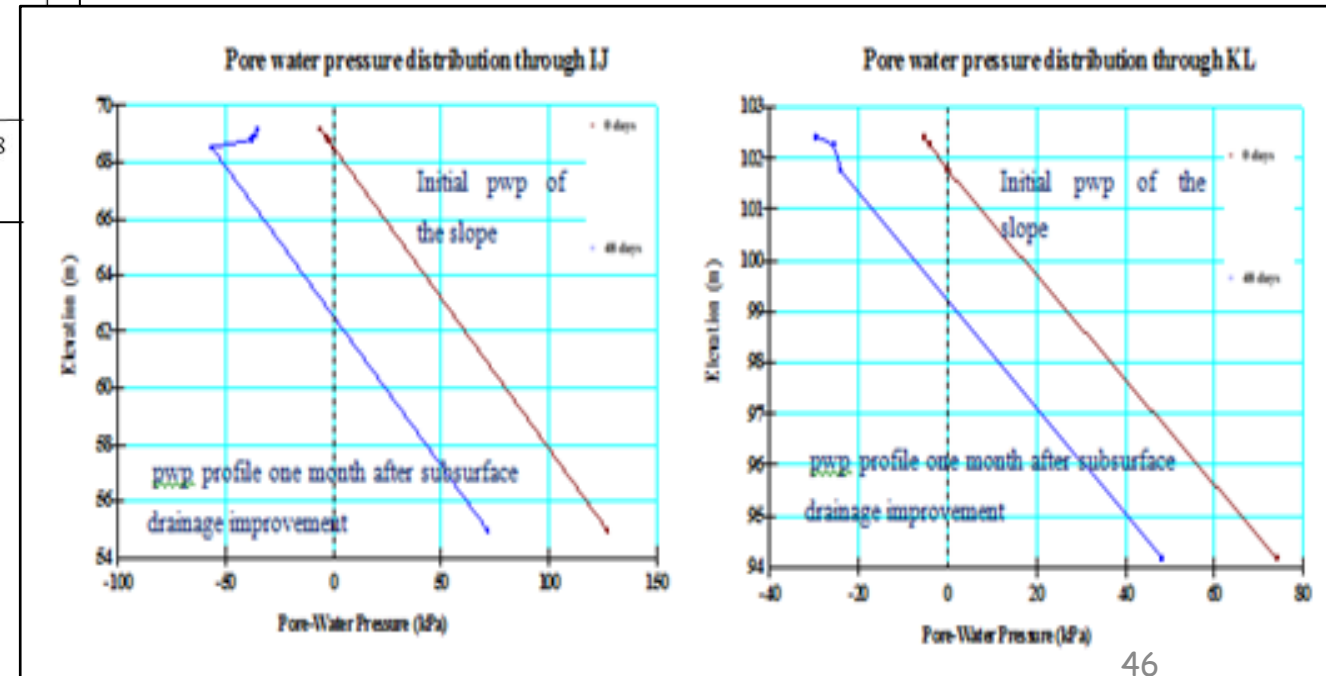
Variation of the pore water pressure profile before and after subsurface drainage improvements: (a) Section IJ, (b) Section KL

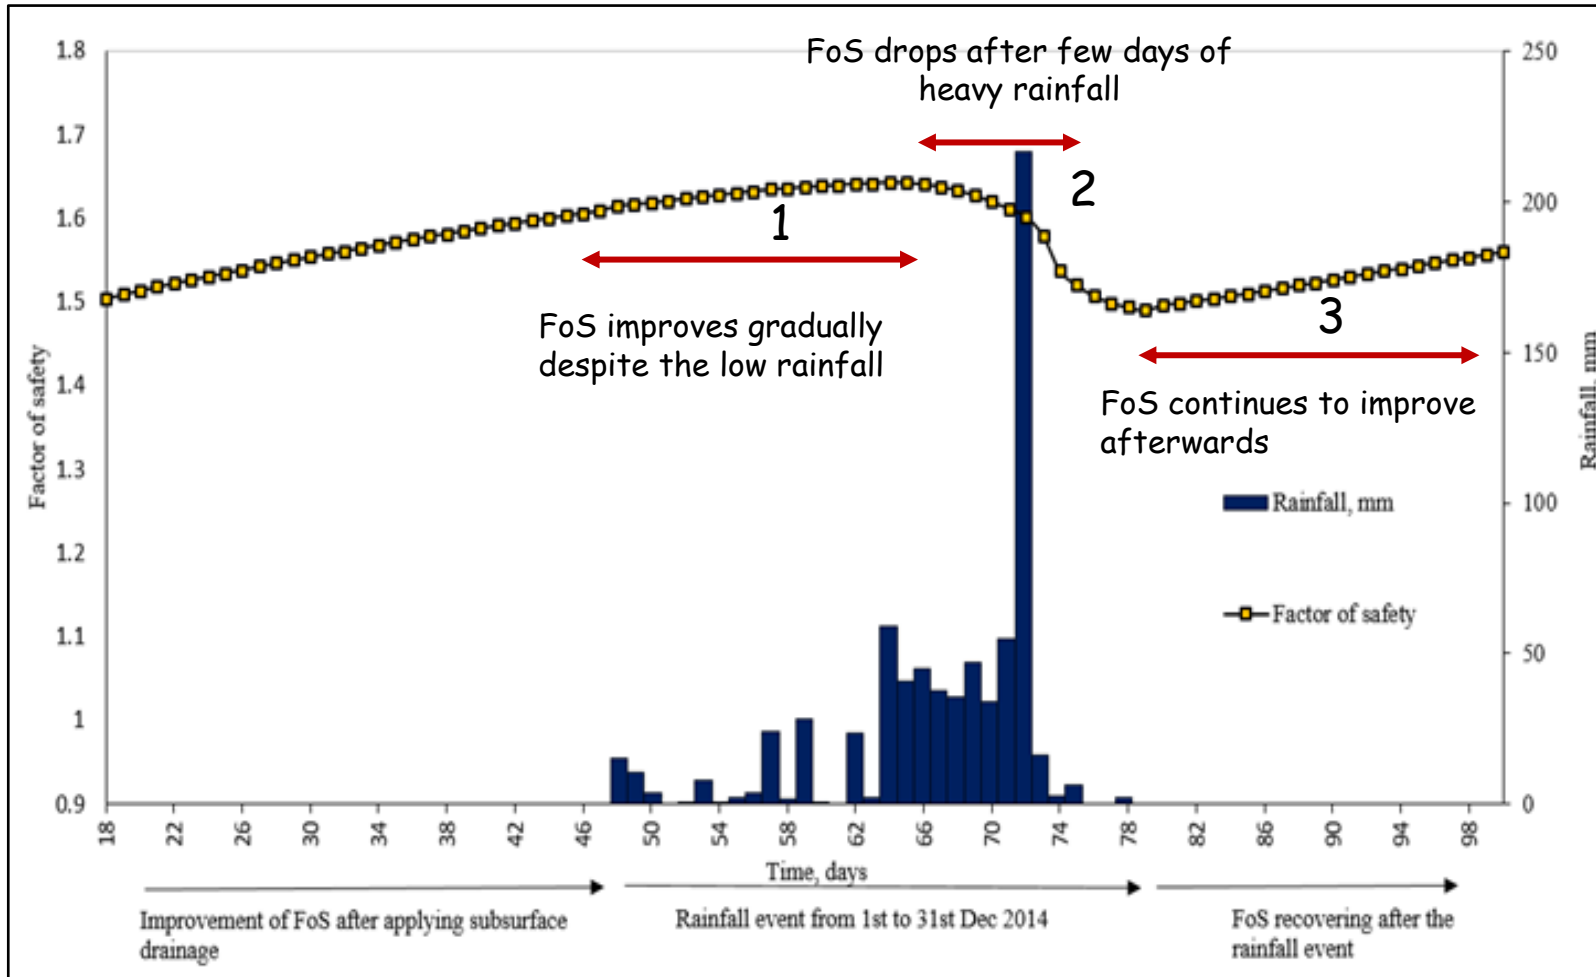
1. During the drain out of initial high ground water table conditions, some residual flow channels are already established. The light infiltration during this period is easily drained through these residual flow channels.
2. When larger infiltration occurs the capacity of residual flow channels are exceeded. Therefore, the water accumulate in the soil body and occupy the remaining void spaces. This results in reduction of FoS.
3. Once the rainfall event is over FoS continues to improve as expected.

Variation of Factor of safety with the daily rainfall
