Failure paths for levees

February 2022

PREPARED BY
Technical Committee on
Geotechnical Aspects of Dikes and Levees
(TC201)

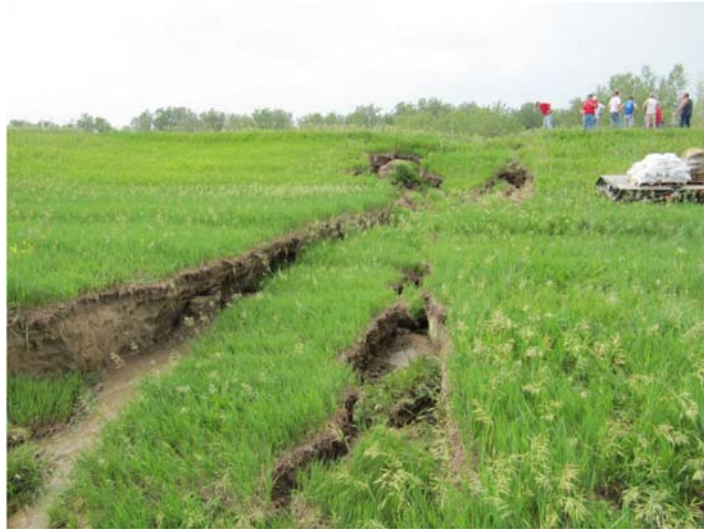
One of the breaches that occurred during the Missouri River flooding of 2011 occurred in the L-575 levee district which protects a large area of agriculture along with the city of Hamburg in southwest Iowa. The breach occurred in an area that had demonstrated several incidents of levee underperformance. Initial distresses, as shown in Figure 3.13 and Figure 3.14, narrowly avoided a full breach as the levee collapsed on itself, sealing off the underseepage path. Emergency repairs were initiated to reinforce this section of levee. The contractor and levee personnel were on site when the next distress appeared. There was a report of a “gurgling” sound, and then the levee collapsed on itself beginning from the protected side (land side) seepage berm and continuing toward the water side. As seen in Figure 3.14, an alluvial fan appeared at the protected side toe of the seepage berm. One additional incident (for 3 total) like this occurred before the final section of the levee breached. For all of these incidents, including the breach, there were a few meters of freeboard on the levee at that time.

Figure 3.13 The initial distress in the levee L-575.

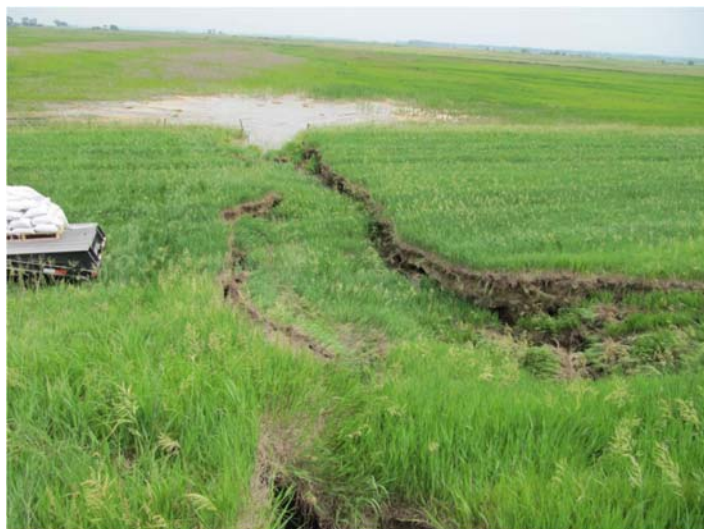
Figure 3.14 Initial distress in levee L-575 showing alluvial fan.

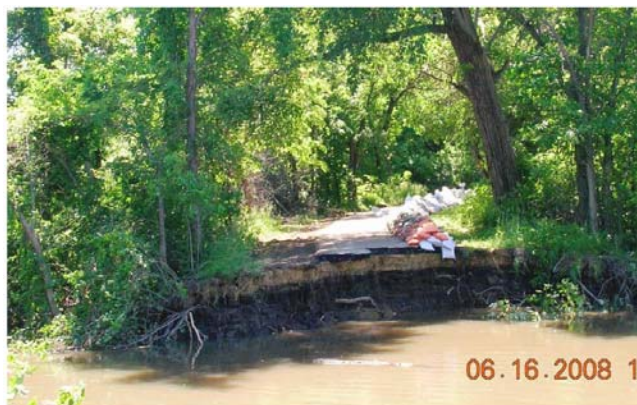
In the area behind North High School, local residents reported that the levee was “sinking” and that the water was “waist high” by 1600 hr. Figure 3.18 shows an image of the breached levee.

Figure 3.18 View looking to the southeast over the Birdland Levee breach (16 June 2008).

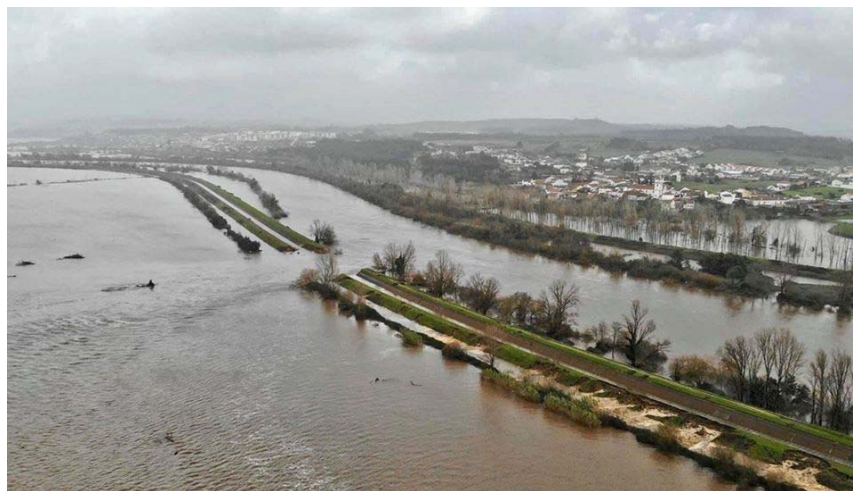
The causes of the failure are still being studied. Available information indicates that there was overtopping before the collapse.

The collapse led to the flooding of the fields in the Central Valley of the Lower Mondego and the cutting of communication routes. Infrastructure was severely damaged, not only the embankment but also the road and the conducting channel at the right bank, for the water supply of agriculture and industries.

Figure 3.21 View of Santo Varão after collapse of the embankment ⁵.

A plan is currently under development to reinforce the Mondego embankments. This plan will consist of integrated solutions, to be implemented in the coming years.

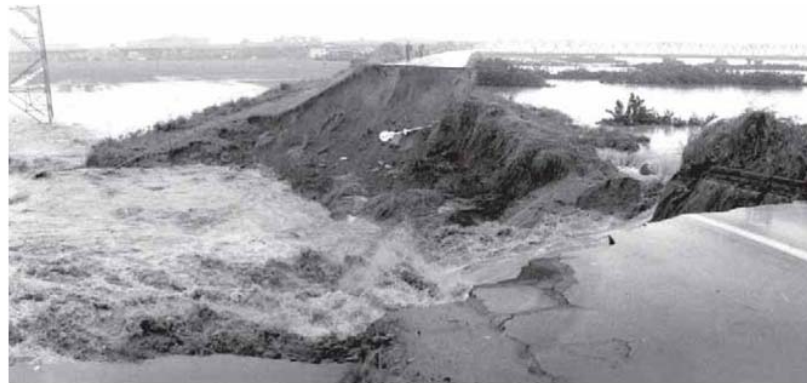
Figure 3.25 illustrates the protection works that were installed as well as the situation following the breach.

Just after
breach

Figure 3.25 Example of slope slide from the presentation 'Picture-Card Show Project' in JGS-JCES', contribution by K. Maeda, M. Ishihara and H. Mori, using materials from the Ministry of Land, Infrastructure, Transport and Tourism in Japan.

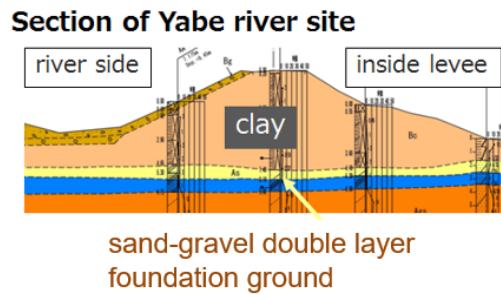
Figure 3.28 Example of piping erosion from the presentation 'Picture-Card Show Project' in JGS-JCES', contribution by K. Maeda, M. Ishihara and H. Mori, using materials from the Ministry of Land, Infrastructure, Transport and Tourism in Japan.

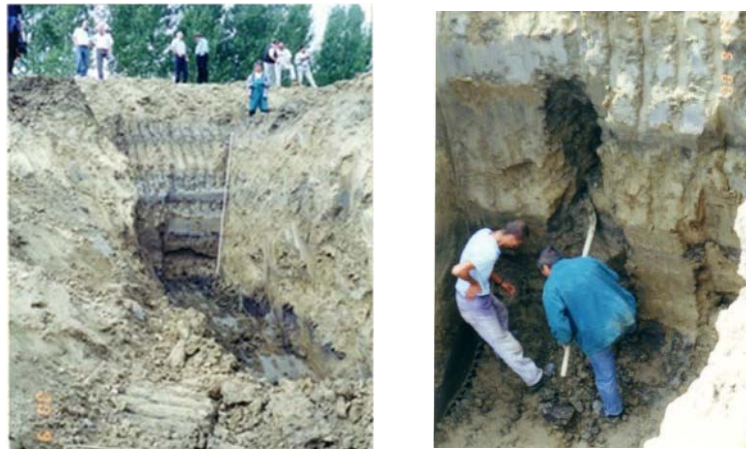
Based on the washout soil, which was more than two cubic meters, a sieve analysis was carried out. The uniformity coefficient of the silty sand was $C_U = 2,74$, $d_{80} = 0.11$ mm. The opening of the sand boil could only take place at the beginning of September. The cut through the levee showed the stratification and the path of the sand boil, which was first deep at the bottom and then it went up the waterside. Figure 3.40 shows the investigation and suggested that the sand boil occurred in a thick silty sand layer, which was covered with arched clay.

Figure 3.40 Opening of the sand boil.

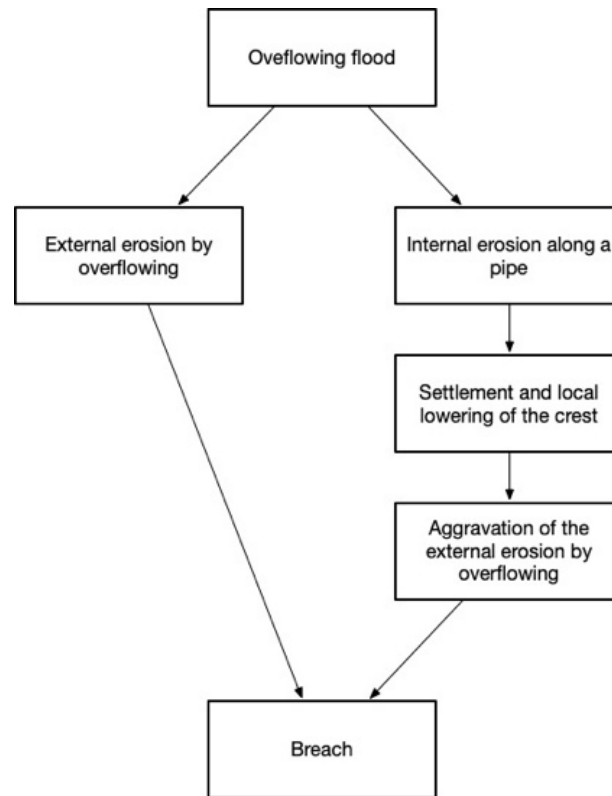
The 1999 breach has been caused by overflow at the location of the waste water treatment plant where internal erosion along a pipe crossing the levee also took place. This pipe probably aggravated the situation, because many other parts of the levee also were damaged by overflow but did not breach. Figure 3.50 shows this in the form of a diagram. It is even possible

Figure 3.50 Failure path for the 1999 Agly breach (Rémy Tourment).

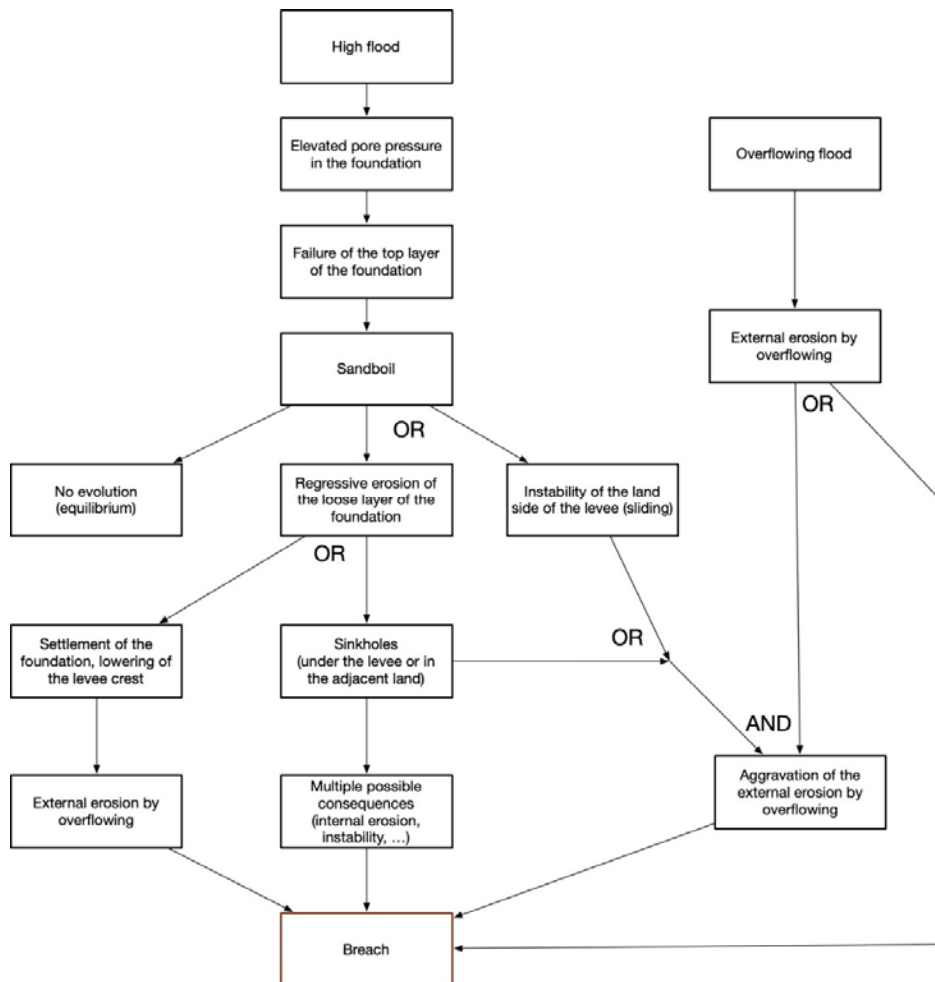
Figure 3.53 Failure tree involving a sand boil (Rémy Tourment).

Figure 3.53 was developed based on the analysis of the various observed damages in relation to the sand boils, using expert analysis. However, for actual cases not all damages lead to the final step of a breach as the condition for continuation to the next step is not always met.

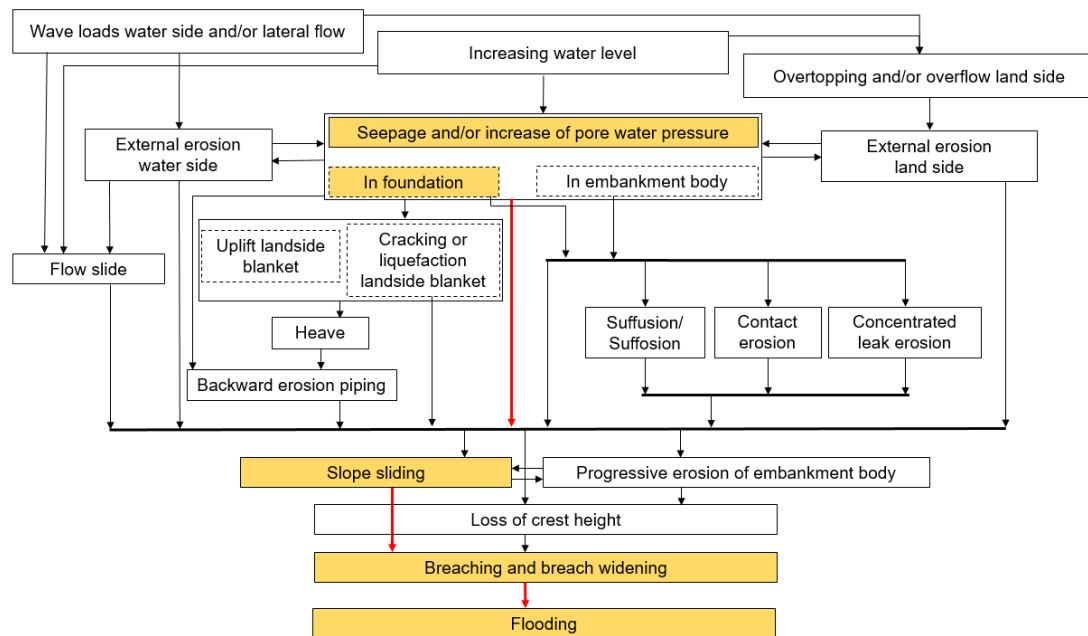
- Increase of water pressures in base:
 - In tensile cracks along sheet pile (cracks affected by shrinkage and pore water pressure);
 - Presence of locally more permeable silt layer in foundation peat layers conducting water along cracks to foundation.
- Slope sliding
 - Extremely dry conditions leading to weight loss and shrinkage of peat embankment;
 - Higher pore water pressure in foundation due to shrinkage at sheet pile and enhanced by presence of local silt layer;
 - Discontinuities present from past land use.

Figure 3.54 Failure tree of Wilnis levee breach, 2003.

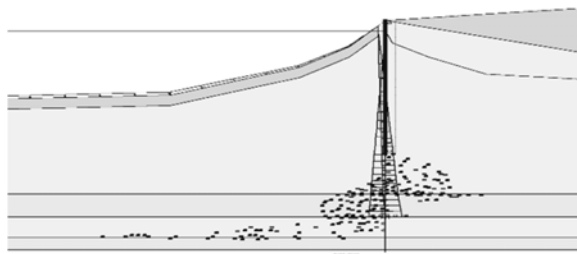
An investigation of the effects of water pressure in vertical cracks in peat showed the cracks to widen substantially upon pressure, due to the very low stiffness of the peat, and despite the peat not being very impervious (see Figure 3.58). The resulting shear stresses at the tip of the water filled cracks in the peat were found sufficient to cause fracture expansion and growth. Thus, penetration of the hydraulic head of the canal a few meters deep along the sheet piles in the peat would result in fracture propagation. Shrinkage of peat due to the dry weather conditions adversely affected stresses and deformation at the sheet pile wall. Increase in evaporation causes negative pore pressure, which induces shrinkage of peat below the already intensely fractured top layer, creating tensional stresses parallel to the levee surface over the depth of the zone experiencing negative pore pressure. The tensional stresses exert a pull on the peat at the sheet pile away from the canal (see Figure 3.58), thus enhancing creation of space along the piles and adding some tensional stress at the tip of shallower cracks. It must be noted that horizontal fracture-like surfaces are widespread in the peat mass. The extent to which the sub horizontal stresses can be transferred across such rough planes was not investigated. These planes are known to be conduits for water in peat, however, enabling high-water pressures to be transferred efficiently through the peat mass. Fracturing of the peat mass by water pressure is therefore not limited to the tip of the initial leak.

Figure 3.58 Cross section of the canal and levee with sheet pile. The dots at the base of the pile indicate occurrence of plastic behaviour in calculations using a Mohr Coulomb model.
