## Structural mitigation of a deep-seated slow moving landslide along a major national road in Sri Lanka

**Asiri Karunawardena**

**ABSTRACT:** The government has implemented large-scale landslide mitigation works along the National roads in highland areas to avoid the frequent disturbance of the transport system due to the occurrence of landslides. The stabilization of Kahagolla landslide is one of the largest mitigation works carried out under the “Landslide Disaster Protection Project”. This landslide was first identified in 1957 and creep movements have followed thereafter at different times affecting the road structure. Detailed field and laboratory investigations, instrumentation and monitoring were performed to investigate the characteristics and the possible causes of the landslide. Stability analysis were carried out on the established landslide profile based on the above information and results indicate that some parts of the landslide are in a highly active stage. Also, analysis indicates that the main reason for landslide activation is the increase of ground water level and subsequent loss of slip surface strength. Based on the results of investigations and stability a

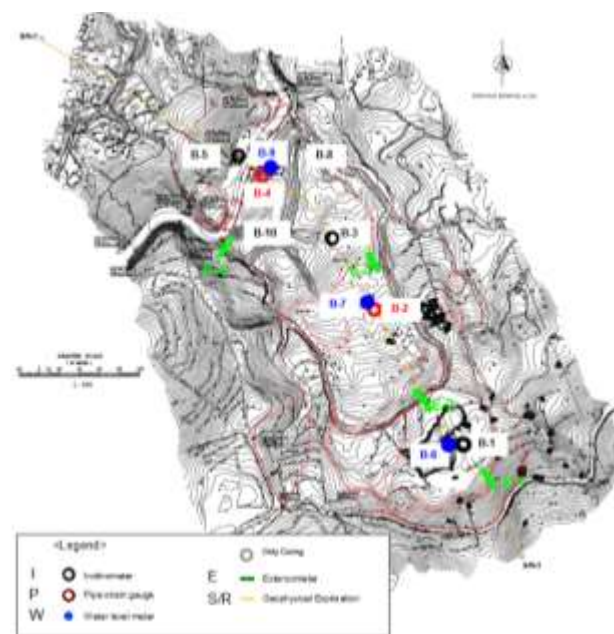
Figure 2. Map of main investigation and instrumentation points

Based on the review of existing reports and the result of the preparatory field surveys, the main investigation and monitoring locations were planned and these are shown in Figure 2.

Field monitoring instrumentation, namely pipe strain gauges, inclinometers, extensometer, water level meters and rain-gauge were installed at identified locations to monitor the behavior of the landslide as indicated in Figure 2. Monitoring was carried out for about a year covering the monsoon periods before the detailed design was carried out and thereafter it was continued during the construction period too. Monitoring was done once a month during the dry period and twice a month during the rainy period. The response of monitoring devices of water level meter and extensometer for the rainfall received is shown in Figure 4. Main observations of the landslide monitoring were made to reveal the relationship with rainfall patterns and slip occurrence.

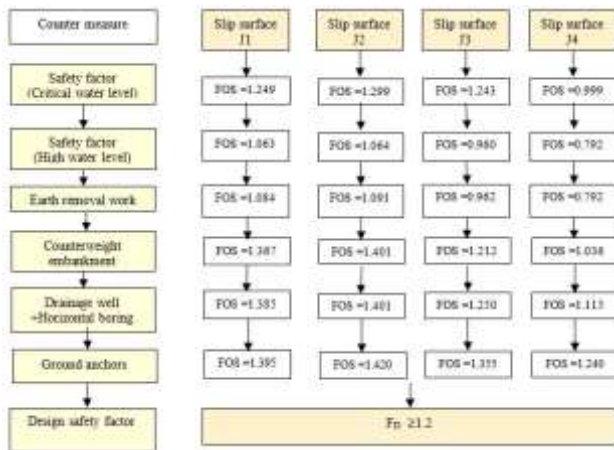
Figure 11. Flow of the safety factor

Counterweight embankment plays a huge role in stabilizing the slip surface J1 and J2 while other most critical slip surfaces are stabilizing with groundwater control works. However, in order to achieve desirable safety margin in slip surface J4, ground anchors are also included in the design.

Based on the results of investigation and stability analysis, several suitable combinations of countermeasures were considered, and examined to decide a couple or more appropriate combinations of countermeasures in terms of both economic efficiency and design requirements. From the more appropriate combinations of countermeasures, an optimum combination of countermeasures was selected by careful examinations and comparison among them. The improvement of safety factor with application of each counter measures are given in Figure 11. The plan and cross section of proposed countermeasures for the landslide mitigation are given in Figure 12.
